# Product Safety Recall

## N212342780 Improper Roof Rail Airbag Deployment

Release Date: August 2021

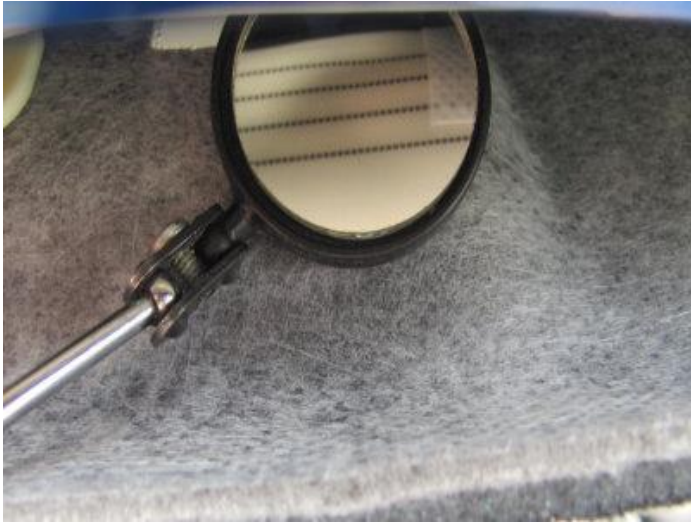
5879614

5. Inspect the airbag from the upper quarter panel trim to the center pillar. There are two black plastic ramps, one at each end of the inspection area.

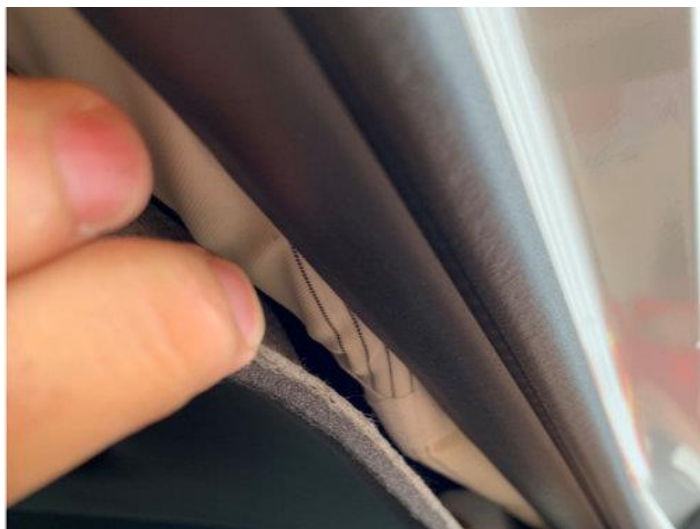
5879619

### Unacceptable Example of Stitching 1

12. Remove all roof rail airbag push pin and threaded fasteners forward of the twist condition. Refer to *Front and Rear Row Roof Rail Airbag Replacement* in SI.
13. Straighten the twist condition using the black stitch lines for reference.
14. Reinstall the roof rail airbag push pin and threaded fasteners in sequence, from rear to front. Verify the black four-line stitching is straight and parallel after installing each fastener. Refer to *Front and Rear Row Roof Rail Airbag Replacement* in SI.
15. Reinstall the interior trim components and weatherstrips. Refer to the appropriate sections in SI.
16. Rearm the SIR system.
