Product Safety Recall

N212345940 High Voltage Battery May Melt or Burn

Release Date: December 2021
Revision: 01
Revision Description: This bulletin has been revised to replace the service procedure with the advanced diagnostic software using the sequential ZFA - Field Action Multimodule Coordinated Sequence programming. The customer letter has also been added. Please discard all previous copies of bulletin N212345940.

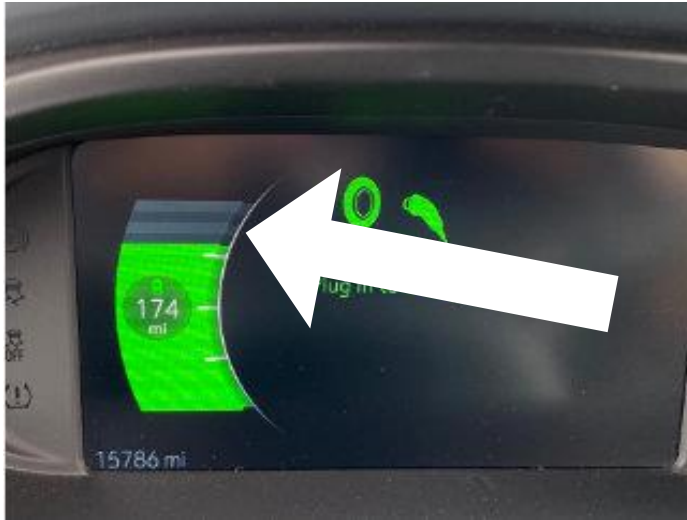
5924268

Important: Verify the vehicle SOC is less than 80%. This can be determined by looking at the bars on the power level indicator. If four or more empty bars (not showing green) are displayed, the SOC is at an acceptable level. If the power level indicator shows an SOC of greater than 80% The SOC must be adjusted before proceeding with the recalibration.

If required, reduce the SOC as follows:

- Vehicle in PARK, Vehicle ON.
- Headlamps Low Beam: ON.
- Temp Control: Hi (Max Heat High) (note: windows should be down).
- Distribution: MAX Defrost (Engages AC Compressor).
- Fan Speed: High (8).
- Select: Fresh Air (Not recirc).
- Select: Heat & A/C .
- If equipped, turn heated seats to hi position.
- Verify SOC after 60 minutes. If the SOC is still greater than 80%, allow additional time for the loads listed above to reduce the SOC to less than 80%.
- When the SOC adjustment is completed return the HVAC controls to 72 Deg. AUTO, Set the headlamp control to AUTO.

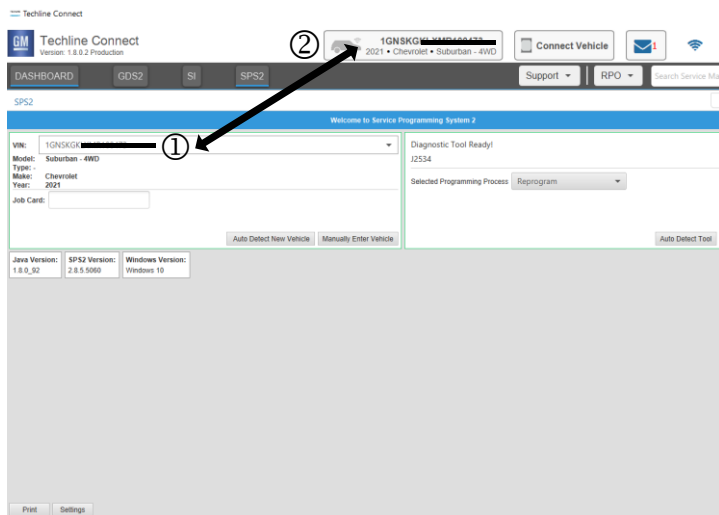
5743643

Caution: Be sure the VIN selected in the drop-down menu (1) is the same as the vehicle connected (2) before beginning programming.

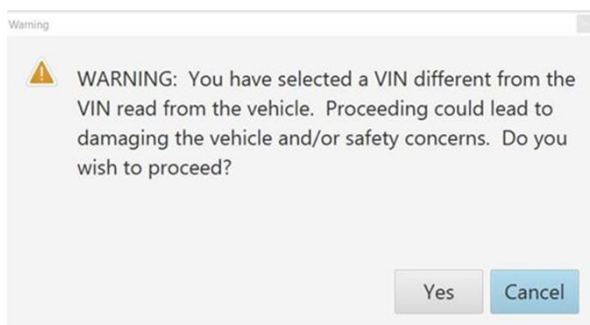
5877000

Important: If the vehicle VIN DOES NOT match, the message below will be shown.
