**CONDITION OF CONCERN**

**OUTLINE OF REPAIR**

**SUBJECT VEHICLES**

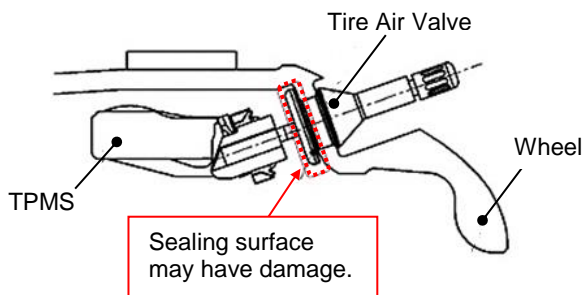
On certain subject vehicles, the wheel and tire assembly may be equipped with a tire air valve having damage to the air valve sealing surface. If the affected tire air valve is installed, it is possible that an inflated tire may result in either a slow or sudden loss of air. A sudden air leak from the tire air valve may cause a loss of vehicle control while driving, increasing the risk of a crash.

**Causal factor:**

Certain previously-installed and removed tire air valves might be mixed with new parts at the supplier due to improper isolation procedure. The previously-installed and removed tire air valve may have a damage on the sealing surface.

The tire air valves on all four wheel and tire assemblies will be replaced with new ones.
