SOP05532

QAAR 9949 Entry Assist Handle Wire

Routed too Close to Fridge Exhaust Flue.

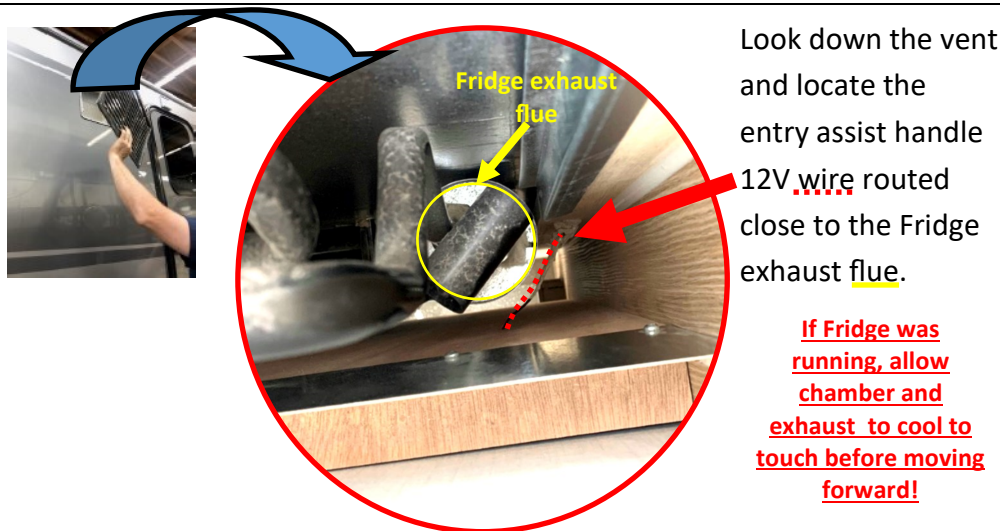
3

Look down the vent and locate the entry assist handle 12V wire routed close to the Fridge exhaust flue.

If Fridge was running, allow chamber and exhaust to cool to touch before moving forward!
