Applicability: 2019-20MY Ascent
2020MY Legacy & Outback

Number: WRK-21

Subject: TR690 Chain Guide Inspection / TCM Reprogramming

Date: 1/31/22

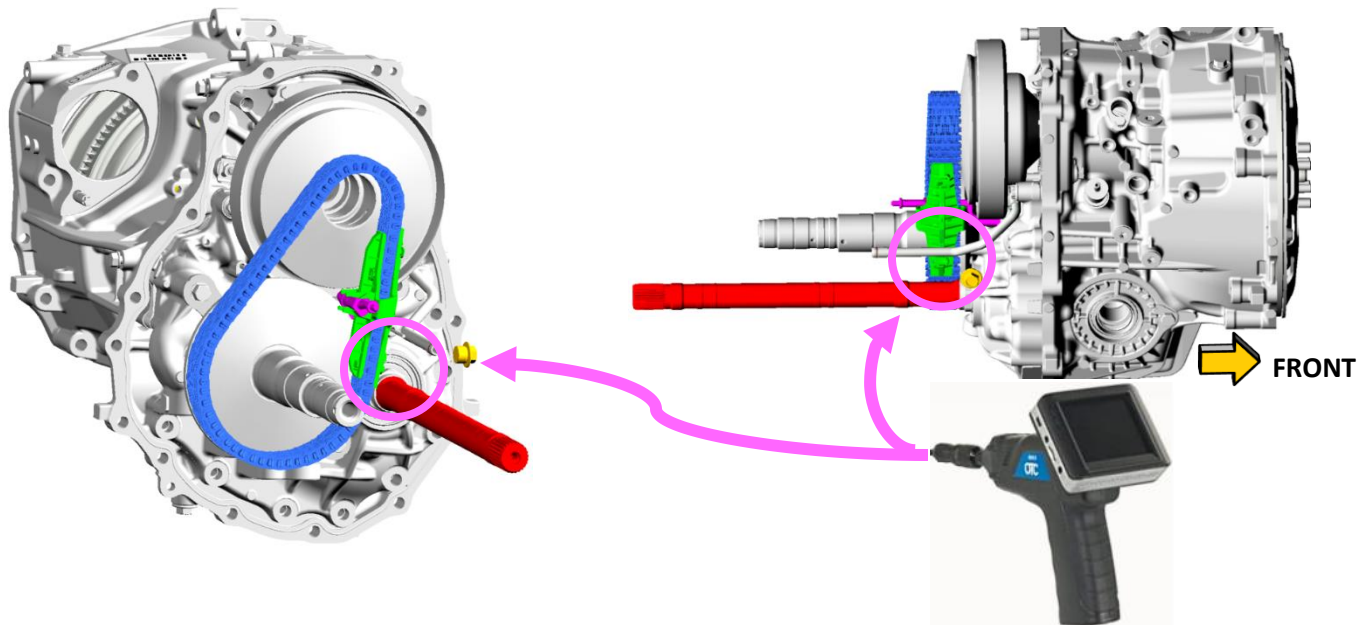
STEP 8E: Inspect the position of the lower end of the chain guide rail and the drive pinion shaft.

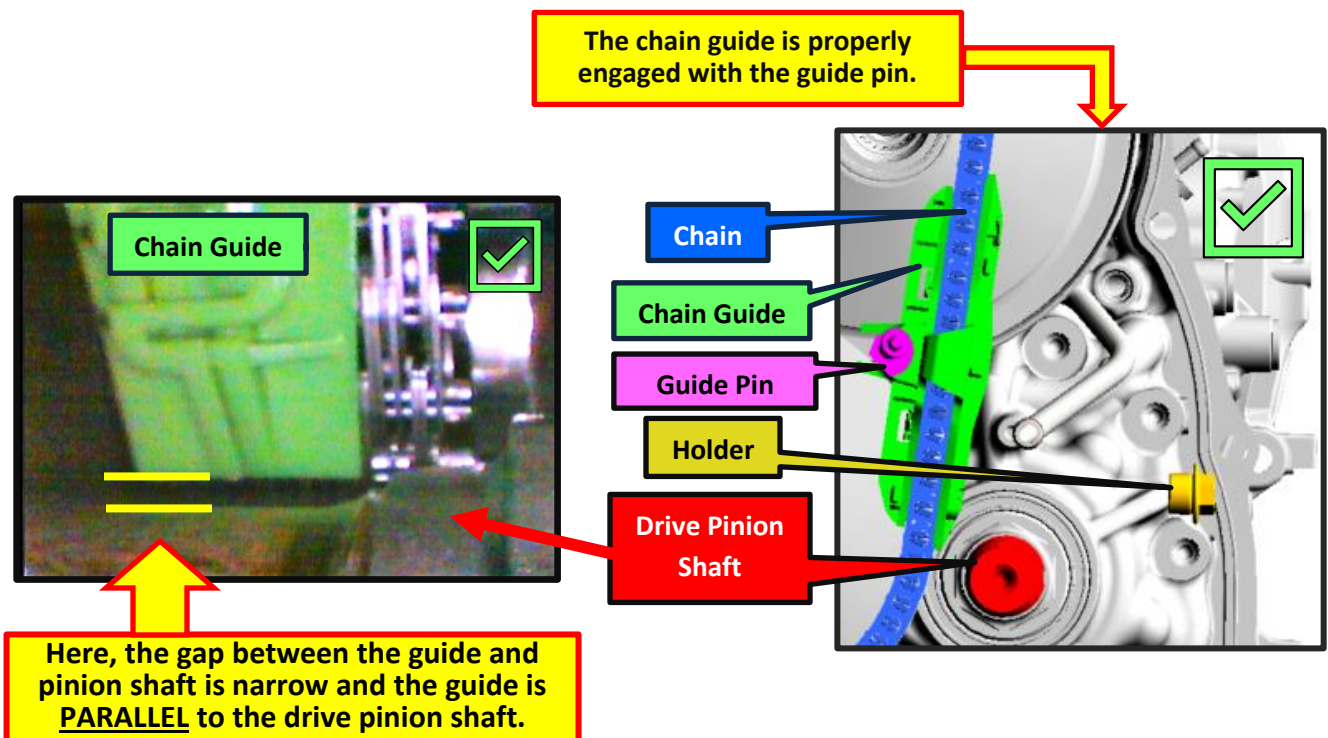
CORRECT GUIDE POSITIONING:

Result	Next step
CORRECT POSITION	Proceed to STEP 10
INCORRECT POSITION 1 OR 2	Proceed to STEP 9

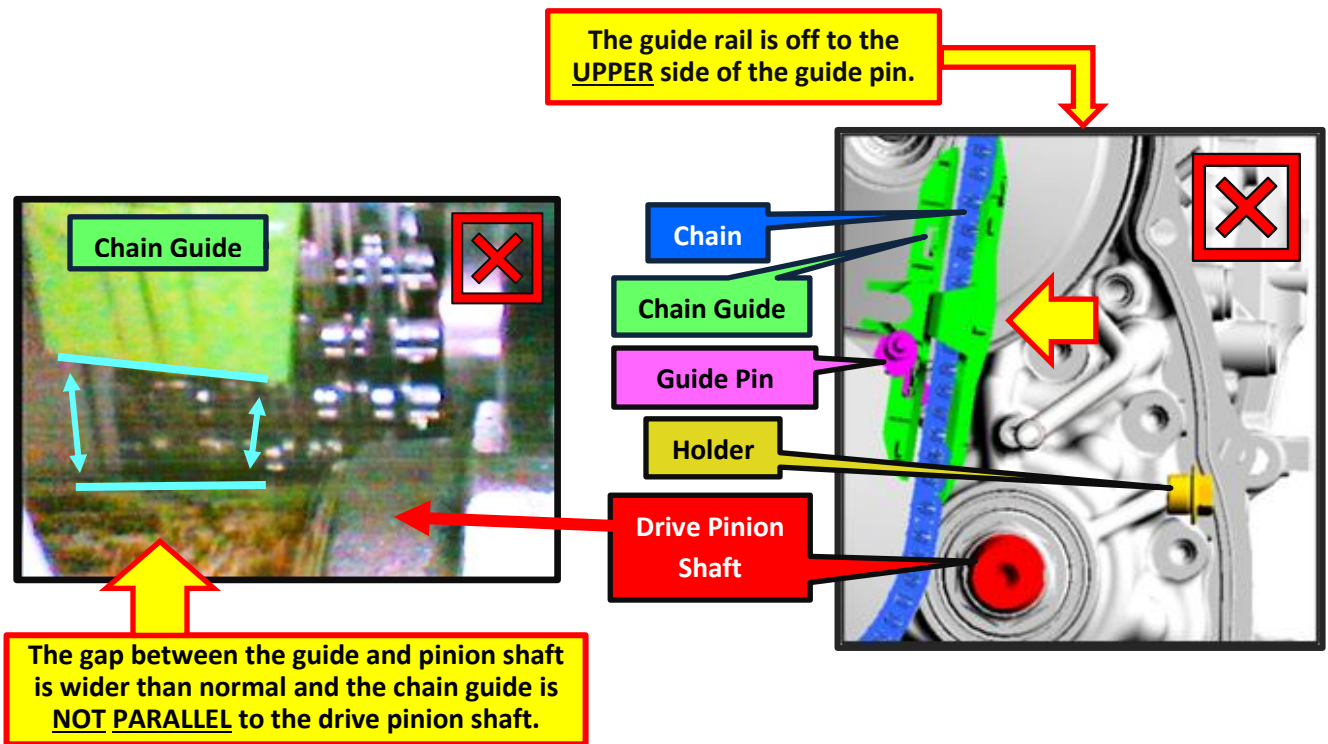
INCORRECT GUIDE POSITIONING 1:

STEP 9A: Replace the CVT assembly.

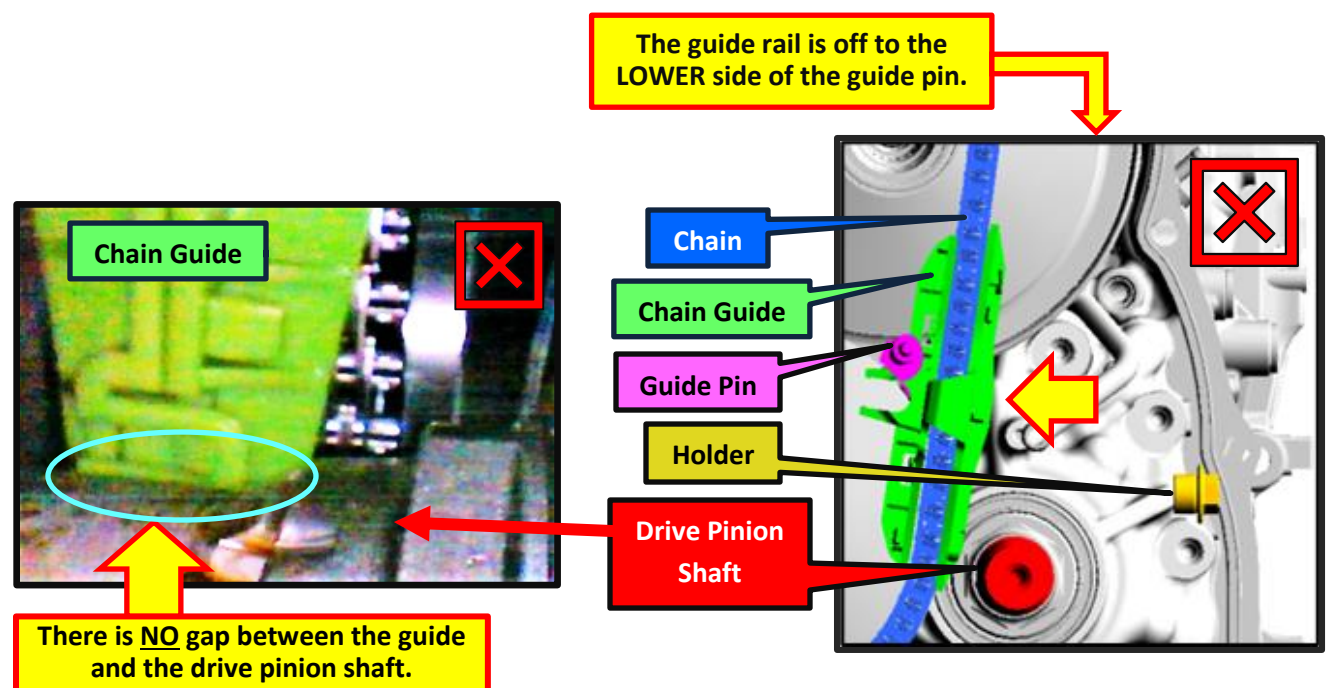
INCORRECT GUIDE POSITIONING 2:
