TO: Mercedes-Benz Principals, General Managers, Sales Managers, Service Managers, Parts Managers	FROM: Anthony Washington, Department Manager, Regulations and Certifications
Re: Recall Campaign Launch Notification Model 907 (Sprinter) Model Years 2021 Replace Tire and Loading Information Label	DATE: March, 2022

Campaign No. 2022030008 March, 2022

SUBJECT: **Model 907 Sprinter, Model Year 2021**
Replace Tire and Loading Information Label

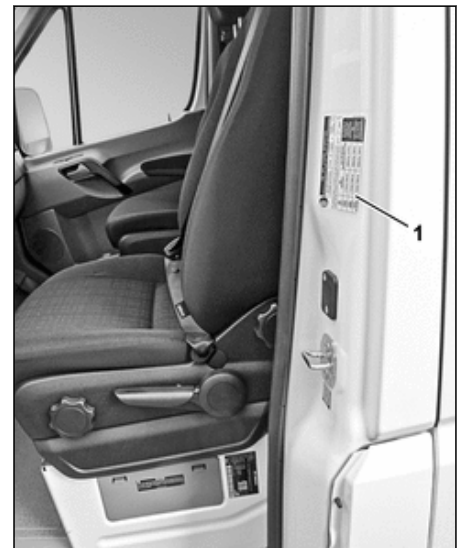
D40.10-1127-02

Mercedes-Benz AG (“MBAG”), the manufacturer of Mercedes-Benz & Freightliner Sprinter vans, has determined that on certain 907 (VS30) platform Sprinter vehicles, the tire and loading information label on the B-pillar could contain erroneous values that overstate the Gross Vehicle Weight Rating. Due to erroneous values for the maximum permissible combined vehicle weight on the tire and loading information label on the B-pillar, overloading of the vehicle could exceed the permissible total weight. As a consequence, over time, this could cause excessive tire wear and in a worst case scenario, could lead to tire failure, which could increase the risk of a crash. MBUSA/DVUSA is conducting a voluntary recall. An authorized Mercedes-Benz/Freightliner Sprinter dealer will check the tire and loading information label and replace it with a corrected label. Additionally, a visual inspection of the tires for excessive wear will be conducted. If necessary, tires with excess wear will be replaced on the affected axles.

1 Tire pressure table information label

WS	Replace tire pressure table information label (1). 000 588 00 84 00 Heat gun	<p>

Removal: Do not heat the B-pillar under the tire pressure table information label (1) too much. Otherwise the paint will be damaged.</p> <p>

Removal: To do so, remove the old tire pressure table information label (1) with a suitable tool and remove adhesive residue with a suitable cleaning agent.</p>	WS54.00-P-0049B
3	Attach protective foil at tire pressure table information label (1).

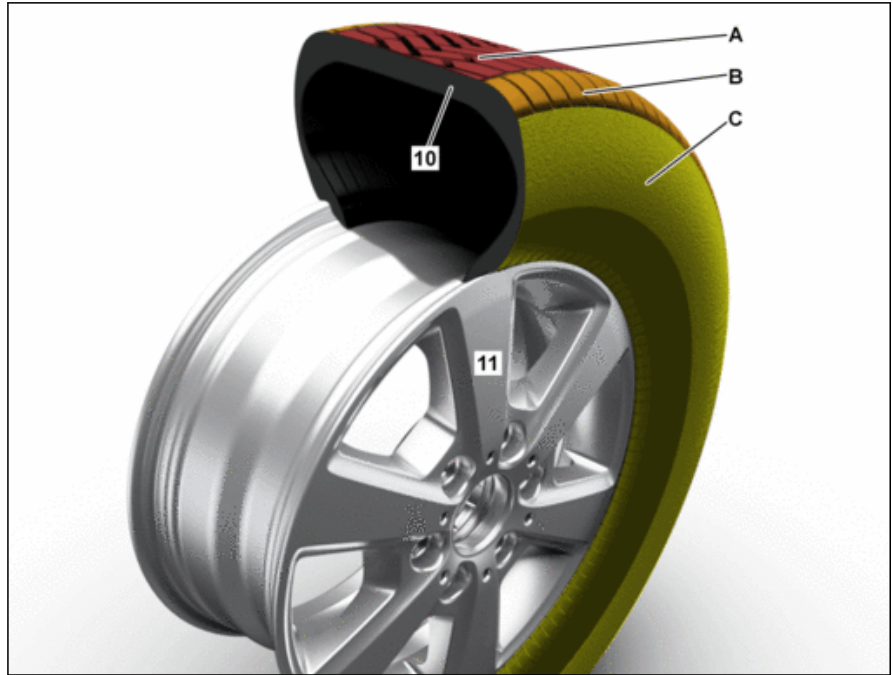
D40.10-A008-76

Schematic diagram of tire structure

- 10 Tires
- A Tread
- B Tire shoulder
- C Tire sidewall
- 11 Light alloy wheel

If the air pressure of the tires (10) is incorrectly adjusted, the wear at the tire shoulders (B) may be significantly increased in particular.</p> <p>If tire shoulders (B) do not exhibit any increased wear, ↓ Continue with operation step 7 and end measure.</p> <p>If tire shoulders (B) exhibit increased wear, ↓ continue with operation step 5.</p>

Replace		
6 AR	Replace tires (10) of affected axle.	<p>i Always replace tires (10) on an axle-by-axle basis.</p> <p>i Tire specifications for the order can be found in the previously installed tires (10).</p>	AR40.10-D-1030TS
7	Lower vehicle.
