Recall Campaign Bulletin

Campaign No. 2022030008 March, 2022

SUBJECT: Model 907 Sprinter, Model Year 2021

Replace Tire and Loading Information Label

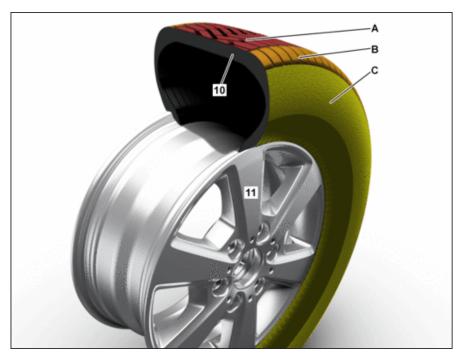
D40.10-A008-76

## Schematic diagram of tire structure

10 Tires

A Tread

B Tire shoulderC Tire sidewall

11 Light alloy wheel

Replace		
2 ⊯ws	Replace tire pressure table information label (1). 000 588 00 84 00 Heat gun		WS54.00-P-0049B
M WS		Bonding surface must be absolutely free of dust and grease. Otherwise, a sufficient degree of adhesion cannot be assured.  Removal: Do not heat the B-pillar under the tire pressure table information label (1) too much. Otherwise the paint will be damaged.  Removal: To do so, remove the old tire pressure table information label (1) with a suitable tool and remove adhesive residue with a suitable cleaning agent.	
3	Attach protective foil at tire pressure table information label (1).		
4	Check		
4	Raise vehicle.		
Notice	Special instructions for lifting and supporting vehicle		AH00.60-D-0100-01KTS
<b>⊯</b> AR			AR00.60-D-1000-04TS
5	Check wear at tire shoulders (B).	If the air pressure of the tires (10) is incorrectly adjusted, the wear at the tire shoulders (B) may be significantly increased in particular.

If tire shoulders (B) do not exhibit any increased wear,	
		Continue with operation step 7 and end measure.	
		If tire shoulders (B) exhibit increased wear,	
		continue with operation step 5.

Replace		
6	Replace tires (10) of affected axle.		
<b>⊯</b> AR			AR40.10-D-1030TS
		Always replace tires (10) on an axle-by-axle basis.  i  Tire specifications for the order can be found in the previously installed tires (10).	
7	Lower vehicle.
