Stacy L. Balzer
 Operating Director
 Service Engineering Operations
 Ford Customer Service Division

December 14, 2022

SUBJECT: **NEW VEHICLE DEMONSTRATION / DELIVERY HOLD**
Safety Recall 22S06 - Supplement #2
 Certain 2015-2017 Model Year Mustang Vehicles
 Luggage Compartment Lid Wiring Inspection and Rear View Camera Improper Function

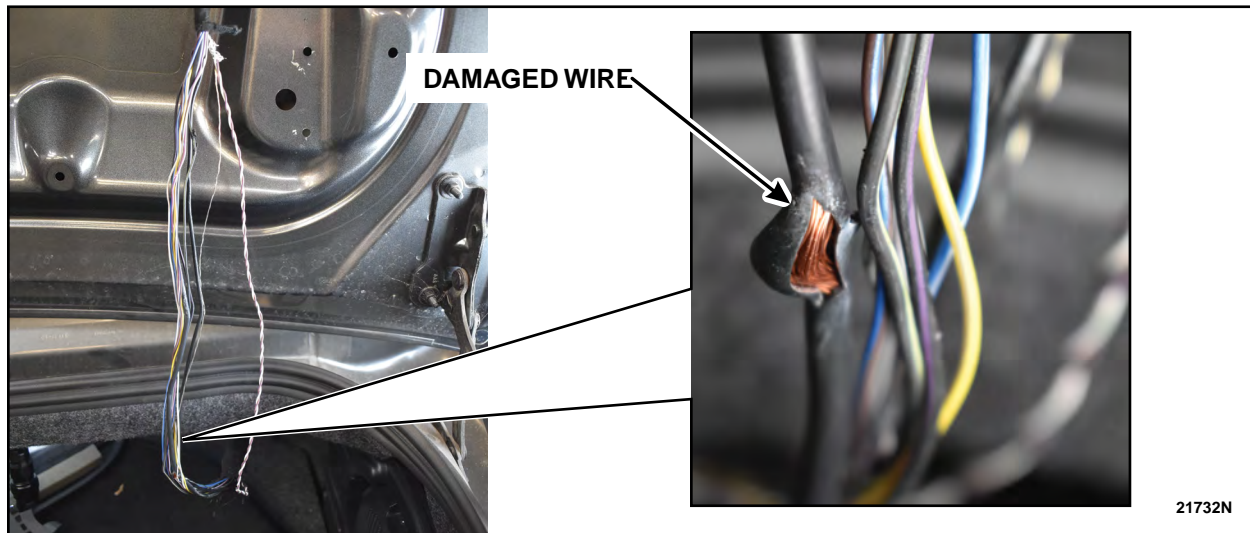
FIGURE 15

In all of the affected vehicles, damage to the luggage compartment lid wiring harness in the area of the right side luggage compartment lid hinge may lead to intermittent rear view camera operation, loss of satellite radio reception, inoperative luggage compartment lamp and/or inoperable luggage compartment release.

NOTE: One example of wiring damage, others similar.

20. Cut out the damaged section of the harness. Make the cut at the location of the harness noted. See Figure 16.

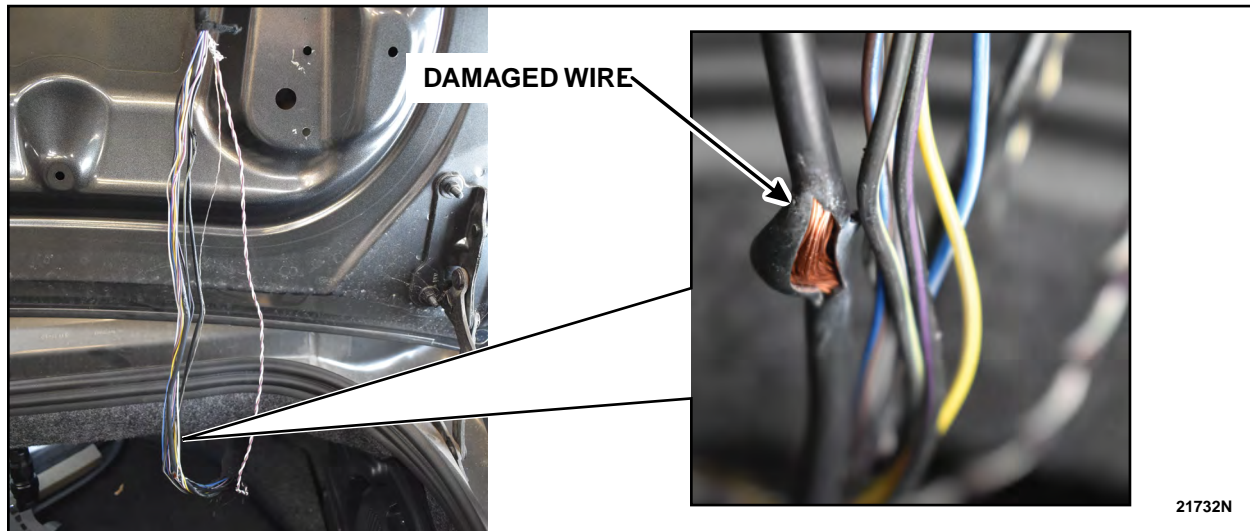
FIGURE 39

Note: One example of wiring damage, others similar.

53. Cut out the damaged section of the harness. Make the cut after the ground wire (front of vehicle side of harness) at the location of the harness noted. See Figure 40.
