March 16, 2022

**SUBJECT: NEW VEHICLE DEMONSTRATION / DELIVERY HOLD
 Safety Recall 22S06**

Certain 2015-2017 Model Year Mustang Vehicles
 Luggage Compartment Lid Wiring Inspection and Rear View Camera Improper
 Function

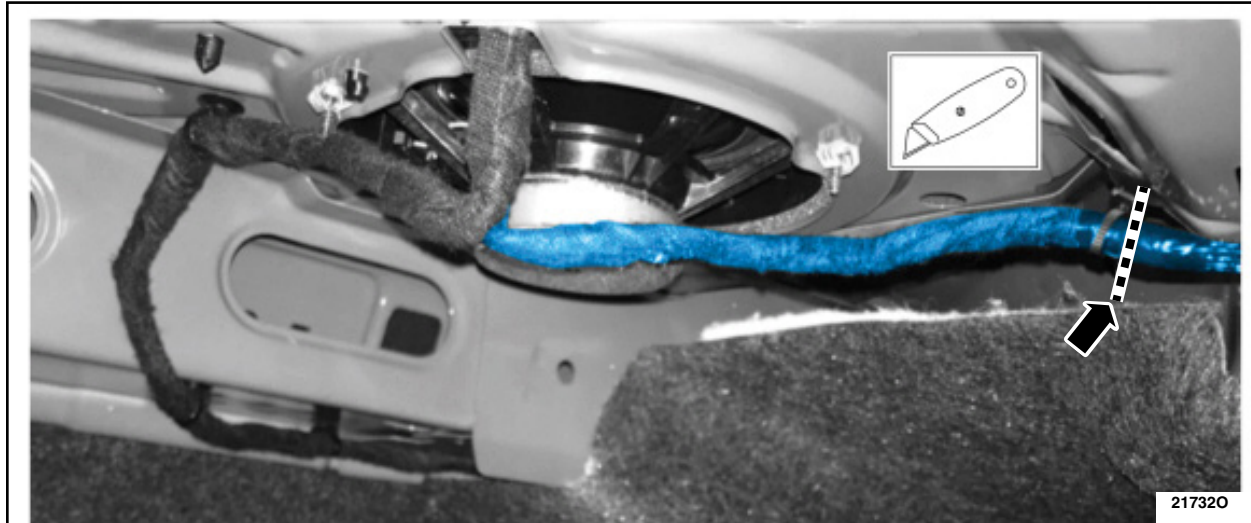
FIGURE 7

10. Disconnect the negative battery cable and position aside. Please follow the WSM procedures in Section 414-01.
11. Cut out the damaged section of the harness. Make the cut at the location of the harness noted. See Figure 7.

NOTE: Obtain two 3U2Z-14A088-AB wiring splice kits. Discard the butt splices and only use the heat shrink tubes for the repair.

12. Splice in the *new* section of harness, matching wire colors on the existing vehicle harness and the replacement section of harness as necessary. Follow the recommended wiring splice procedures using the soldering method in Section 5 of the Wiring Diagram. Stagger the location of each of the wire splices along the harness to minimize the overall size of the repair.

13. Wrap the spliced area in Coroplast 837 Electrical Wire Harness Tape or equivalent.
14. Secure the replacement section of harness into the same body holes as the original section of harness was using the clips attached to the replacement section of harness.

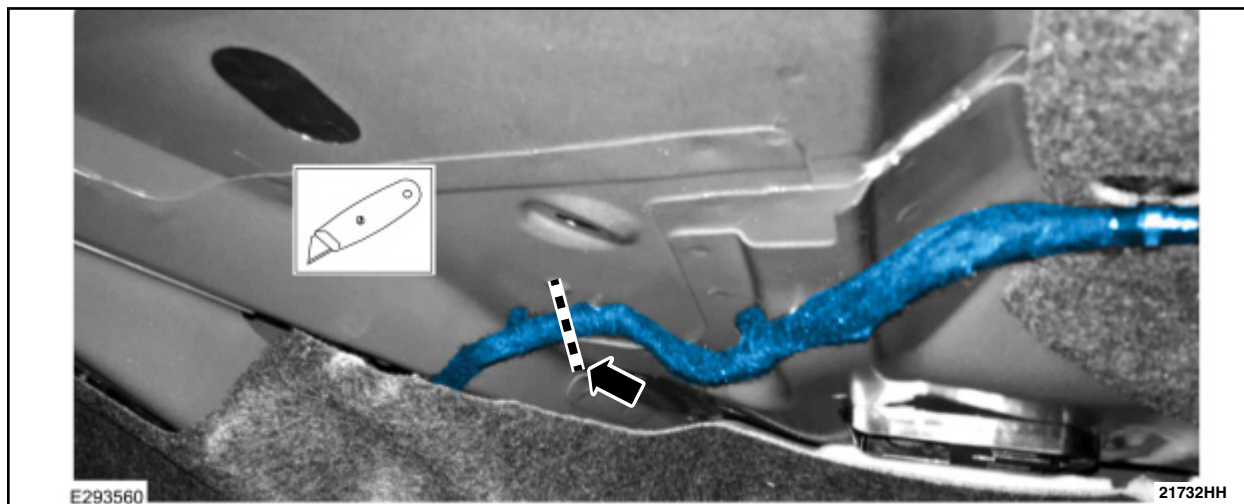
FIGURE 11

21. Disconnect the negative battery cable and position aside. Please follow the WSM procedures in Section 414-01.
22. Cut out the damaged section of the harness. Make the cut at the location of the harness noted. See Figure 11.

NOTE: Obtain three 3U2Z-14A088-AB wiring splice kits. Discard the butt splices and only use the heat shrink tubes for the repair.

23. Splice in the *new* section of harness, matching wire colors on the existing vehicle harness and the replacement section of harness as necessary. Follow the recommended wiring splice procedures using the soldering method in Section 5 of the Wiring Diagram. Stagger the location of each of the wire splices along the harness to minimize the overall size of the repair.
