Stacy L. Balzer
 Operating Director
 Service Engineering Operations
 Ford Customer Service Division

August 31, 2023

SUBJECT: **NEW VEHICLE DEMONSTRATION / DELIVERY HOLD**
Safety Recall 22S06 - Supplement #3
 Certain 2015-2017 Model Year Mustang Vehicles
 Luggage Compartment Lid Wiring Inspection and Rear View Camera Improper Function

Luggage Compartment Lid Wiring Inspection and Rear View Camera Improper Function

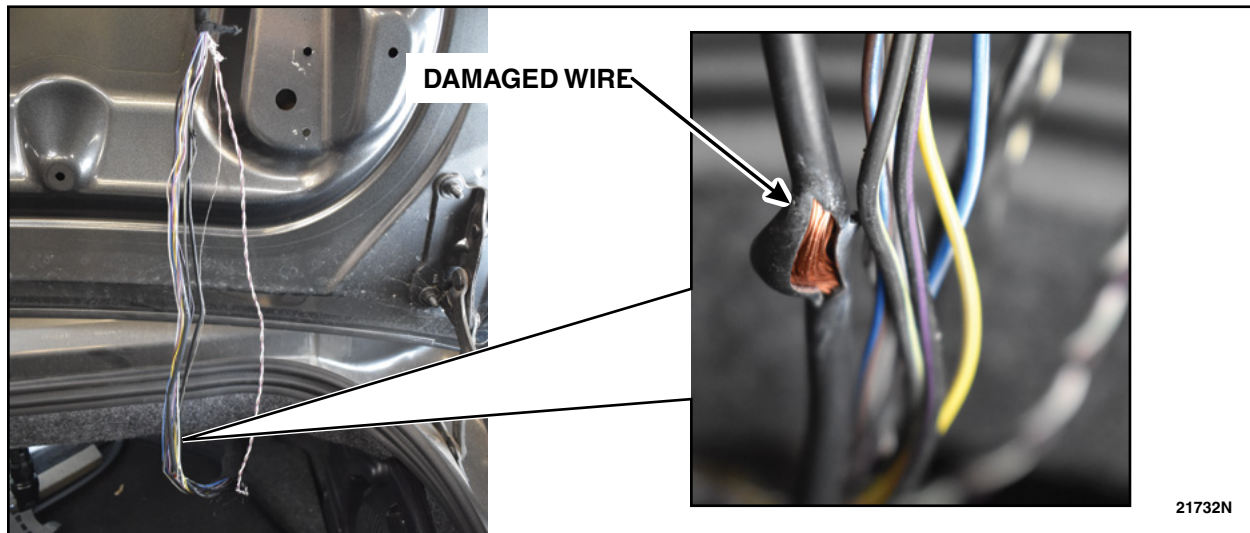
FIGURE 15

In all of the affected vehicles, damage to the luggage compartment lid wiring harness in the area of the right side luggage compartment lid hinge may lead to intermittent rear view camera operation, loss of satellite radio reception, inoperative luggage compartment lamp and/or inoperable luggage compartment release.

NOTE: *One example of wiring damage, others similar.*

20. Cut out the damaged section of the harness. Make the cut at the location of the harness noted. See Figure 16.

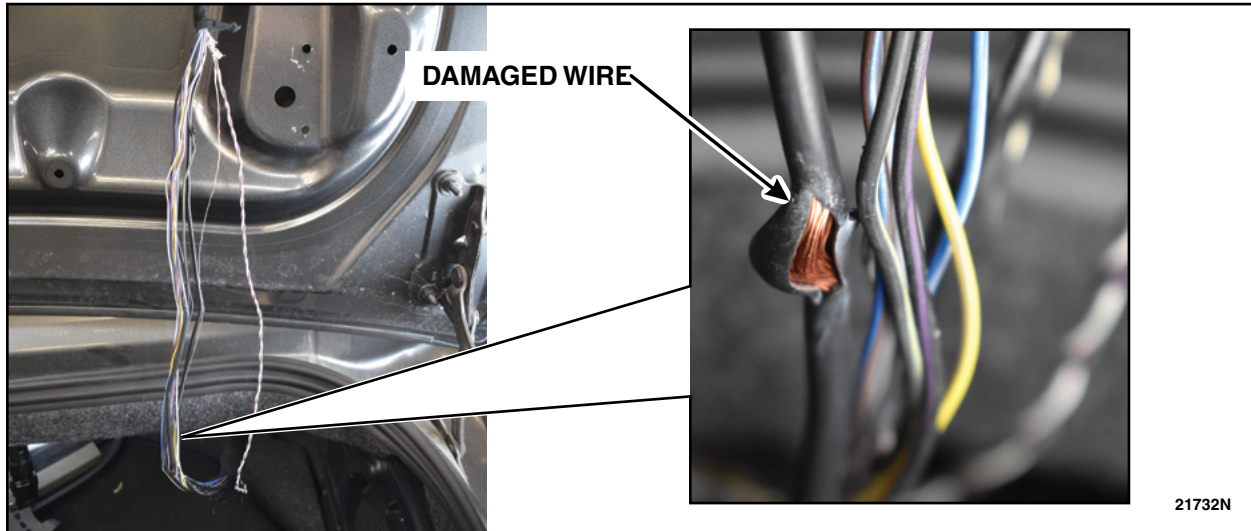
FIGURE 39

NOTE: One example of wiring damage, others similar.

53. Cut out the damaged section of the harness. Make the cut after the ground wire (front of vehicle side of harness) at the location of the harness noted. See Figure 40.
