SUBJECT: **NEW VEHICLE DEMONSTRATION / DELIVERY HOLD**
Safety Recall 22S06 - Supplement #1
 Certain 2015-2017 Model Year Mustang Vehicles
 Luggage Compartment Lid Wiring Inspection and Rear View Camera Improper Function

Safety Recall 22S06 - Supplement #1

Certain 2015-2017 Model Year Mustang Vehicles

Luggage Compartment Lid Wiring Inspection and Rear View Camera Improper Function

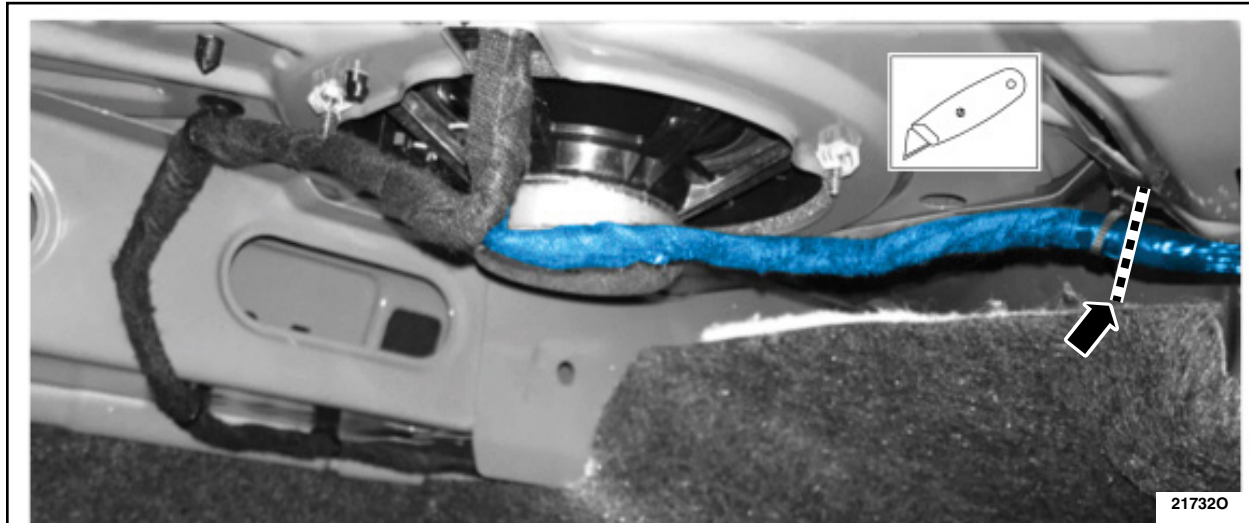
FIGURE 5

10. Disconnect the negative battery cable and position aside. Please follow the WSM procedures in Section 414-01.
11. Cut out the damaged section of the harness. Make the cut at the location of the harness noted. See Figure 5.

NOTE: Obtain two 3U2Z-14A088-AB wiring splice kits. Discard the butt splices and only use the heat shrink tubes for the repair.

12. Splice in the *new* section of harness, matching wire colors on the existing vehicle harness and the replacement section of harness as necessary. Follow the recommended wiring splice procedures using the soldering method in Section 5 of the Wiring Diagram. Stagger the location of each of the wire splices along the harness to minimize the overall size of the repair.

13. Wrap the spliced area in Coroplast 837 Electrical Wire Harness Tape or equivalent.
14. Secure the replacement section of harness into the same body holes as the original section of harness was using the clips attached to the replacement section of harness.

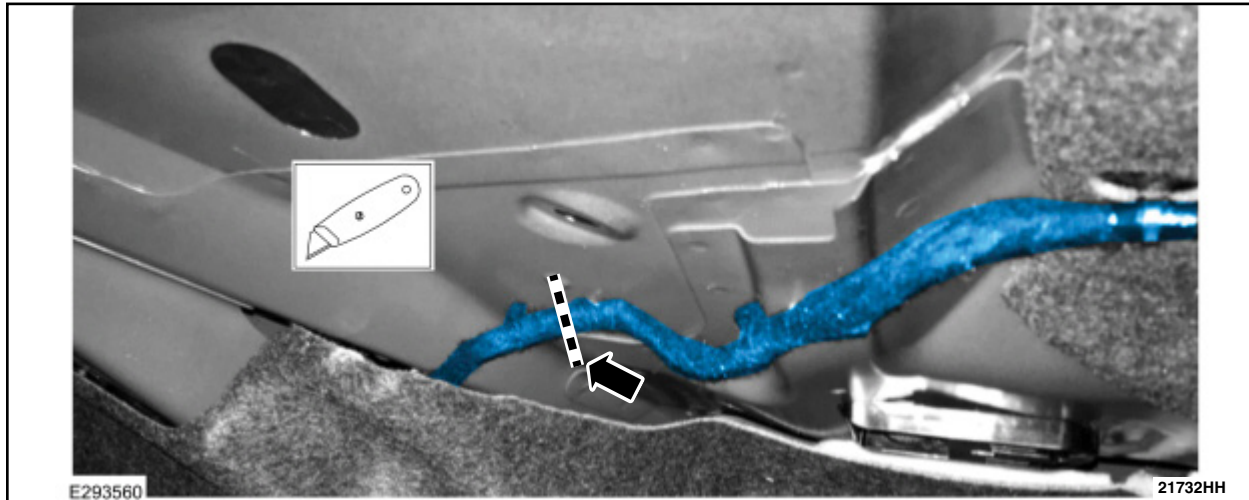
FIGURE 9

21. Disconnect the negative battery cable and position aside. Please follow the WSM procedures in Section 414-01.
22. Cut out the damaged section of the harness. Make the cut at the location of the harness noted. See Figure 9.

NOTE: Obtain three 3U2Z-14A088-AB wiring splice kits. Discard the butt splices and only use the heat shrink tubes for the repair.

23. Splice in the *new* section of harness, matching wire colors on the existing vehicle harness and the replacement section of harness as necessary. Follow the recommended wiring splice procedures using the soldering method in Section 5 of the Wiring Diagram. Stagger the location of each of the wire splices along the harness to minimize the overall size of the repair.

24. Remove the existing ground on this section of the harness from the body of the vehicle. Reinstall the ground on the *new* section of harness to the body of the vehicle.
25. Overlay the satellite radio antenna cable included with the *new* section of harness. Refer to WSM, Section 415-00B, Satellite Radio Antenna, Removal and Installation.
26. Wrap the spliced area in Coroplast 837 Electrical Wire Harness Tape or equivalent.
27. Secure the replacement section of harness into the same body holes as the original section of harness using the clips attached to the replacement section of harness.
28. Re-assemble the luggage compartment lid trim by reversing Steps 20-18.
29. Connect the negative battery cable. Please follow the WSM procedures in Section 414-01.
