Safety Recall 22S09 - Supplement #5

Certain 2017 - 2022 Model Year F-250/F-350 Vehicles Equipped with a 6.2L/7.3L Gas Engine, Crew Cab/Super Cab, 160"/164" Wheelbase, 4x4, and One-Piece Aluminum

Loose/Sagging Underbody Insulator

CERTAIN 2017-2022 MODEL YEAR F-250/F-350 VEHICLES EQUIPPED WITH A 6.2L/7.3L GAS ENGINE, CREW CAB/SUPER CAB, 160"/164"WHEELBASE, 4X4, AND ONE-PIECE ALUMINUM DRIVESHAFT – LOOSE/SAGGING UNDERBODY INSULATOR

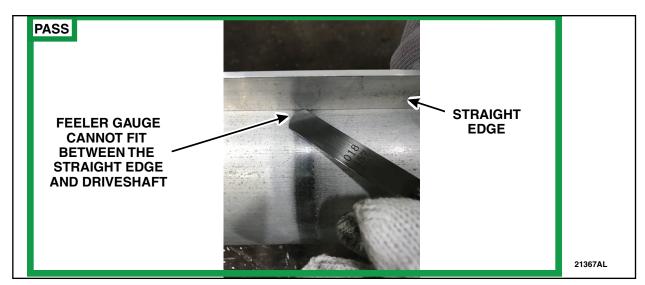
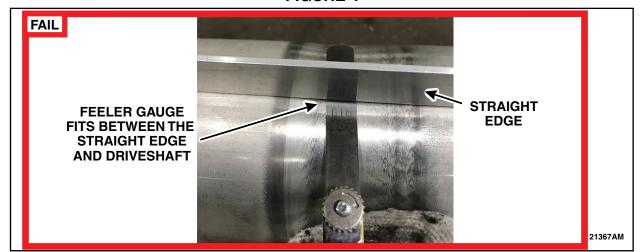
- 3. What is the current odometer reading?
 - > 2,500 miles Proceed to step 4.
 - < 2,500 miles Proceed to step 11.
- 4. Place a straight edge along the driveshaft over the wear mark and attempt to fit a 0.018in (0.45mm) feeler gauge between the flat edge and the wear mark. Can the feeler gauge fit between the straight edge and anywhere along the wear mark? See Figures 4 and 5.
 - Yes Does not pass inspection. Contact the SSSC and provide a picture of the driveshaft with the feeler gauge fitting between the straight edge and wear mark. Once approved, rear driveshaft replacement will be required. Proceed to step 7.
 - No Passes inspection. Proceed to step 5.

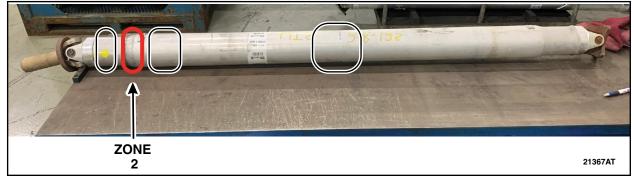
FIGURE 6

- 5. Inspect Zone 2 (transition from larger tube diameter to smaller diameter section) of the driveshaft tube for any marks caused by the front edge of the passenger side insulator. Are there any marks present? See Figure 6.
 - Yes Does not pass inspection. Proceed to step 6.
 - No Passes inspection. Driveshaft may be reused. Proceed to step 11.

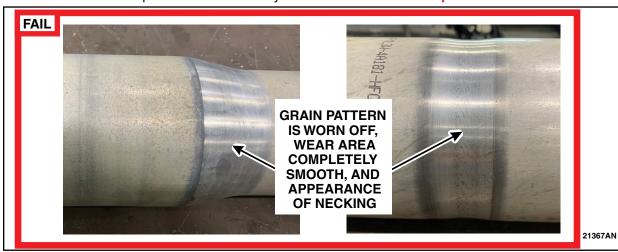
FIGURE 7

- 6. Inspect the marks found on Zone 2. Is the aluminum tube surface grain pattern worn off, completely smooth, or have an appearance of necking? See Figures 7 through 10.
 - Yes Does not pass inspection. Contact the SSSC and provide a picture of the driveshaft with the grain pattern worn off. Be sure to show a clear image of the grain pattern missing. Once approved, rear driveshaft replacement will be required. Proceed to step 7.
 - No Passes inspection. Driveshaft may be reused. *Proceed to step 11.*
