SUBJECT: NEW VEHICLE DEMONSTRATION / DELIVERY HOLD -

Safety Recall 22S09 – Supplement #4

Certain 2017 - 2022 Model Year F-250/F-350 Vehicles Equipped with a 6.2L/7.3L Gas Engine, Crew Cab/Super Cab, 160"/164" Wheelbase, 4x4, and One-Piece Aluminum Driveshaft
 Loose/Sagging Underbody Insulator

SERVICE PROCEDURE

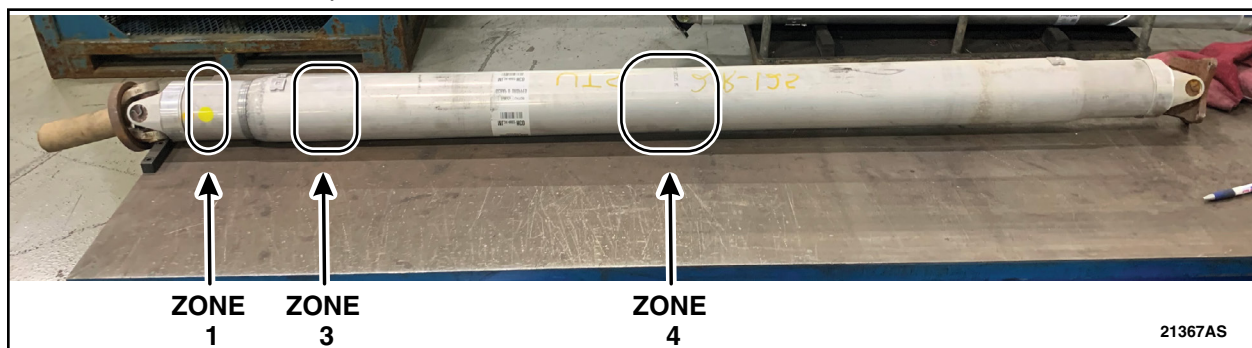
FIGURE 3

2. Inspect Zones 1, 3 and 4 of the rear driveshaft for any marks caused by the front and/or rear edges of the passenger side insulator. Are there any marks present in Zones 1, 3 or 4? See Figure 3.

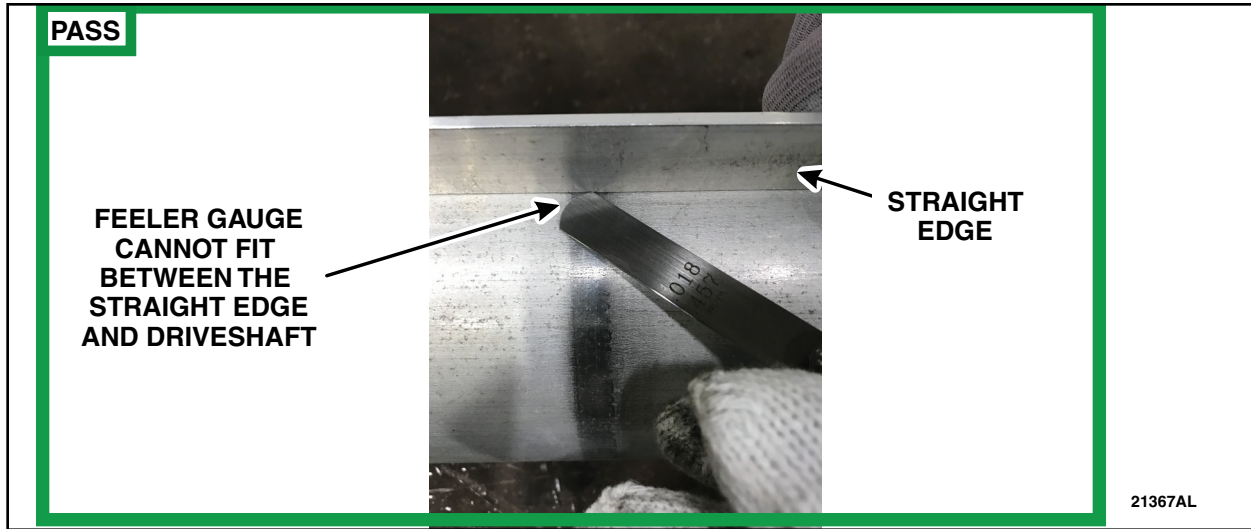
4. Place a straight edge along the driveshaft over the wear mark and attempt to fit a 0.018in (0.45mm) feeler gauge between the flat edge and the wear mark. Can the feeler gauge fit between the straight edge and anywhere along the wear mark? See Figures 4 and 5.

Yes – Does not pass inspection. Contact the SSSC and provide a picture of the driveshaft with the feeler gauge fitting between the straight edge and wear mark. Once approved, rear driveshaft replacement will be required, but do not install at this time. Proceed to step 7.

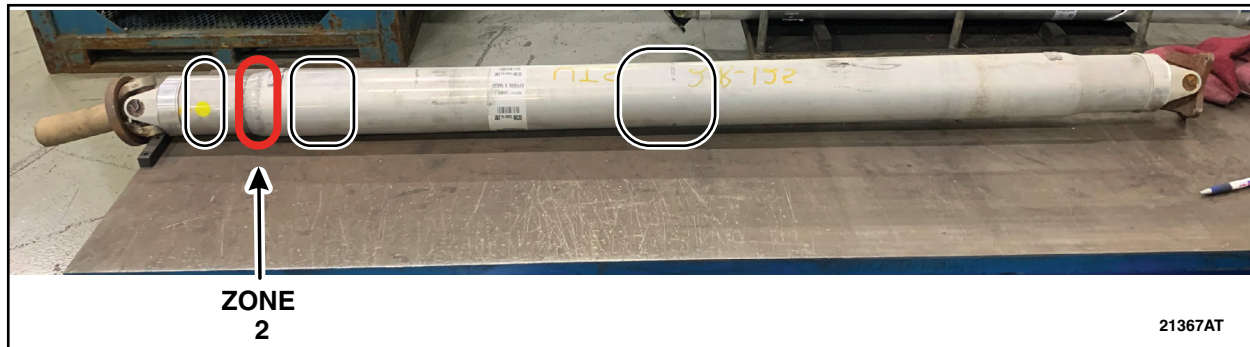
FIGURE 6

5. Inspect Zone 2 (transition from larger tube diameter to smaller diameter section) of the driveshaft tube for any marks caused by the front edge of the passenger side insulator. Are there any marks present? See Figure 6.

Yes – Does not pass inspection. Proceed to step 6.

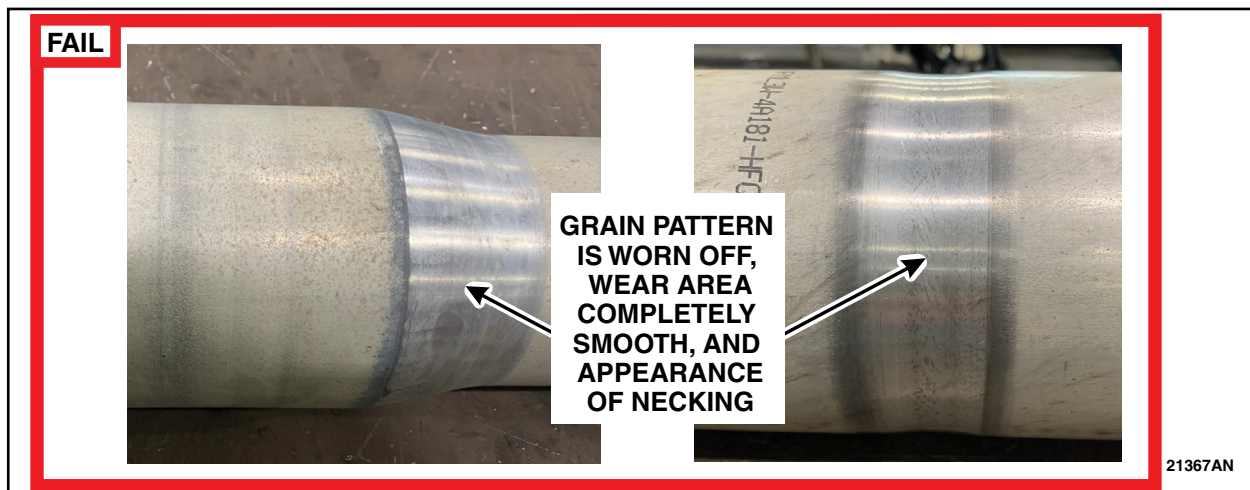
6. Inspect the marks found on Zone 2. Is the aluminum tube surface grain pattern worn off, completely smooth, or have an appearance of necking? See Figures 7 through 10.

Yes – Does not pass inspection. Contact the SSSC and provide a picture of the driveshaft with the grain pattern worn off. Be sure to show a clear image of the grain pattern missing. Once approved, rear driveshaft replacement will be required, but do not install at this time. Proceed to step 7.
