# Recall Campaign Bulletin

Campaign No. 2022030015, March 2022

SUBJECT: **Model GLE-Class (167 platform)**  
**Model Year 2020**

## **Replace Prefuse Box**

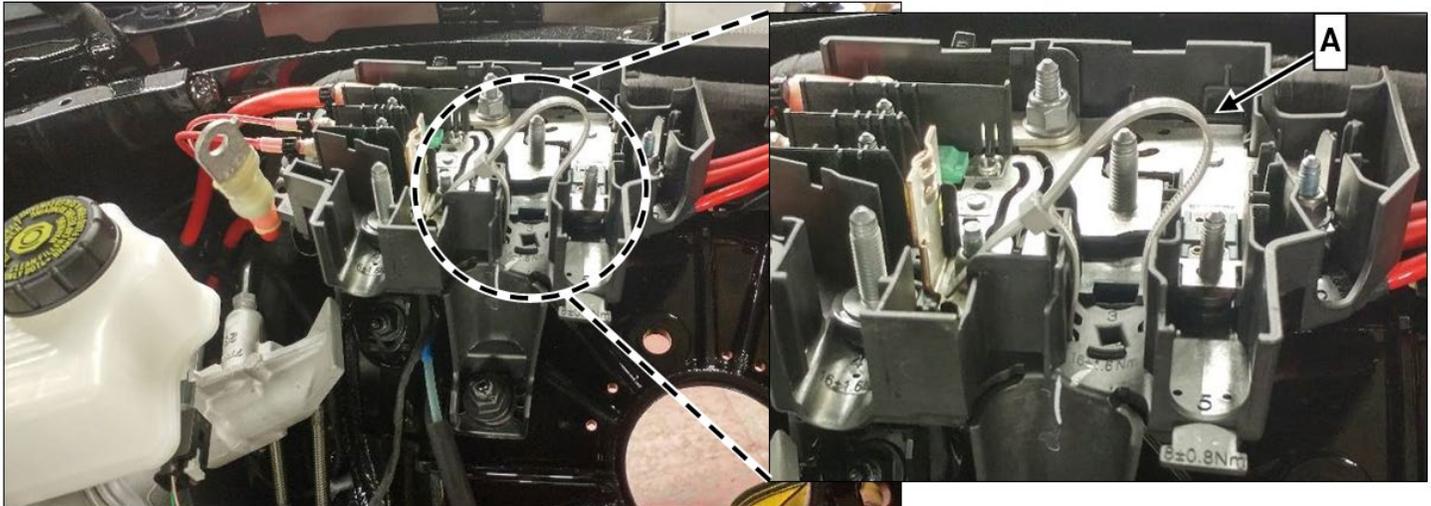
Figure 1

1. Switch off ignition and keep transmitter keys outside of transmitter range (at least 2 meters / 6.6 feet).
2. Remove cover for left air/water duct above prefuse box in engine compartment.  
i For basic data, see **AR54.15-P-1330ME**, operation step 2.
3. Remove cover of prefuse box in engine compartment.  
i For basic data, see **AR54.15-P-1330ME**, operation step 3.
4. Check whether there is a cable tie (**A**) for the supply line from the alternator to the prefuse box in the engine compartment at connection 3 (**Figure 1**).

- a. **Cable tie** at connection 3 of prefuse box **not** present:  
Carry out **work procedure**.
- b. **Cable tie** at connection 3 of prefuse box **present**:  
**Assemble** in reverse order and **end measure**.

1. Replace prefuse box in engine compartment.

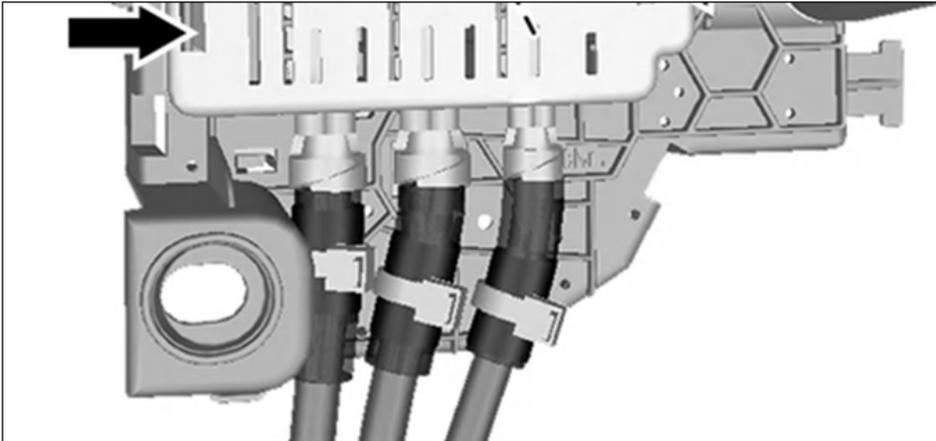
Figure 2

**i** The cable ties for the remaining electrical cables must be replaced (**Figure 2**).

**i** The number of electrical cables varies depending on the vehicle equipment.

**i** The cable tie for the supply line at connection 3 of the prefuse box is included in the delivery package.

2. Assemble in reverse order.
