# McLaren Artura – Low Pressure Fuel Pipe Assembly Replacement – ROW

<b>Bulletin type:</b>	Recall Campaign
<b>Reference number:</b>	N/A
<b>Campaign reference:</b>	SRC 16 K 003
<b>Attention:</b>	Retailer Aftersales Managers, Retailer Sales Managers, Retailer Marketing Managers, Retailer Service Managers, Retailer Service Advisors, Retailer Technicians, Retailer Parts Managers, Retailer General Managers, All Retailer Staff
<b>Affected vehicles:</b>	McLaren Artura
<b>Situation:</b>	Replacement of the low pressure fuel pipe assembly
<b>Procedure:</b>	Action all affected vehicles. Please refer to the information outlined in this document to complete the required work
<b>Date:</b>	07 December 2023

### Urgent Safety Recall Campaign – McLaren Artura – Low Pressure Fuel Pipe Assembly Replacement

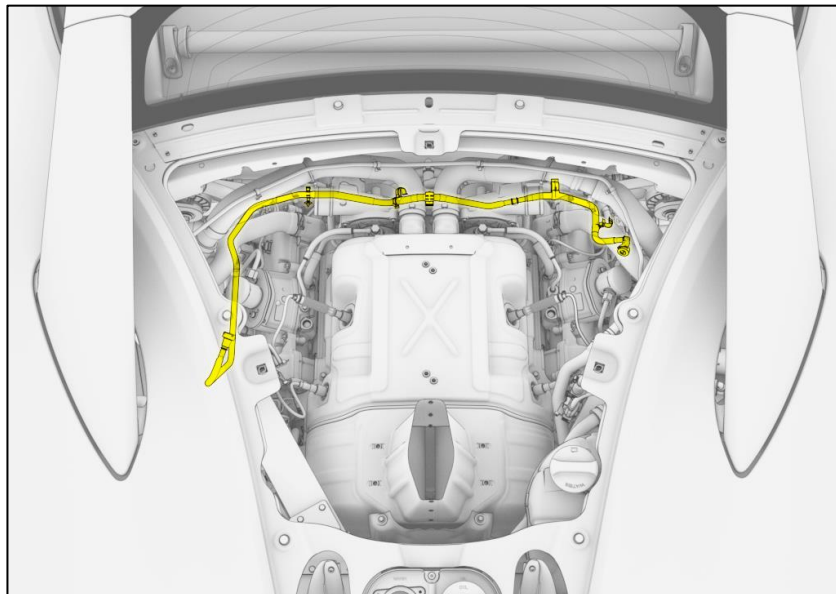
This voluntary safety recall relates to a small batch of low-pressure fuel pipe assemblies which can potentially become disconnected and leak fuel, particularly during the engine start process.

Image 1: Low Pressure Fuel Supply Assembly to GDI Pumps location

The below part is required to action this Recall and replace the 'Low Pressure Fuel Supply Pipe Assembly'. The part in the list below can be ordered in the usual way via Unidial 2.

PART NUMBER	PART DESCRIPTION	QUANTITY
16FC746CP	ASSY FUEL PIPE-VEHICLE TO GDI PUMPS 11MM	1
