SAFETY RECALL NOTICE

McLaren Voluntary Safety Recall

McLaren GT Driver's Airbag Resistance Check

Urgent Safety Recall Campaign – McLaren GT Driver's Airbag Resistance Check

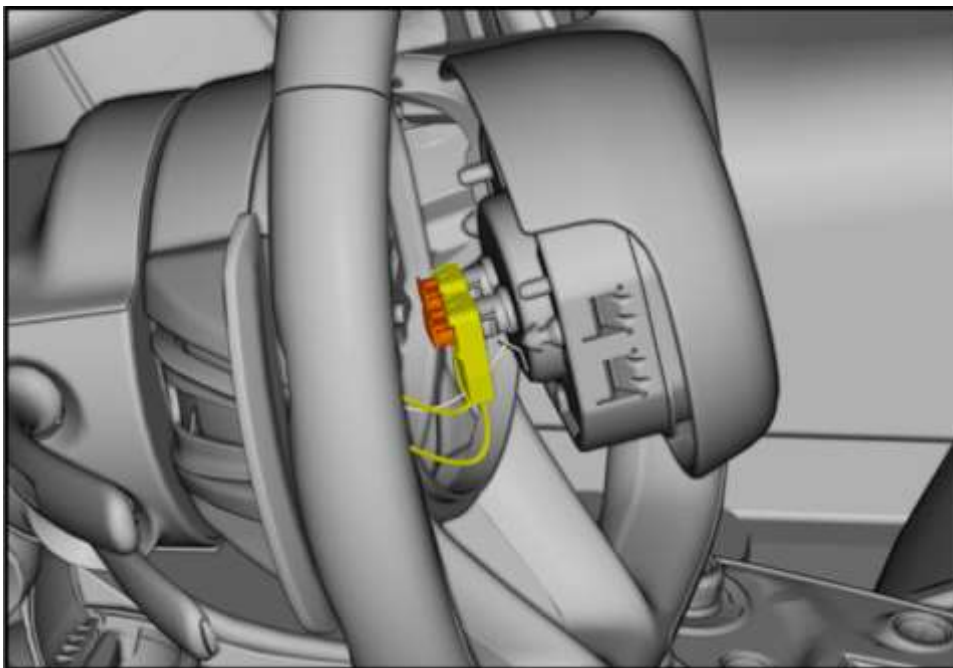
This voluntary recall relates to a potential risk that the connection between the driver's airbag and the occupant restraint controller may not been fully engaged, whereby the connector is connected but the secondary locking tab is not locked. In the event that the connector is connected but the secondary locking mechanism is not locked, it is possible that the airbag warning light may not illuminate even though the airbag is not operational. In the event of an accident, if the connection is not fully engaged, the driver's airbag may not deploy, which could lead to more severe injuries.

Image 1 – Driver's Airbag Connectors (example taken from the Service Information System (SIS))

Disconnect the driver's airbag connectors and visually inspect them for any anomalies, then fully re-connect the connectors. Make sure both stages of the connectors (including secondary locking mechanism) are correctly locked and engaged. The connector may otherwise be installed, but not locked

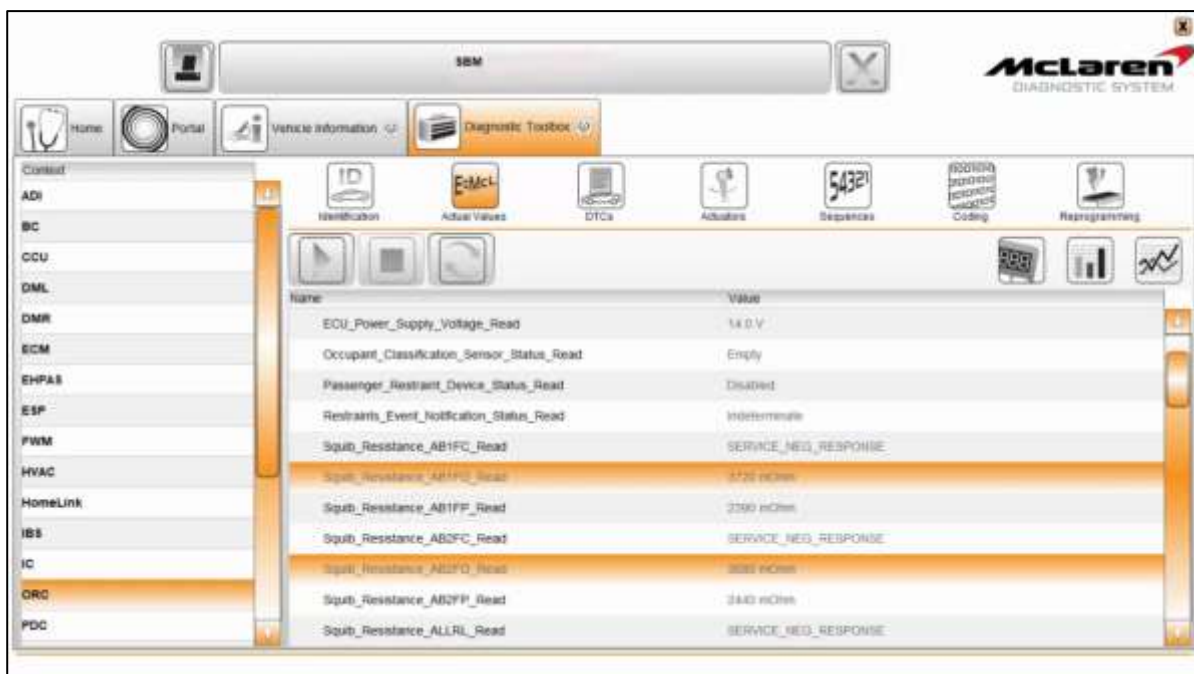
Image 2 - Example Screenshot of MDS Airbag Resistance Actual Value Location
