TO: Mercedes-Benz Dealer Principals, General Managers, Sales Managers, Service Managers, Parts Managers	FROM: Gregory Gunther, Department Manager, Vehicle Compliance and Analysis, Engineering Services
RE: Recall Campaign Launch Notification- STOP DRIVE Check and Replace Rear Axle Carrier MY22 S-Class (223 platform)	DATE: 4/1/2022

Campaign No. 2022030028, April 2022

SUBJECT: **Model S-Class (223 platform)**
Model Year 2022

Check and Replace Rear Axle Carrier

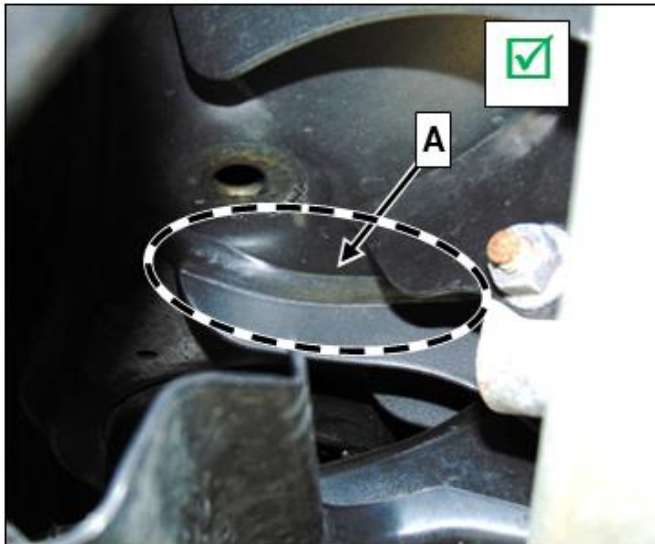
Figure 2

1. Lift vehicle.
2. Check weld seam (**A, figure 2**) of thrust arm connection to rear axle carrier **on both sides**.

i The connection must be end-to-end welded at the rear axle carrier!

- a. Weld seam (A) **not** OK: Perform **work procedure**.
- b. Weld seam (A) OK: Perform **step 3 and End measure**.

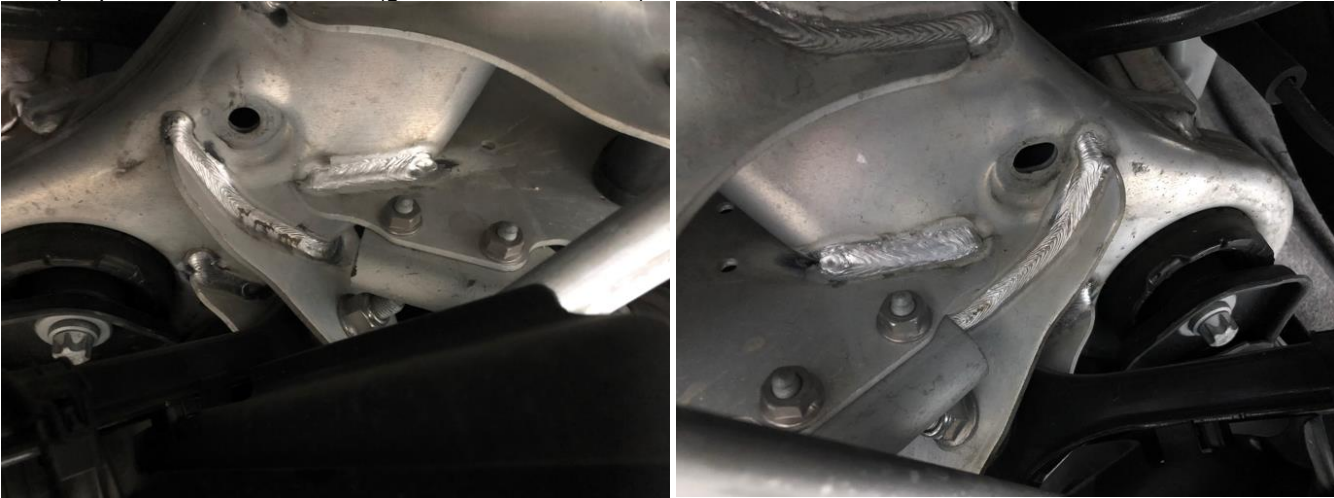
Sample pictures to be attached (good rear axle carrier)

(the color/material of the rear axle carrier could deviate from sample pictures)
