Stacy L. Balzer
 Operating Director
 Service Engineering Operations
 Ford Customer Service Division

October 18, 2023

SUBJECT: **NEW VEHICLE DEMONSTRATION / DELIVERY HOLD**
Safety Recall 22S27 - Supplement # 7
 Certain 2020-2022 Model Year Explorer Vehicles
 Rear Axle Bolt Fractures

In the affected vehicles, a rear axle mounting bolt may fracture during vehicle acceleration. A fractured rear axle bolt will allow the rear axle housing to move out of position, resulting in severe noise and vibration. If the rear axle bolt breaks, the driveshaft, or half shafts may become disconnected, resulting in loss of transmission torque to the rear wheels. Transmission torque is necessary to hold the vehicle in park and is also needed for the vehicle to move forward or backward. The loss of the primary park torque will allow the vehicle to roll in park if the parking brake is not applied, increasing the risk of crash and injury.

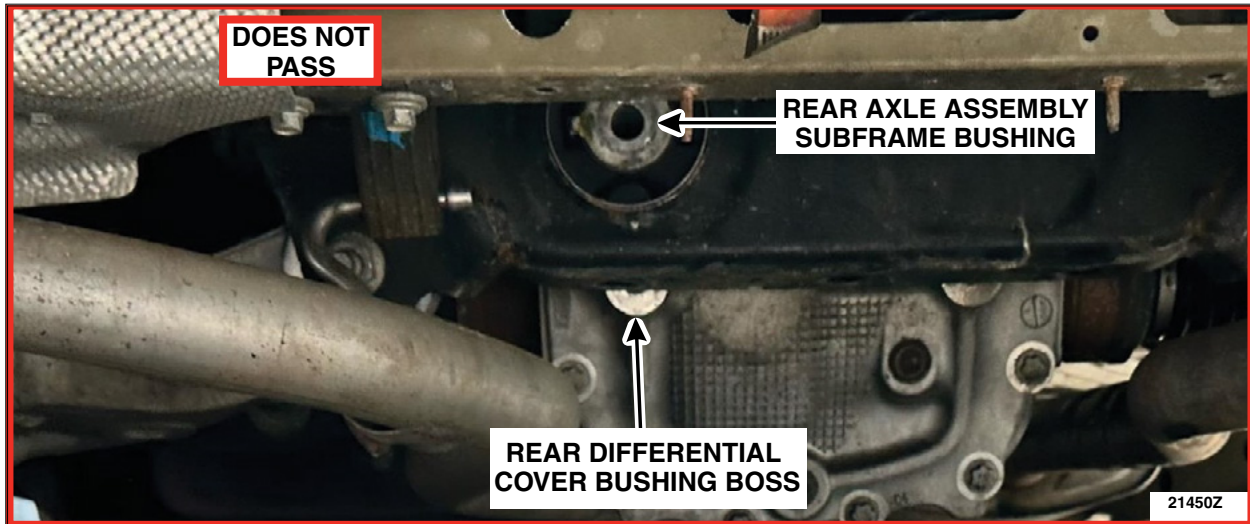
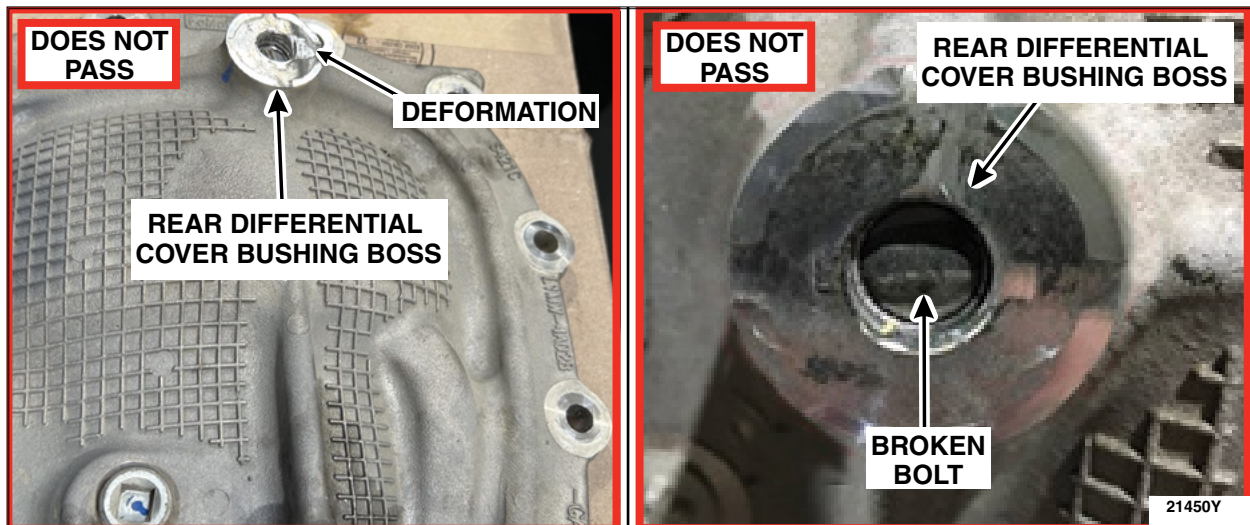
20. Visually inspect the rear differential cover bushing boss for damage (broken fastener, scoring, cracks and/or deformation and damaged threads). Is the rear differential cover bushing boss damaged?
See Figures 13 and 14.

YES - Does not pass inspection. Install a new differential housing cover. Follow the WSM procedures, in Section 205-02. Proceed to Step 23.

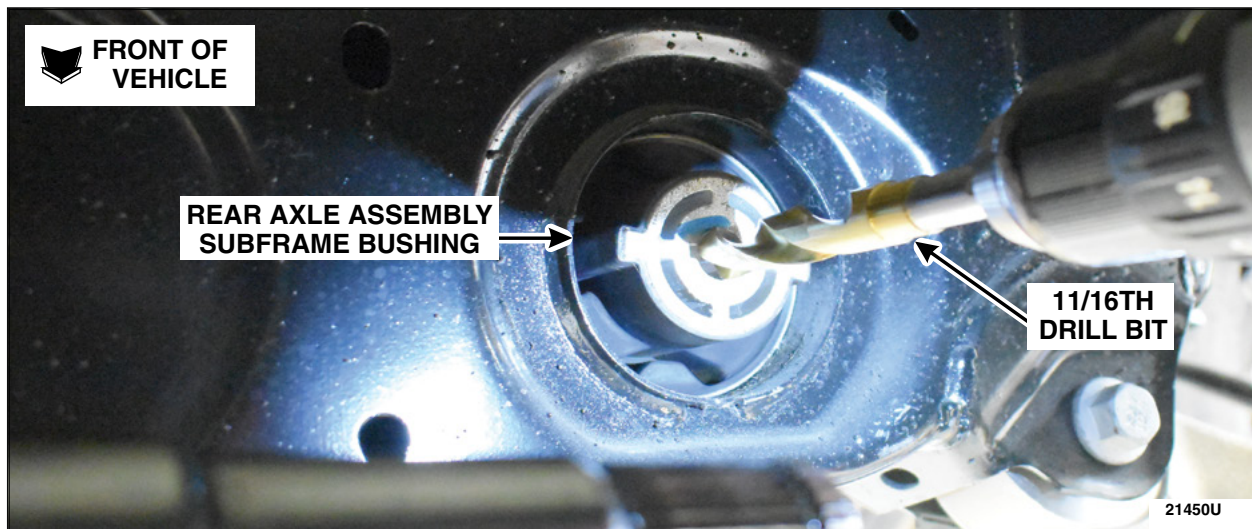
FIGURE 15

21. Using an M14 bolt ensure the threads of the rear differential cover bushing boss are not damaged. Can the M14 bolt be fully threaded in?
YES - Passes inspection. Proceed to Step 22.
NO - Does not pass inspection. Install a new differential housing cover. Follow WSM procedures in Section 205-02. Proceed to Step 23.
22. Using a straight edge check to ensure the rear differential cover bushing boss is flat. Is the rear differential cover bushing boss flat?
YES - Passes inspection. Proceed to Step 23.
NO - Does not pass inspection. Install a new differential housing cover. Follow WSM procedures in Section 205-02. Proceed to Step 23.
23. Using an 11/16th or larger drill bit drill out the rear axle assembly subframe bushing bolt hole. See Figure 15.
