Stacy L. Balzer  
 Director  
 Service Engineering Operations  
 Ford Customer Service Division

**SUBJECT:** **NEW VEHICLE DEMONSTRATION / DELIVERY HOLD**  
**Safety Recall 22S27 - Supplement # 9**  
 Certain 2020-2022 Model Year Explorer Vehicles  
 Rear Axle Bolt Fractures

In the affected vehicles, a rear axle mounting bolt may fracture during vehicle acceleration. A fractured rear axle bolt will allow the rear axle housing to move out of position, resulting in severe noise and vibration. If the rear axle bolt breaks, the driveshaft, or half shafts may become disconnected, resulting in loss of transmission torque to the rear wheels. Transmission torque is necessary to hold the vehicle in park and is also needed for the vehicle to move forward or backward. The loss of the primary park torque will allow the vehicle to roll in park if the parking brake is not applied, increasing the risk of crash and injury.

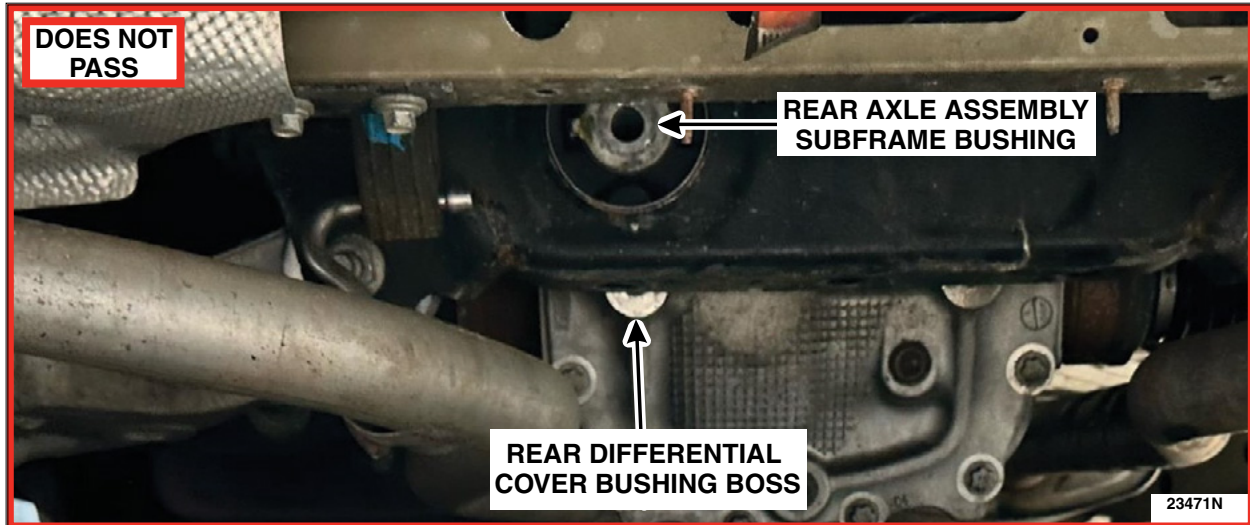
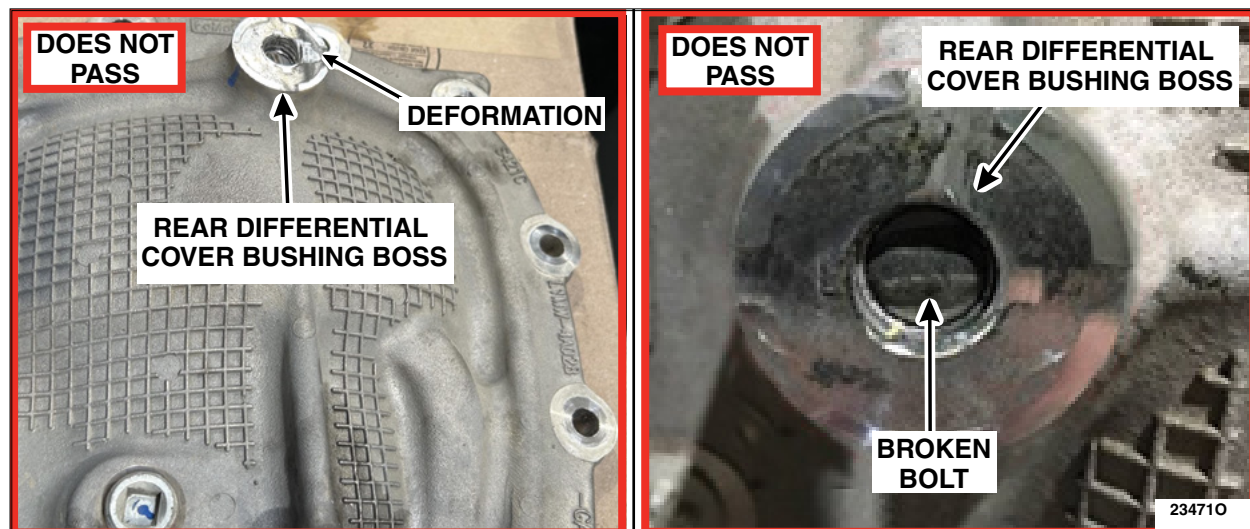
20. Visually inspect the rear differential cover bushing boss for damage (broken fastener, scoring, cracks and/or deformation and damaged threads). Is the rear differential cover bushing boss damaged?  
See Figures 14 and 15.

**YES** - Does Not Pass inspection. Install *only* a new differential housing cover (*Do Not install the rear axle assembly at this time*). Follow the WSM procedures in Section 205-02. Proceed to Step 23.
