Stacy L. Balzer
 Operating Director
 Service Engineering Operations
 Ford Customer Service Division

SUBJECT: **NEW VEHICLE DEMONSTRATION / DELIVERY HOLD**
Safety Recall 22S27 - Supplement # 5
 Certain 2020-2022 Model Year Explorer Vehicles
 Rear Axle Bolt Fractures

In the affected vehicles, a rear axle mounting bolt may fracture during vehicle acceleration. A fractured rear axle bolt will allow the rear axle housing to move out of position, resulting in severe noise and vibration. If the rear axle bolt breaks, the driveshaft, or half shafts may become disconnected, resulting in loss of transmission torque to the rear wheels. Transmission torque is necessary to hold the vehicle in park and is also needed for the vehicle to move forward or backward. The loss of the primary park torque will allow the vehicle to roll in park if the parking brake is not applied, increasing the risk of crash and injury.

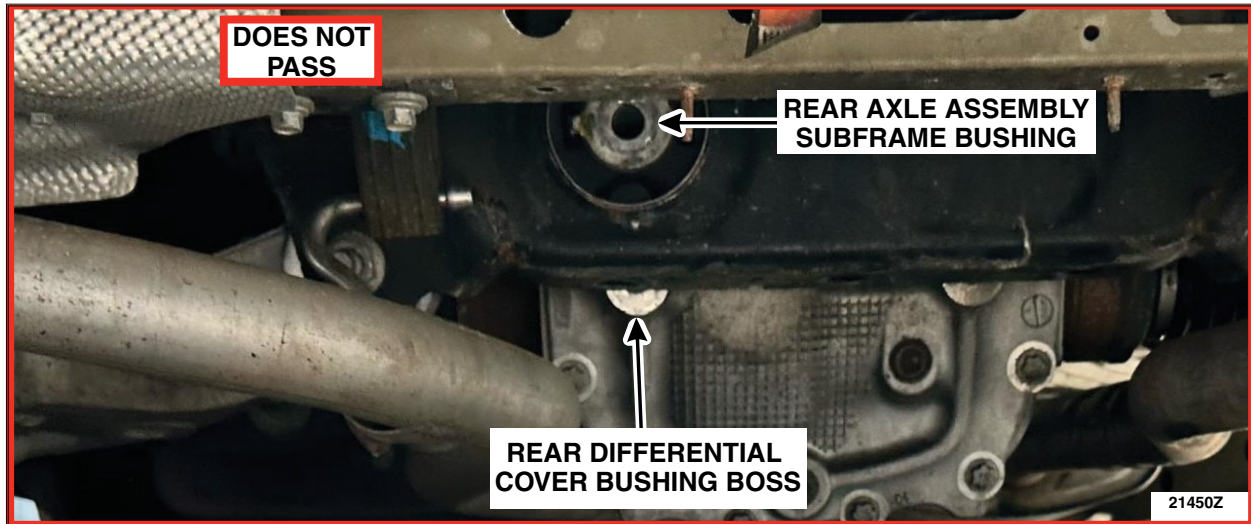
FIGURE 3

7. Visually inspect the rear differential cover bushing boss for damage (broken fastener, scoring, cracks and/or deformation and damaged threads). Is the rear differential cover bushing boss damaged?

YES - Does not pass inspection. Install a *new* differential housing cover. Please follow the WSM procedures, in Section 205-02. Proceed to Step 10.

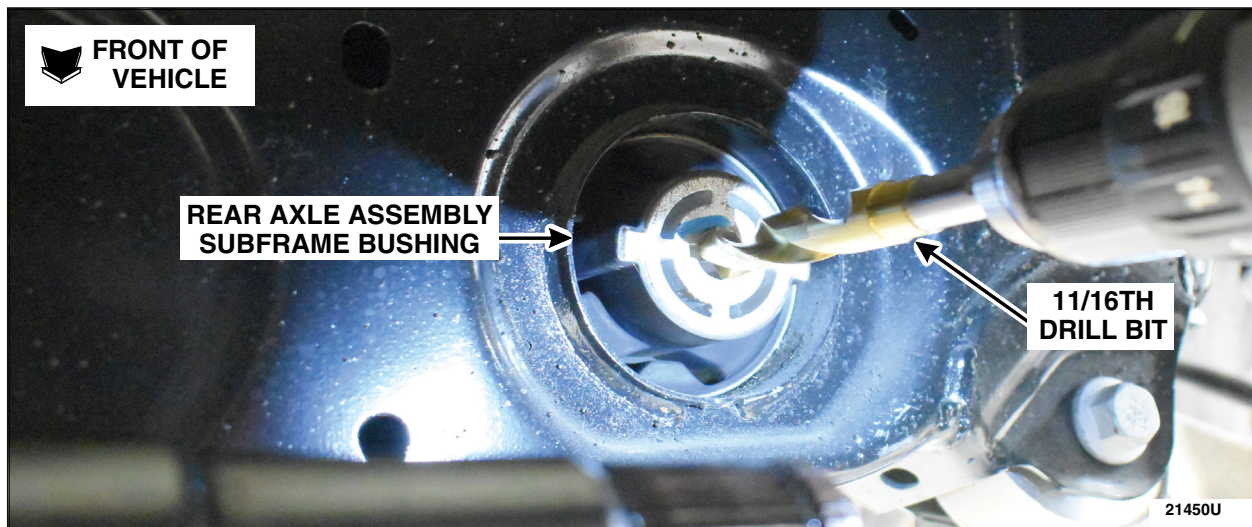
FIGURE 5

8. Using a M14 bolt ensure the threads of the rear differential cover bushing boss are not damaged. Can the M14 bolt be fully threaded in?
YES - Passes inspection. Proceed to Step 9.
NO - Does not pass inspection. Install a *new* differential housing cover. Please follow the WSM procedures, in Section 205-02. Proceed to Step 10.
9. Using a straight edge check to ensure the rear differential cover bushing boss is flat. Is the rear differential cover bushing boss flat?
YES - Passes inspection. Proceed to Step 10.
NO - Does not pass inspection. Install a *new* differential housing cover. Please follow the WSM procedures, in Section 205-02. Proceed to Step 10.
10. Using an 11/16th or larger drill bit drill out the rear axle assembly subframe bushing bolt hole. See Figure 5.

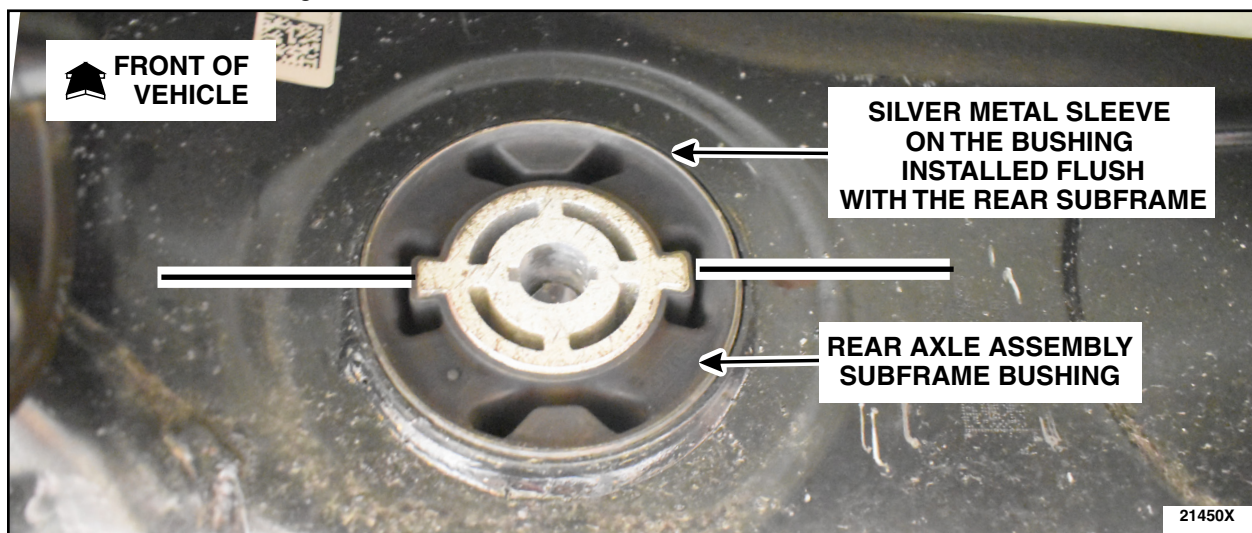
FIGURE 7

NOTE: Make sure the tabs on the *new* rear axle assembly subframe bushing are horizontal with the subframe. See Figure 7.
