Stacy L. Balzer
 Operating Director
 Service Engineering Operations
 Ford Customer Service Division

March 29, 2023

SUBJECT: **NEW VEHICLE DEMONSTRATION / DELIVERY HOLD - Safety Recall 22S22**
 Certain 2020 Model Year Super Duty Vehicles with a 6.7L Diesel Engine and 10R140 Transmission
 Transmission Output Planetary Four Assembly Replacement

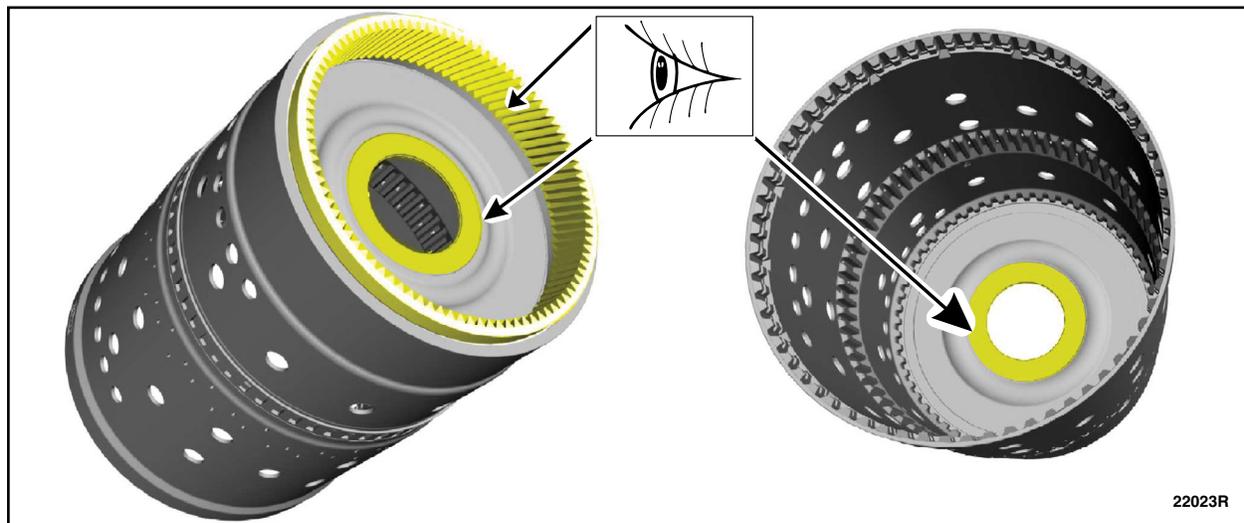
FIGURE 24

27. Inspect the No. 4 ring gear and the thrust bearing surfaces for damage. See Figure 24.

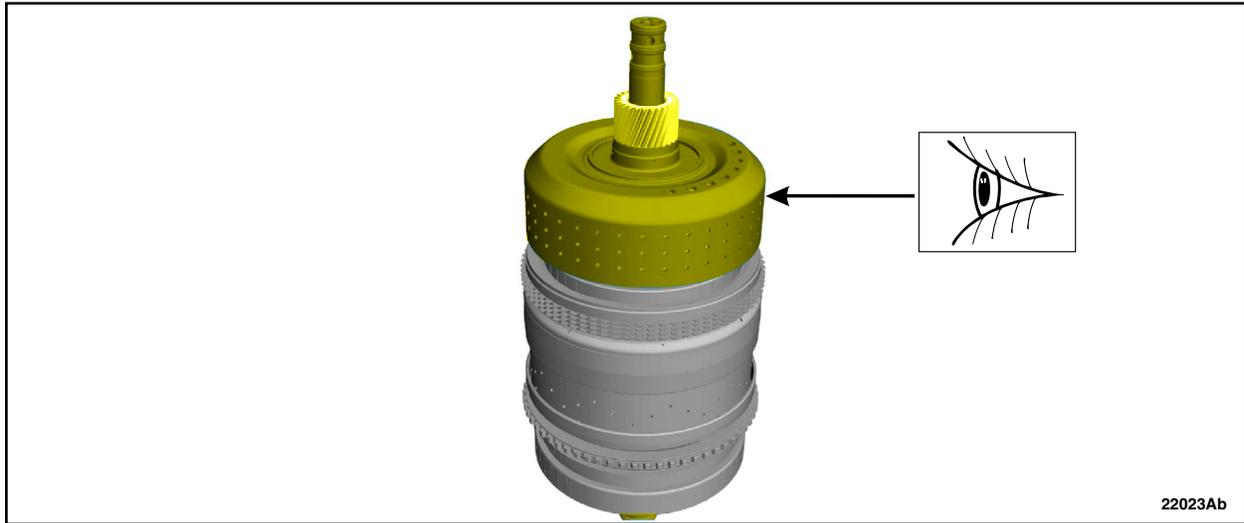
FIGURE 25

28. Inspect the No. 4 sun gear surfaces for damage. See Figure 25.

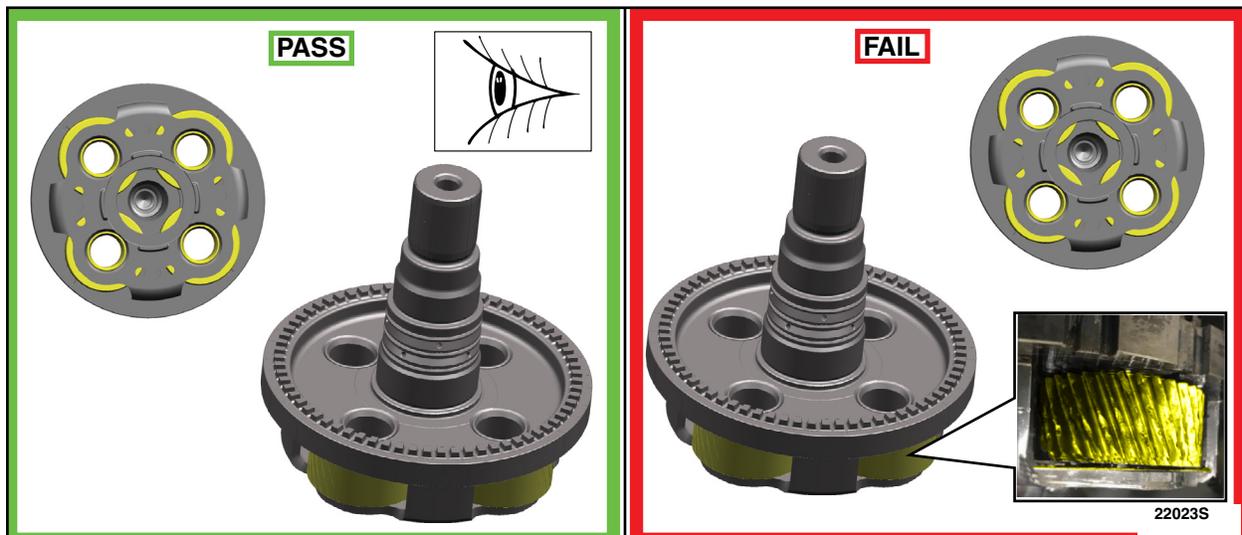
FIGURE 26

In some of the affected vehicles, the pinion thrust washer within the 10R140 transmission planetary 4 carrier assembly can disintegrate, causing metallic debris to contaminate the gearset and potentially damage the gear teeth. Metallic debris can subsequently get lodged in the transmission’s mechanical park pawl mechanism and prevent the vehicle from achieving or holding park. Inability to achieve or hold park can result in unintended vehicle movement, increasing the risk of a crash.

29. Inspect the output shaft and planetary carrier No. 4 assembly for damage. Are the output shaft and/or planetary carrier No. 4 assembly damaged? See Figure 26.

Yes: Inspection **FAIL – TRANSMISSION ASSEMBLY REPLACEMENT IS REQUIRED.**

- Capture and submit clear photo(s) of the damaged output shaft and/or planetary carrier No. 4 assembly and the VIN tag to the Special Service Support Center (SSSC) for transmission assembly replacement approval. Reverse the disassembly steps to reassemble the transmission assembly. Install the *new* transmission assembly. Follow the Workshop Manual (WSM) procedures, in Section 307-1B.
