RE: **Recall Campaign Launch Notification**
Check Level Sensor Linkage Rear Axle
MY21 247 (GLB-Class)

Campaign No. 2022050011, May 2022

SUBJECT: **Model GLB-Class (247 platform)**
Model Year 2021

Check Level Sensor Linkage Rear Axle

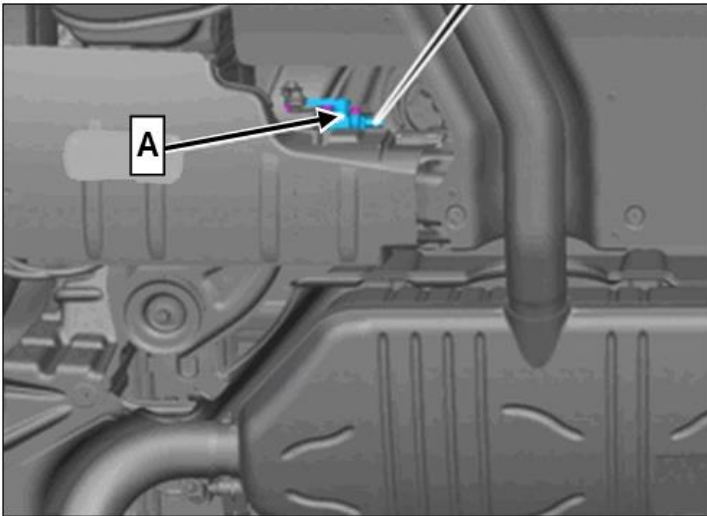
Figure 1

2. Check installation position of link rod of right rear axle level sensor (**A, figure 1**).

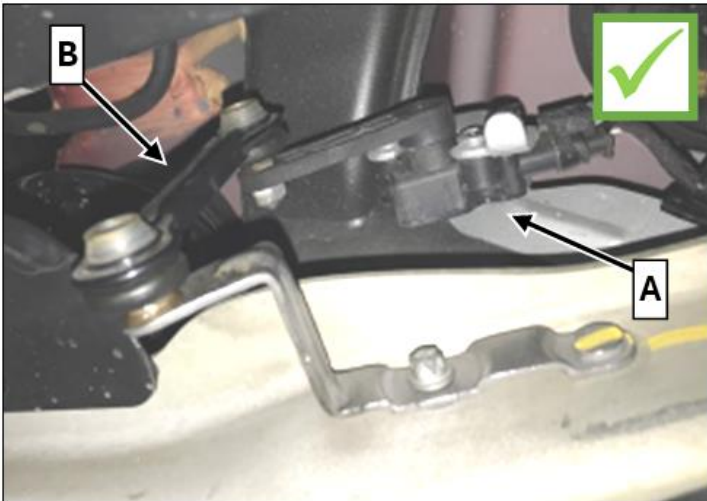
Figure 2 (OK picture)

i The installation position of the link rod (B) of the right rear axle level sensor (A) must be installed as shown in figure 2 (**OK picture**)!

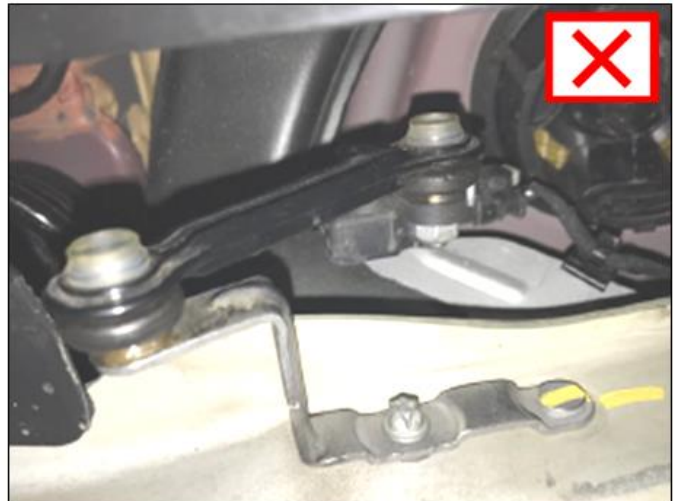
Figure 3 (NOK picture)

i The figure 3 (**not OK picture**) represents an **incorrect** installation position!

- a. If the **Installation position** of the link rod is **not OK**: Carry out **work procedure**.
- b. If the **installation position** of the link rod is **OK**: **End measure**.

1. Release link rod from the right rear axle level sensor.
i For basic data, see AR82.10-P-0005MFA.
 2. Position the link rod and right rear axle level sensor.
i Spacer ring is seated directly under the connecting flange of the upper oil line!
 3. Secure link rod of the right rear axle level sensor.
i For basic data, see AR82.10-P-0005MFA.
 4. Perform function test of automatic beam range control.
i For basic data, see AP82.10-P-8250EW.
-
