TO: Mercedes-Benz Dealer Principals, General Managers, Sales Managers, Service Managers, Parts Managers	FROM: Gregory Gunther, Senior Manager, Vehicle Compliance and Analysis, Engineering Services
RE: <b>Updated Recall Campaign Launch Notification</b> <b>STOP DRIVE</b> <b>Inspect and Replace Brake Booster with Pedal Rework</b> <b>MY06-12 GL-Class, ML-Class, R-Class</b> <b>(X164, W164, V251 platform)</b>	UPDATE: May 24, 2024

Campaign No. 2022050014, May 2022

SUBJECT: **Model GL-Class, ML-Class, and R-Class (X164, W164 and 251 platform)  
Model Year 2007-2008**

## **Inspect Brake Booster – with Pedal Rework**

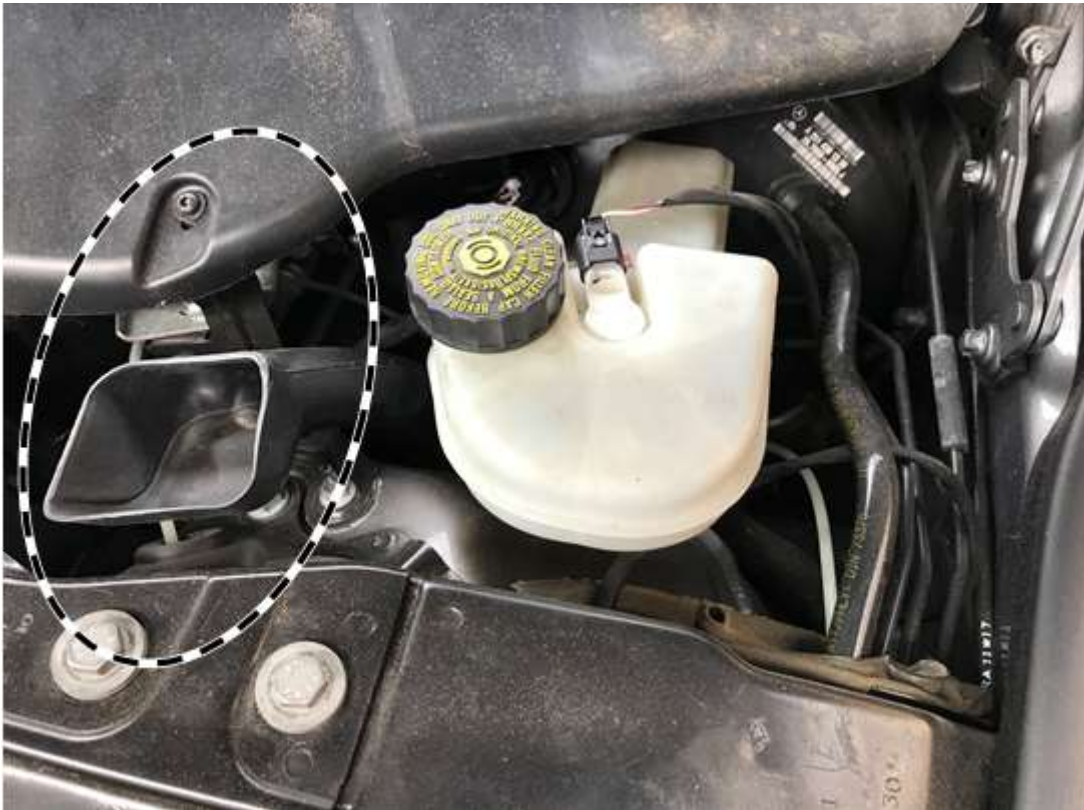
Figure 1

1. Open the hood and check the water drains (**marking, Figure 1**) for correct installation and ability to drain.
  - i** Only for model 251
  - i** Clean and correctly install water drains if necessary.

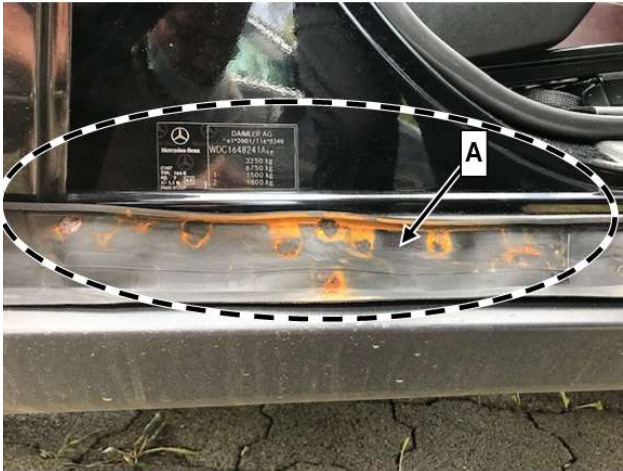
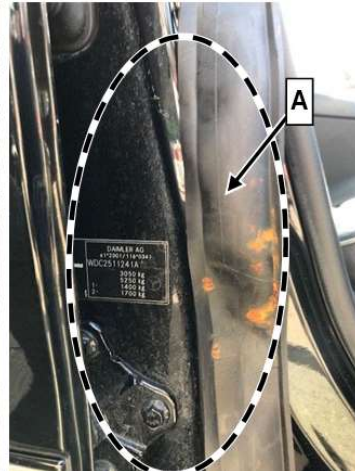
3. Take a photo of the rubber sleeve with the VIN label of the B-pillar (A, Figures 3 and 4) and store to a local HDD/computer storage location with the vehicle service file and attach it to the warranty claim in EVA.

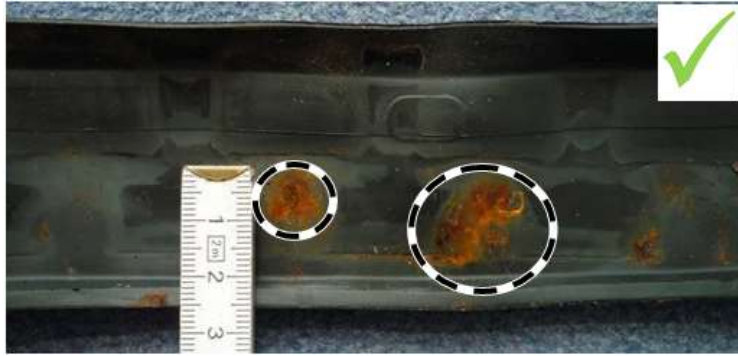
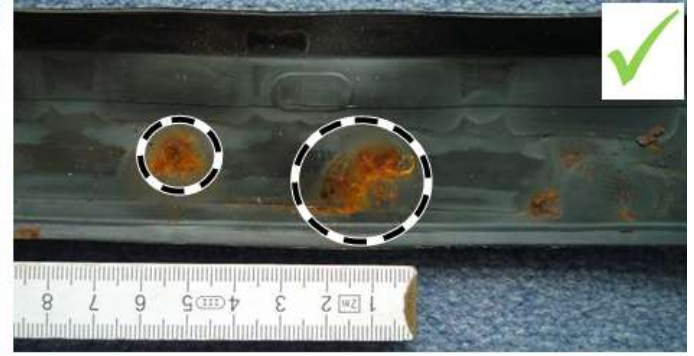
A maximum of **one point-shaped corrosion mark** with a diameter **greater than 15 mm** (Figures 6 and 7) is permitted.

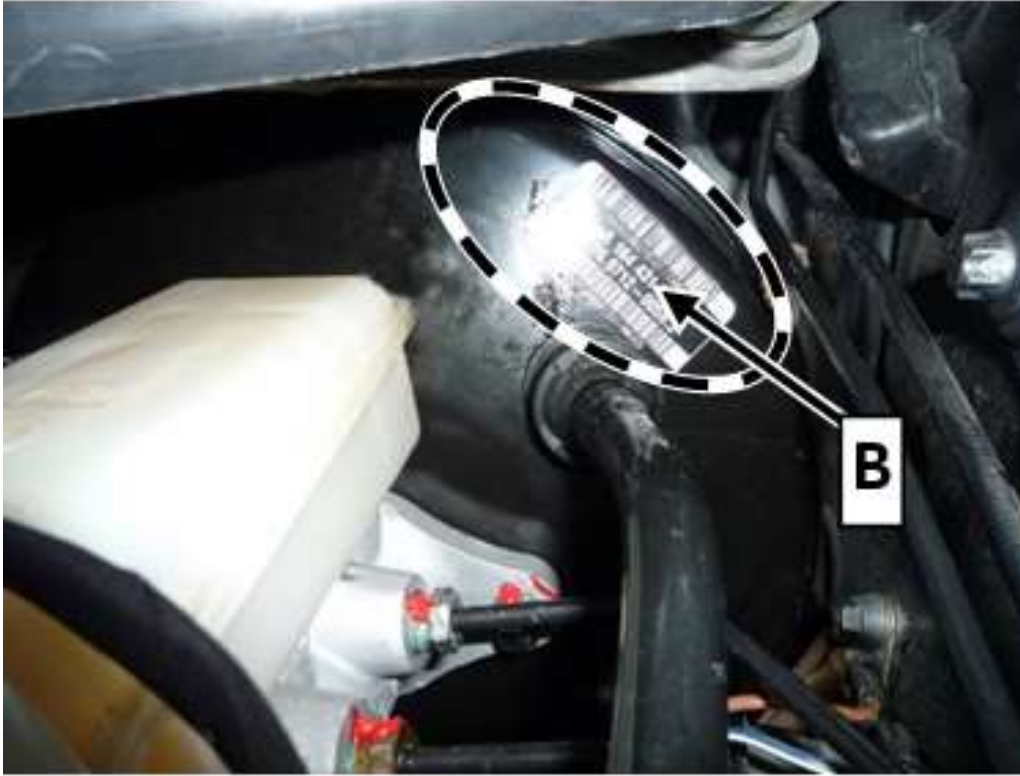
**Figure 8**

1. Take a photo of the barcode label (B, Figure 8) on the brake booster and store to a local HDD/computer storage location with the vehicle service file and attach to the warranty claim in EVA.

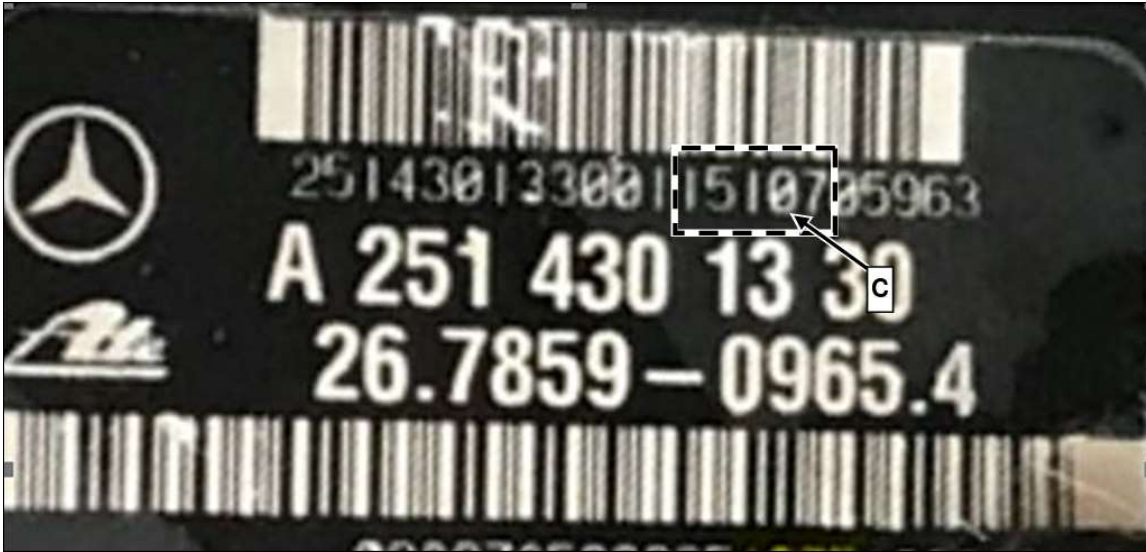
Figure 9

2. Check sequence of numbers on the barcode label (**C**, Figure 9).

- a. If the numeric sequence between the 13<sup>th</sup> and 17<sup>th</sup> digits are **less than** "15126": Carry out **work procedure below**.
- b. If the numeric sequence between the 13<sup>th</sup> and 17<sup>th</sup> digits are **greater than or equal to** "15126": **End measure**.

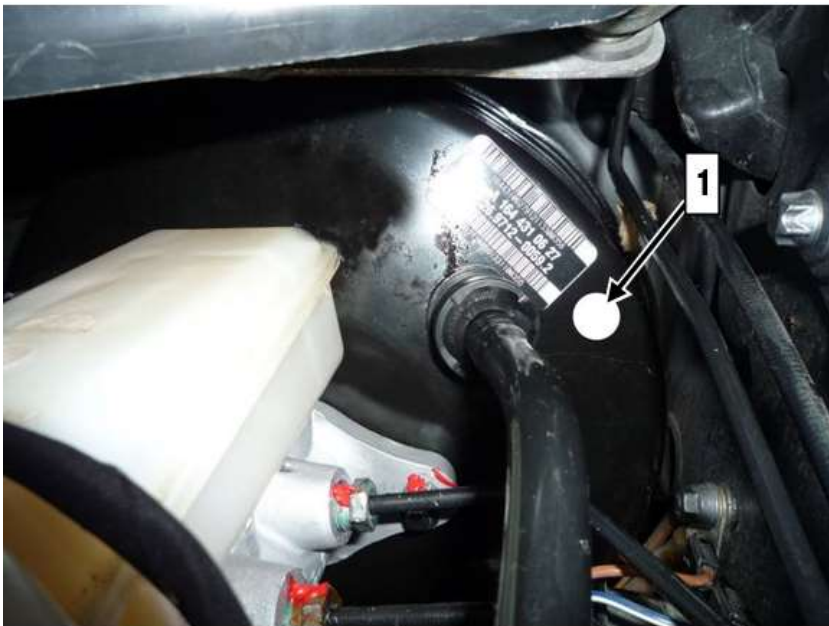
Figure 10

3. Apply marking with **white touch-up paint pen (1, Figure 10)** to the inspected brake booster.

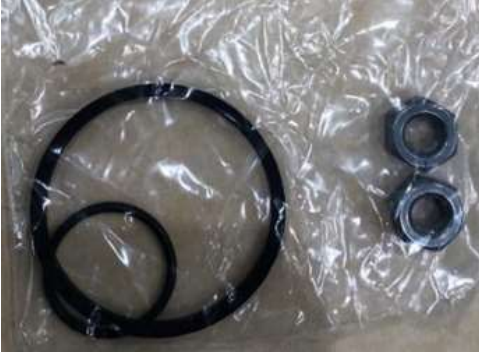
**Figure 11**

**i** The new brake booster contains a small parts kit (**Figure 11**).

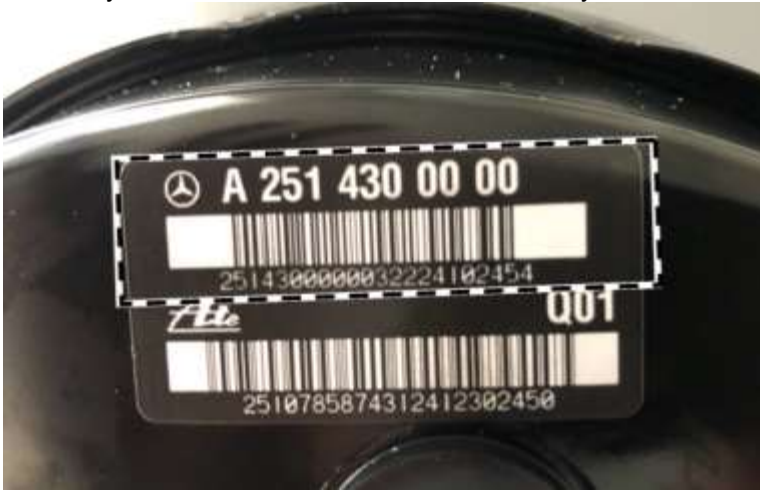
**Figure 12**

5. Read out serial number (**Figure 12**) using the **Mercedes-Benz PartScan** app.
