IMPORTANT RECALL CAMPAIGN UPDATE

Campaign No. 2022050015, May 2022

SUBJECT: **Model GL-Class, ML-Class, and R-Class (X164, W164 and 251 platform)
Model Year 2006-2012**

Inspect Brake Booster – without Pedal Rework

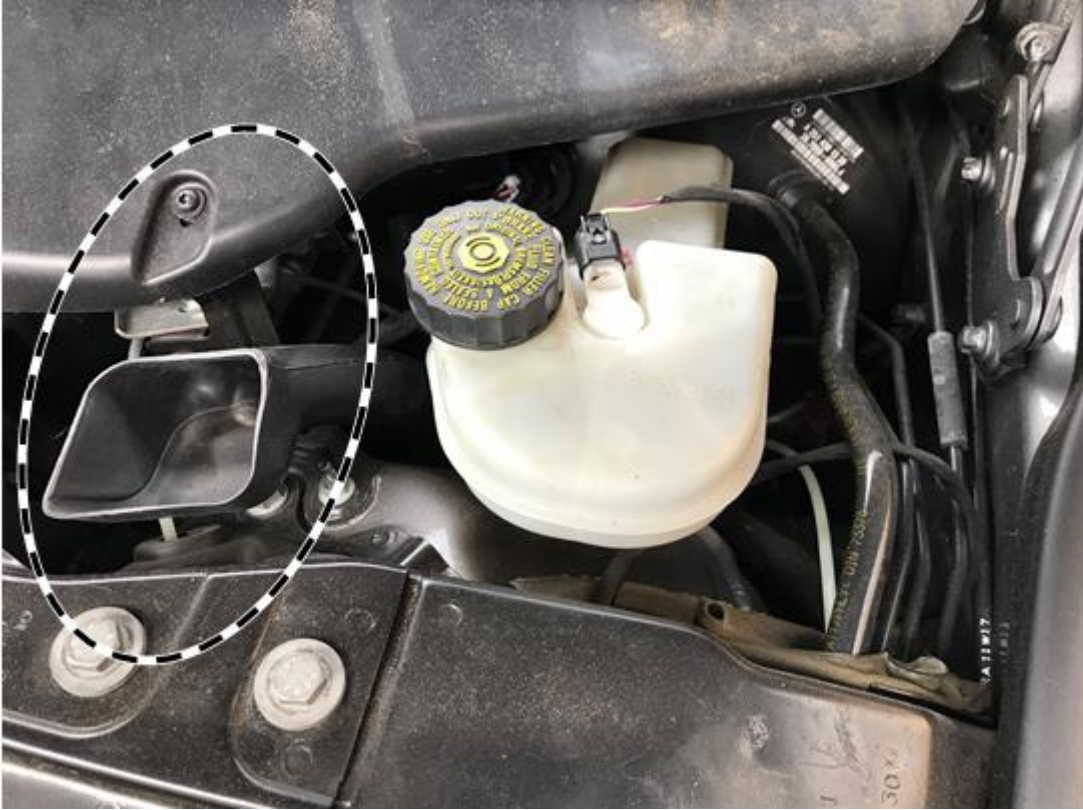
Figure 1

1. Open the hood and check the water drains (**marking, figure 1**) for correct installation and ability to drain.

i Clean and correctly install water drains if necessary.

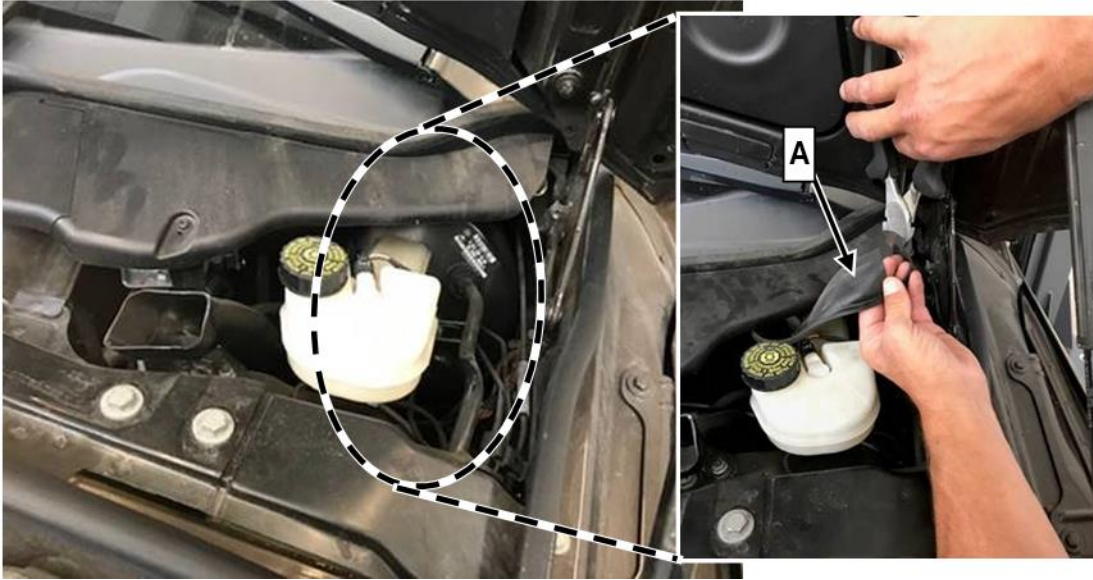
Figure 2

2. Remove the rubber sleeve wrapped around the brake booster (**A, figure 2**) with a suitable tool (hook and side cutting pliers). If the rubber sleeve is not present, please proceed to check/test procedure **A1**.
 - i** The rubber sleeve should be separated above the barcode label on the brake booster as seen in (**A, figure 2** and **B, figure 4.1**).

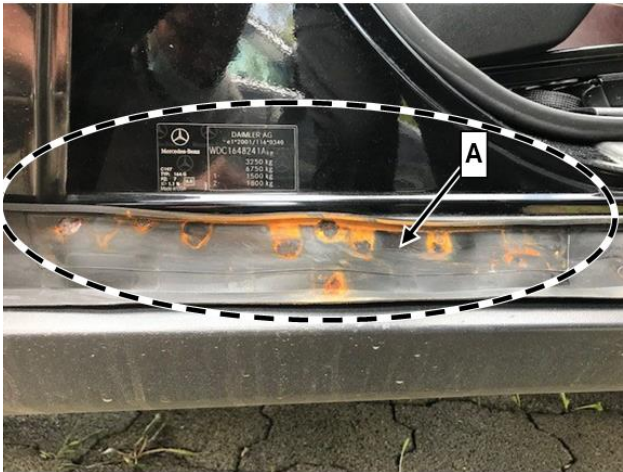
Figure 3

3. Take a photo of the rubber sleeve with the VIN label of the B-pillar (**A, figures 3 and 4**) and store to a local HDD/computer storage location with the vehicle service file and attach it to the warranty claim in EVA.
 - i** These pictures serve as documentation of the current condition of the brake booster.

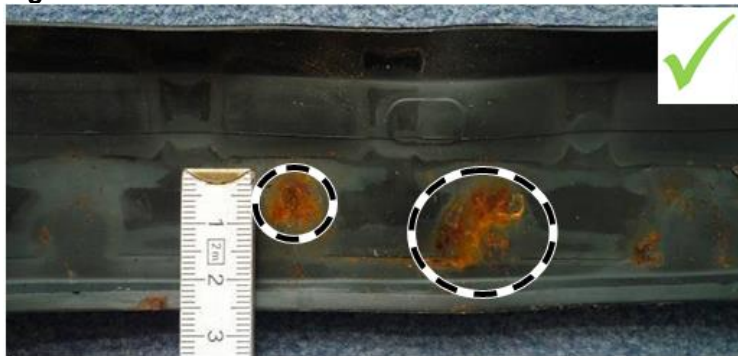
A maximum of **one point-shaped corrosion mark** with a diameter **greater than 15 mm** (**figures 6 and 7**) is permitted.

Figure 6 OK

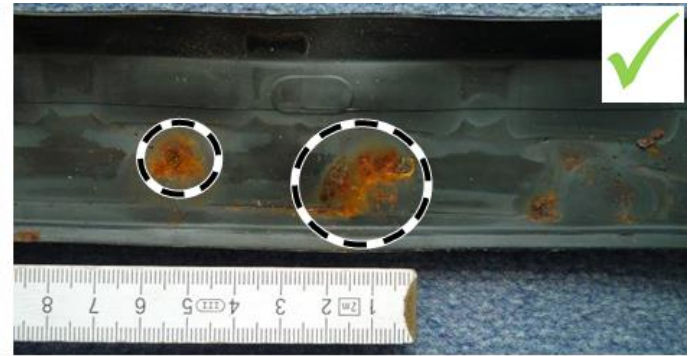
Figure 7 OK

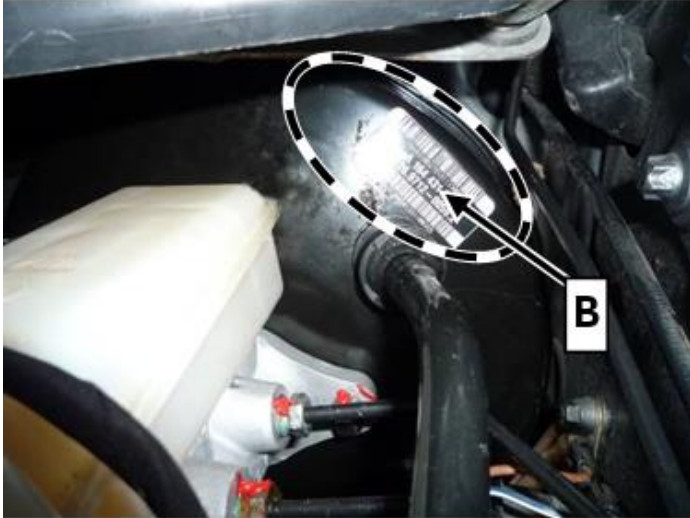
Figure 8

1. Take a photo of the barcode label (B, figure 8) on the brake booster and store to a local HDD/computer storage location with the vehicle service file and attach to the warranty claim in EVA.

i If the measure is ended, **do not** re-install a new rubber sleeve. Apply marking with **white touch-up paint pen (1, figure 8)** to the brake booster checked.

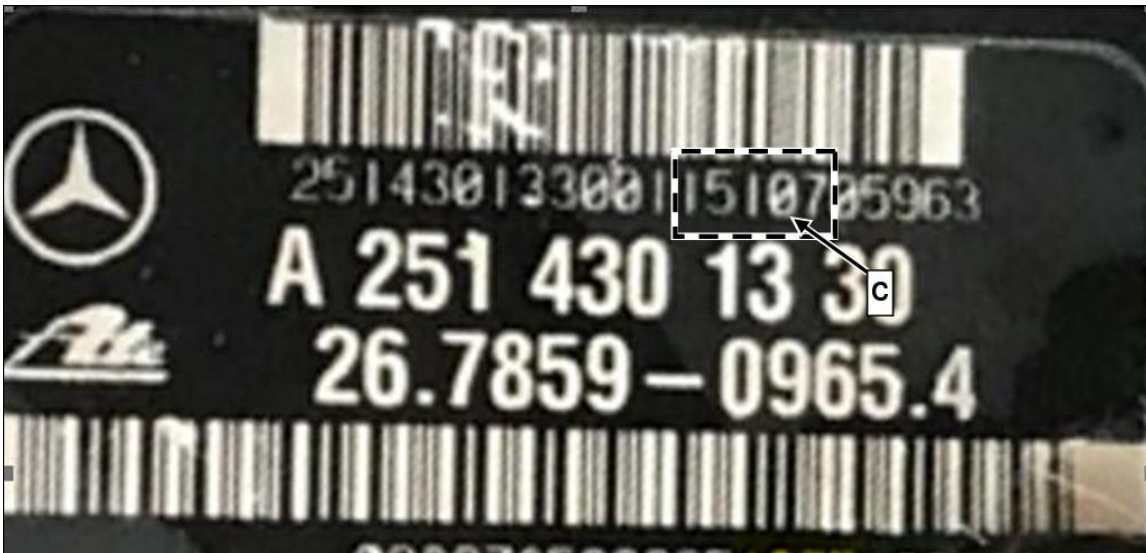
Figure 9

1. Check sequence of numbers on the barcode label (C, figure 9).
 - a. If the numeric sequence between numbers 13 and 17 is **less than** "15126": Carry out **scope of testing B - XENTRY/DAS**.
 - b. If the numeric sequence between numbers 13 and 17 is **greater than or equal to** "15126": **End measure**.
