IMPORTANT RECALL CAMPAIGN UPDATE

Campaign No. 2022050015, May 2022

SUBJECT: **Model GL-Class, ML-Class, and R-Class (X164, W164 and 251 platform)
Model Year 2006-2012**

Inspect Brake Booster – without Pedal Rework

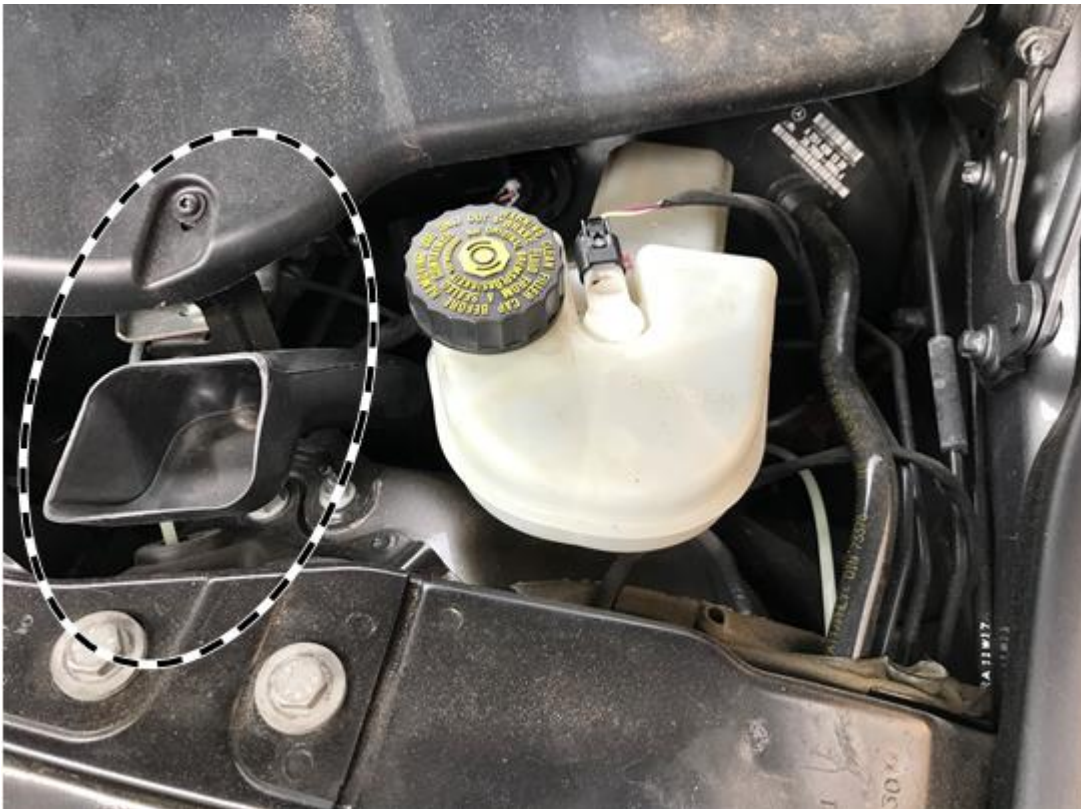
Figure 1

- i** The following work must be invoiced using **damage code (SSL) "42 900 05"**.
1. Open the hood and check the water drains (**marking, figure 1**) for correct installation and ability to drain.
 - i** Clean and correctly install water drains if necessary.

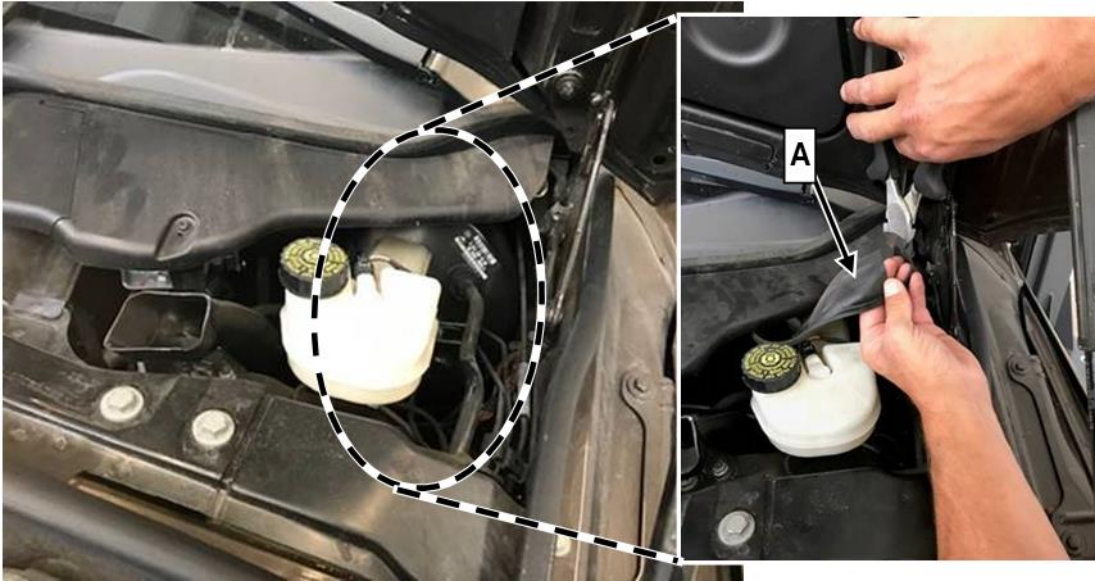
Figure 2

2. Remove the rubber sleeve wrapped around the brake booster (A, figure 2) with a suitable tool (hook and side cutting pliers). If the rubber sleeve is not present, please proceed to check/test procedure A1.

i The rubber sleeve should be separated above the barcode label on the brake booster as seen in (A, figure 2 and B, figure 4.1).

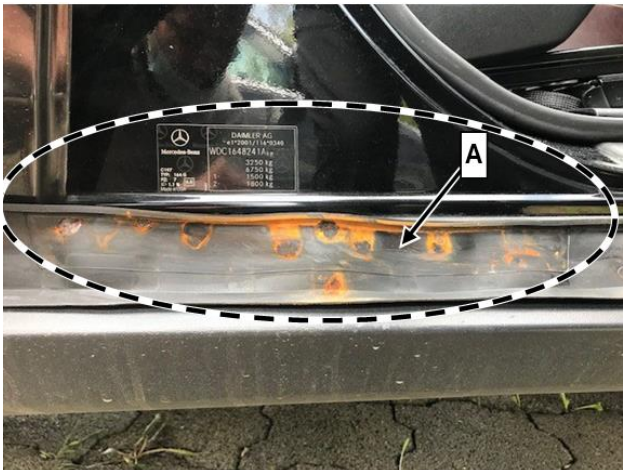
Figure 3

3. Take a photo of the rubber sleeve with the VIN label of the B-pillar (A, figures 3 and 4) and store to a local HDD/computer storage location with the vehicle service file and attach it to the warranty claim in EVA.

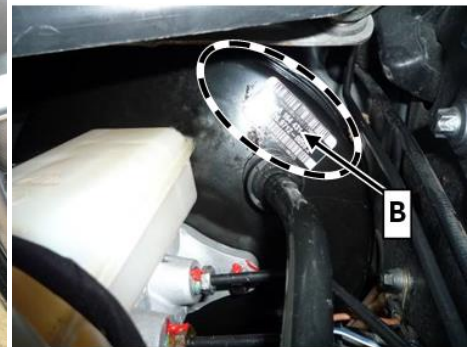
Figure 4.1

i If the rubber sleeve on the brake booster is **not** present, please take a photo of the barcode label (**B, figure 4.1**) on the brake booster and store to a local HDD/computer storage location with the vehicle service file and attach to the warranty claim in EVA. Then continue with **check/test procedure A1**.

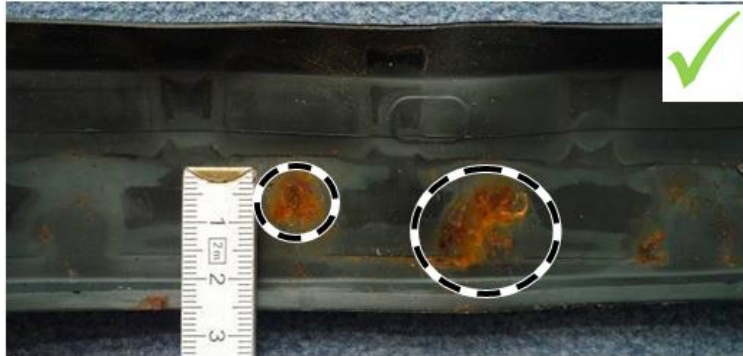
A maximum of **one point-shaped corrosion mark** with a diameter **greater than 15 mm** (**figures 6 and 7**) is permitted.

Figure 6 Ok

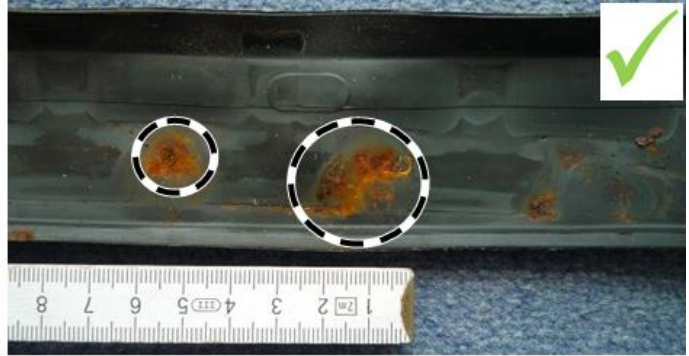
Figure 7 OK

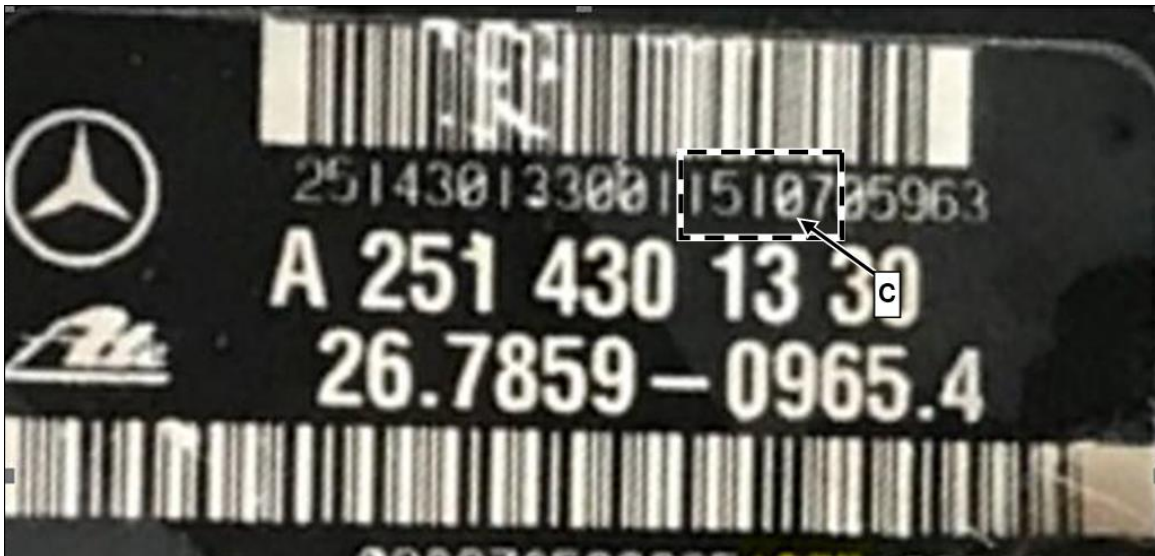
Figure 4.2

1. Check sequence of numbers on the barcode label (**C, figure 4.2**).
 - a. IF the sequence of numbers is **less than** "15126" starting from the 13th number: Perform **check/test procedure B - XENTRY/DAS**.
 - b. If the sequence of numbers is **greater than or equal to** "15126" starting from the 13th number: **End the measure**.
