TO: Mercedes-Benz Dealer Principals, General Managers, Sales Managers, Service Managers, Parts Managers	FROM: Gregory Gunther, Senior Manager, Vehicle Compliance and Analysis, Engineering Services
RE: Updated Recall Campaign Launch Notification STOP DRIVE Inspect and Replace Brake Booster without Pedal Rework MY06-12 GL-Class, ML-Class, R-Class (X164, W164, V251 platform)	UPDATE: May 24, 2024

Campaign No. 2022050015, May 2022

SUBJECT: **Model GL-Class, ML-Class, and R-Class (X164, W164 and 251 platform)
Model Year 2006-2012**

Inspect Brake Booster – without Pedal Rework

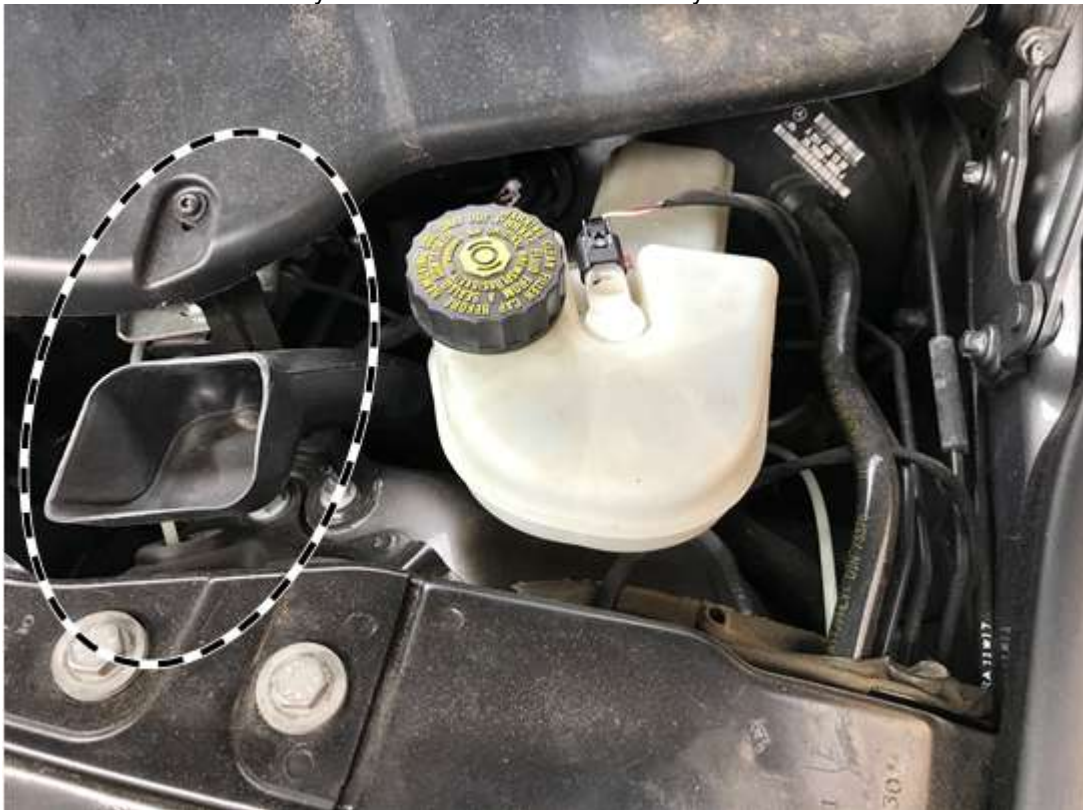
Figure 1

- Open the hood and check the water drains (**marking, Figure 1**) for correct installation and ability to drain.

i Clean and correctly install water drains if necessary.

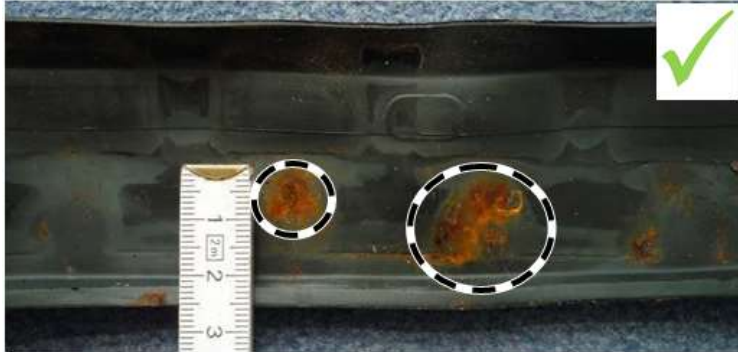
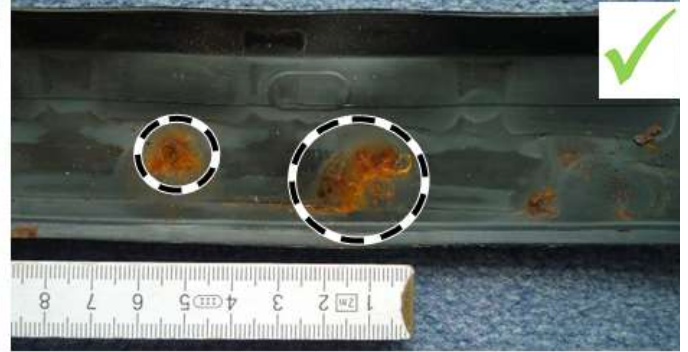
A maximum of **one point-shaped corrosion mark** with a diameter **greater than 15 mm** (Figures 6 and 7) is permitted.
