TO: Mercedes-Benz Dealer Principals, General Managers,	FROM: Gregory Gunther, Department Manager, Vehicle
Sales Managers, Service Managers, Parts Managers	Compliance and Analysis, Engineering Services
RE: Updated Recall Campaign Launch Notification –	
STOP DRIVE	
Inspect Brake Booster without Pedal Rework	UPDATE: February 14, 2023
MY06-12 GL-Class, ML-Class, R-Class	
(X164, W164, V251 platform)

IMPORTANT RECALL CAMPAIGN UPDATE

STOP DRIVE NOTIFICATION!

Recall Cam	paign Launc	h Notification	February 14, 2023	
Campaign No. :	NHTSA ID	Campaign Desc. :	Inspect Brake Booster	
2022050015	22V315	22P4290005	Without Pedal Rework	
Class, ML-Class, and R-Cl	ass (X164, W164 an	d V251 platform) vehicles. The r	the brake booster on <u>278,173</u> Model Year ("MY") 2006-2012 GL- recall campaign will be visible on the <u>www.safercar.gov</u> website and ere flagged in VMI as "OPEN" on May 28, 2022.	
		Backgrou	Ind	
Issue What We're Doing		 Mercedes-Benz AG ("MBAG"), the manufacturer of Mercedes-Benz vehicles, has determined that on certain Model Year ("MY") 2006-2012 ML-Class, GL-Class (W164/X164 platform) and R-Class (V251 platform) vehicles, the function of the brake booster might be affected

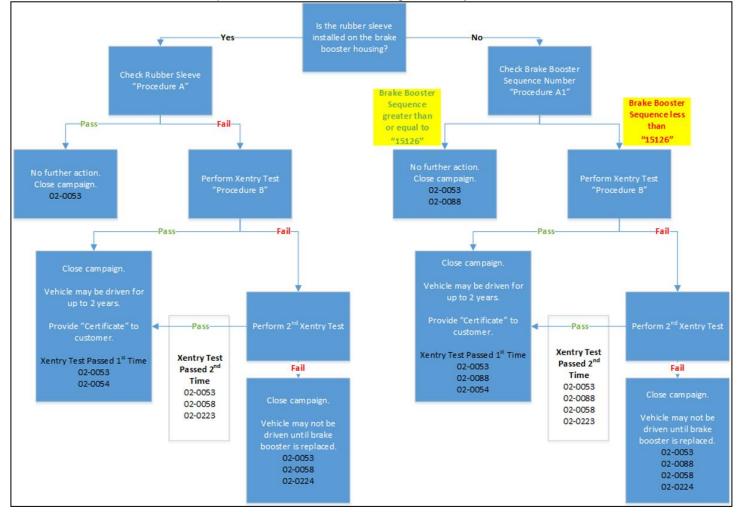
1. Flow chart with allowable labor operation codes when submitting a warranty claim.

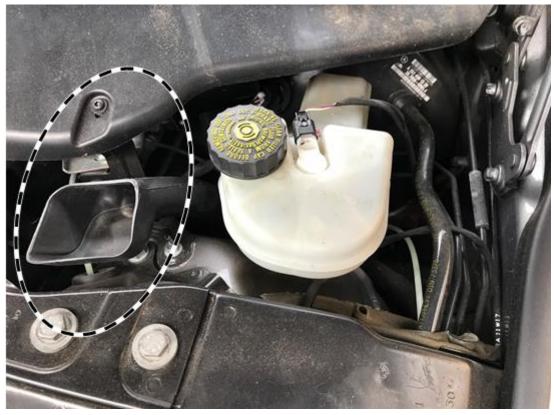
Open the hood and check the water drains (marking, figure 1) for correct installation and ability to drain.
 Only for model 251

i Clean and correctly install water drains if necessary.

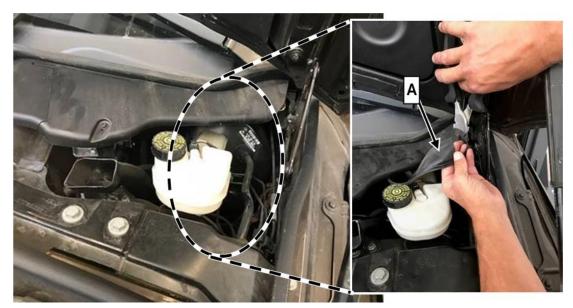
2. Remove the rubber sleeve wrapped around the brake booster (A, figure 2) with a suitable tool (hook and side cutting pliers). If the rubber sleeve is not present, please proceed to check/test procedure A1.

i The rubber sleeve should be separated <u>above</u> the barcode label on the brake booster as seen in (A, figure 2 and B, figure 4.1).

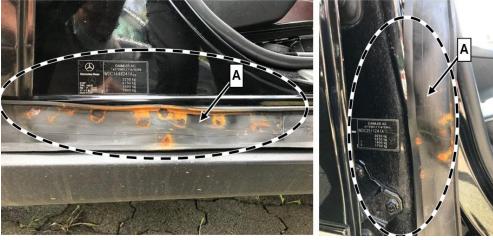
Figure 4

3. Take a photo of the rubber sleeve with the VIN label of the B-pillar (A, figures 3 and 4) and store to a local HDD/computer storage location with the vehicle service file and attach it to the warranty claim in EVA.
 1 These pictures serve as documentation of the current condition of the brake booster.

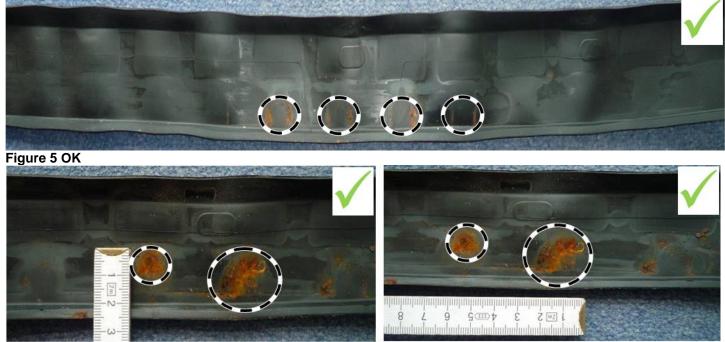
Multiple point-shaped corrosion marks (figure 5) are permissible.

A maximum of one point-shaped corrosion mark with a diameter greater than 15 mm (figures 6 and 7) is permitted.

Figure 6 OK

Figure 7 OK

Widespread corrosion marks spanning the rubber sleeve are not permissible. More than one corrosion mark with a diameter greater than 15 mm is not permissible.

- a. Corrosion measurements Exceeds thresholds-NOK: Carry out check/test procedure B XENTRY/DAS.
- **b.** Corrosion measurements **Does not exceed threshold-OK** (figure 5, 6 or 7): **End measure**. (**Certificate of Passed Initial Diagnostic Brake Test not required**).

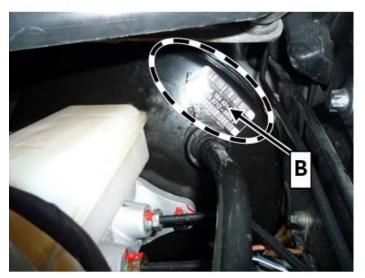
1. Take a photo of the barcode label (B, figure 8) on the brake booster and store to a local HDD/computer storage location with the vehicle service file and attach to the warranty claim in EVA.

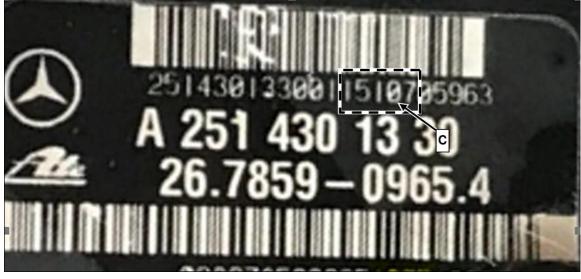
- 1. Check sequence of numbers on the barcode label (C, figure 9).
 - a. If the numeric sequence between numbers 13 and 17 is *less than* "15126": Carry out scope of testing B
 XENTRY/DAS.
 - **b.** If the numeric sequence between numbers 13 and 17 is *greater than or equal to* "15126": End measure.

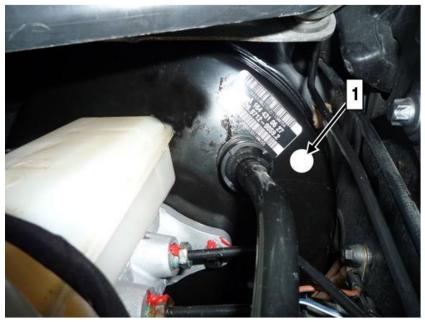
- 2. Apply marking with *white touch-up paint pen* (1, figure 10) to the inspected brake booster.
- Under no circumstances should you treat the brake booster with anti-corrosion agent/paint.
