David J. Johnson  
 Director  
 Service Engineering Operations  
 Ford Customer Service Division

**SUBJECT:** **NEW VEHICLE DEMONSTRATION / DELIVERY HOLD – Safety Recall 22S36 – Supplement #5**  
 Certain 2021 Model Year Expedition and Lincoln Navigator Vehicles equipped with a Standard Duty Cooling Fan  
 Underhood Fire

**REF:** **NEW VEHICLE DEMONSTRATION / DELIVERY HOLD – Safety Recall 22S48 – Supplement #2**  
 Certain 2021 Model Year Expedition and Lincoln Navigator Vehicles equipped with a Heavy Duty Cooling Fan  
 Underhood Fire

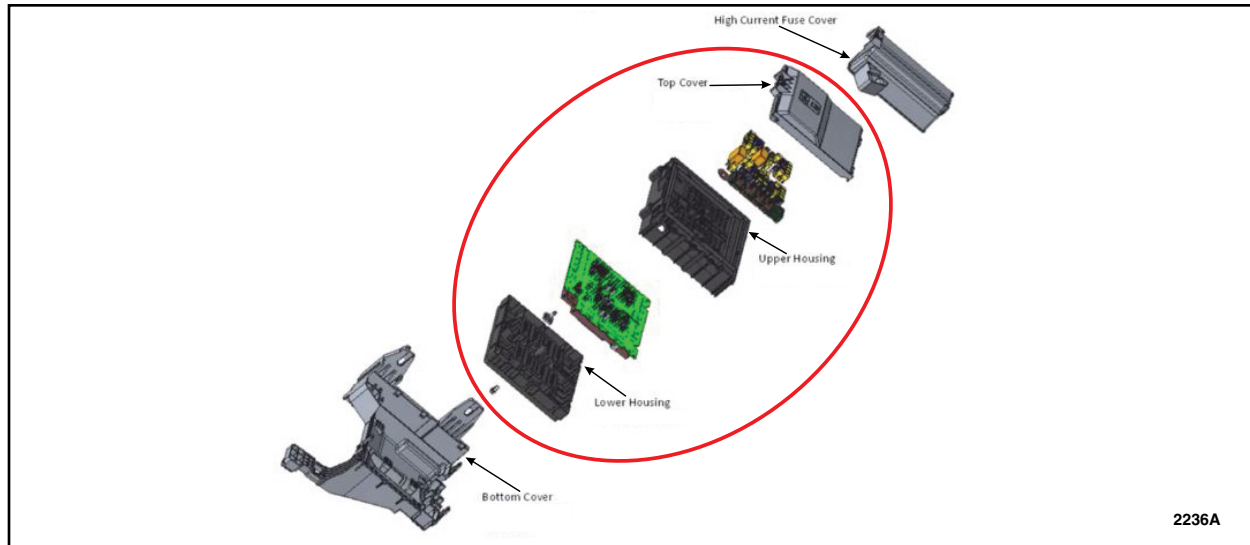
**FIGURE 1**

**NOTE:** Items circled in red are included with a new BJB. Covers can be ordered independently of the BJB.

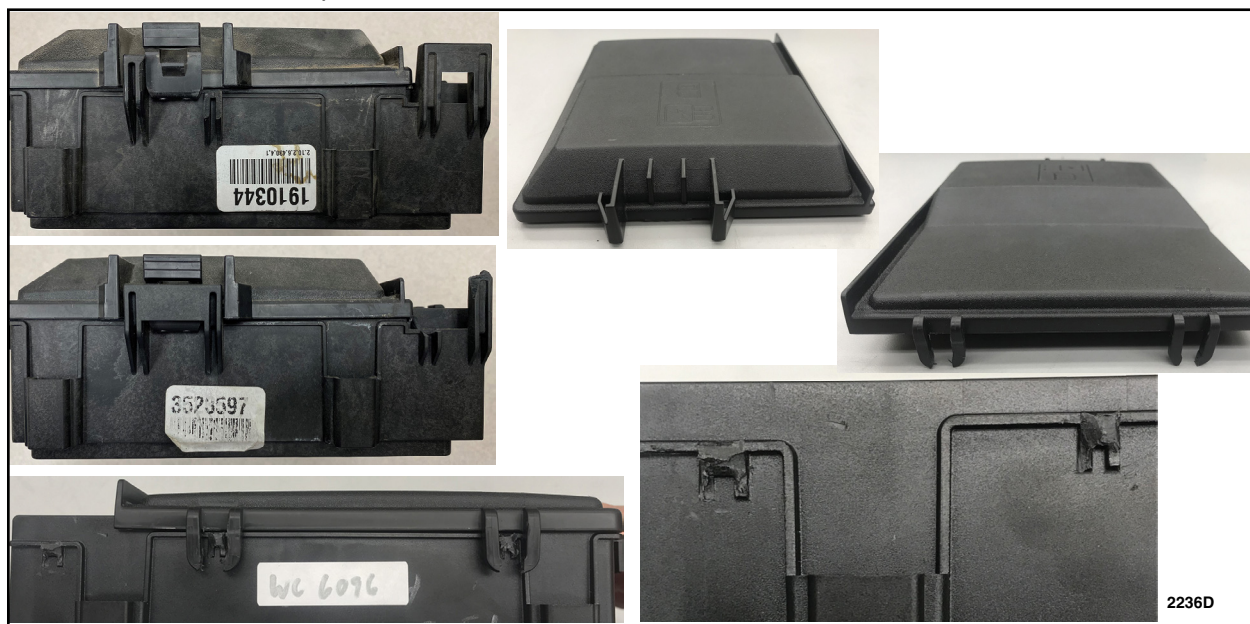
FIGURE 4

4. Check for any damage such as cracks, excessive warping, melting, broken hoop(s), and/or broken latch(es) on both covers. Is there any damage present on either cover? See Figure 4.

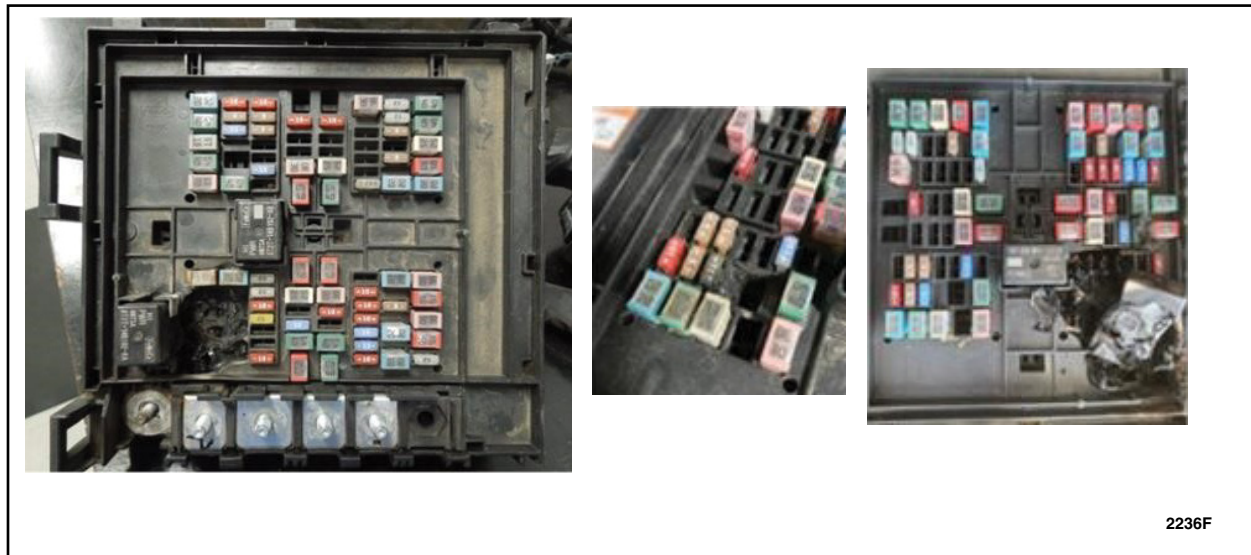
**FIGURE 5**

5. Remove covers and inspect BJB. Is there any evidence of melted fuse(s), melted relay(s), or melted plastic in the BJB? See Figure 5.
  - Yes - Replace BJB, (photos and Special Service Support Center (SSSC) approval required to proceed. Is the part available?
    - Yes - Proceed to Step 6.
    - No - Part is on back-order. Park vehicle outside, disconnect negative battery cable, and contact the SSSC for approval for rental vehicle for customer.
  - No - Proceed to Step 6.
