TO: Mercedes-Benz Dealer Principals, General Managers, Sales Managers, Service Managers, Parts Managers	FROM: Anthony Washington, Senior Manager, Regulations and Certifications
<b>Re: Launch Recall Campaign Notification</b> <b>Model: Metris (447)</b> <b>Model Years: 2016-2021</b> <b>Replace eCall Communication Module Metris</b>	DATE: April, 2024

<b>Campaign No. :</b>	<b>Campaign Desc. :</b>	<b>Replace eCall Communication Module</b>
<b>2024030014</b>	<b>VS2SIMKOW</b>	
<p>This is to notify you of a Recall Campaign launch to replace the eCall Communication Module on approximately <b>24</b> MY 2016-2021 Metris Vans. The recall campaign will be visible on the <a href="http://www.safercar.gov">www.safercar.gov</a> website and may generate questions from customers. All affected VINs will be flagged as "<b>OPEN</b>" in VMI and cannot be sold until remedied.</p>		
<b>Background</b>		
<b>Issue</b>	<p>Mercedes-Benz AG ("MBAG"), the manufacturer of Mercedes-Benz Metris vans, has determined that due to an interaction between a SIM card security mechanism and the affected SIM profile, the SIM card might inadvertently become disabled. Should this occur, the communication module would not be able

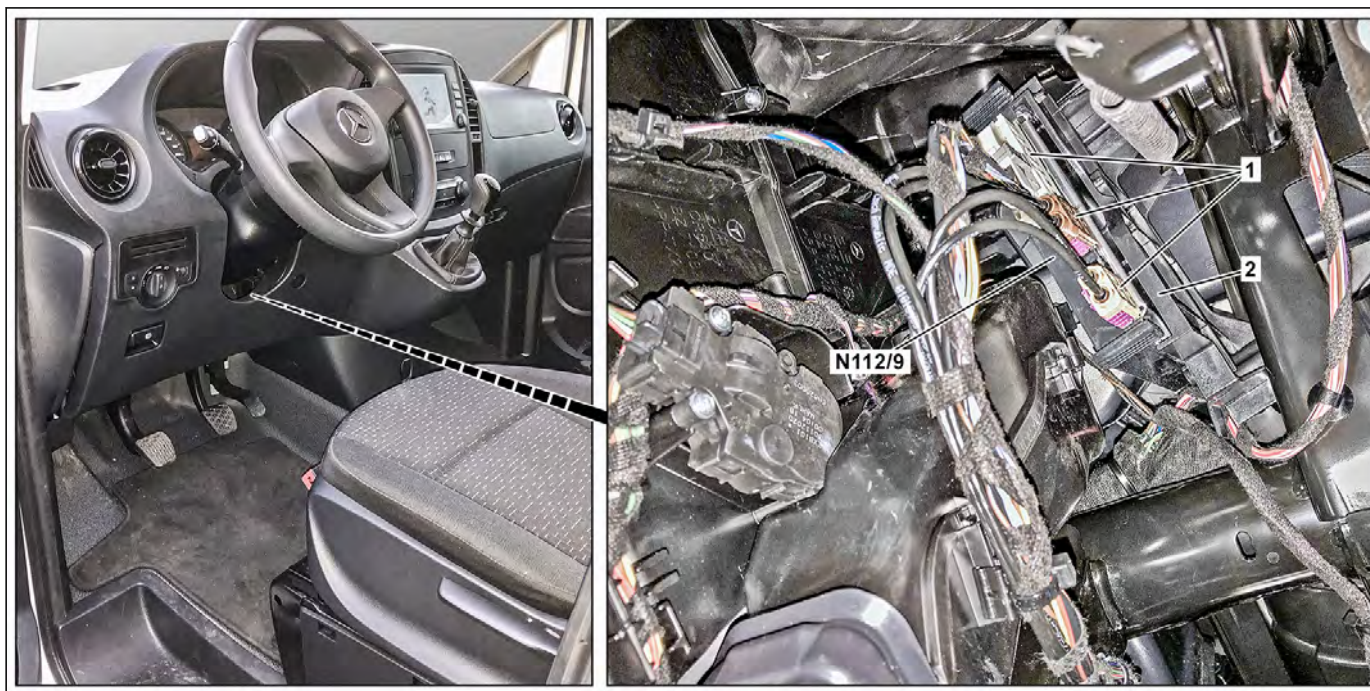
S82.95-A014-79

- 1 Electrical connector
- 2 Bracket

N112/9 HERMES control unit

<b>Install</b>		
12	Install new HERMES control unit (N112/9) on holder (2) and lock.	Only if, after about 7 minutes or after starting 3 times in succession, the SIM card data in the HERMES control unit (N112/9) was not successfully updated.	
13	Connect electrical connectors (1).	Only if, after about 7 minutes or after starting 3 times in succession, the SIM card data in the HERMES control unit (N112/9) was not successfully updated.
