Safety Recall Launch Notification

Campaign #	NHTSA ID	Description	Update Communication Module SIM Card Software – Wave 4
2023110006	22V365	23P5497319

Recall Campaign Bulletin

SIM Card Communication Module – Wave 4

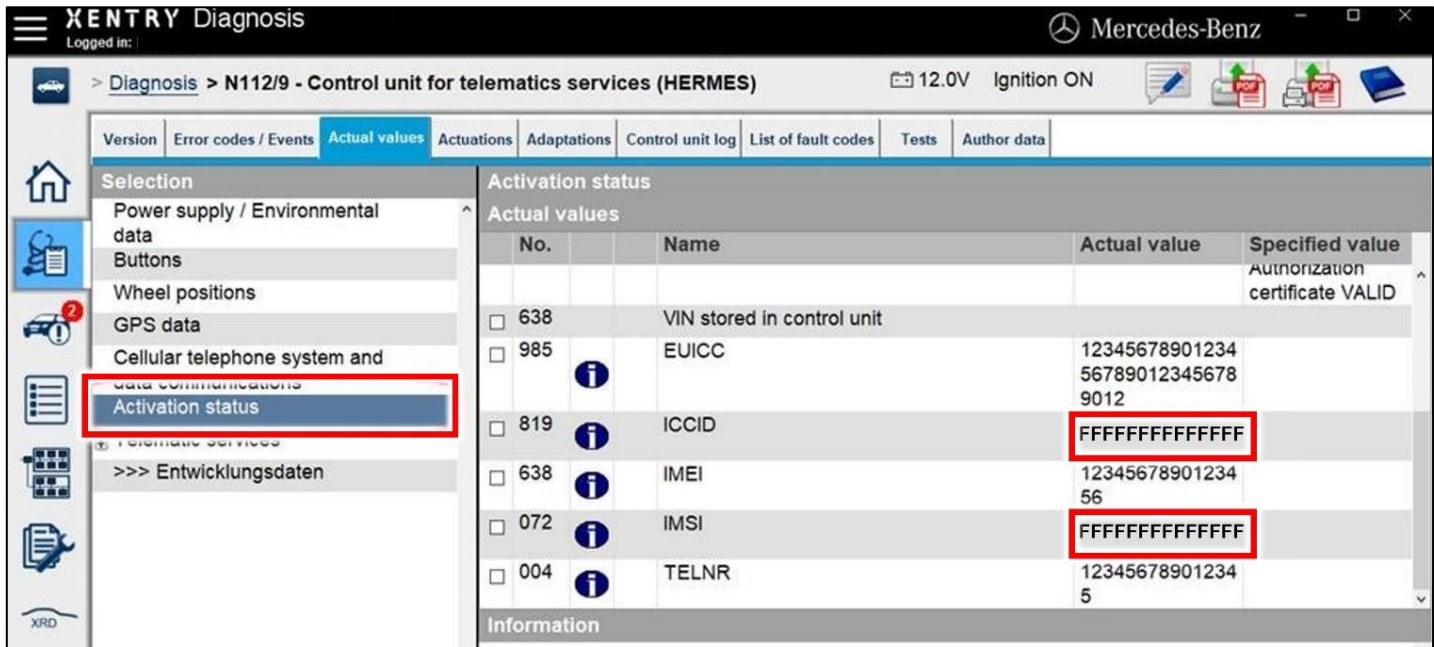
Figure 1

- If XENTRY Diagnosis displays "FFFFFFFFFFFFFF" for the "ICCID" and "IMSI" actual values (Figure 1): Carry out only **Work Procedures 3 and 4**.
NOTE: This must be documented in the Repair Order text!
- If XENTRY Diagnosis "IMSI" actual value starts with "90140..." (Figure 2). **End Measure**.
NOTE: This must be documented in the Repair Order text!
- If XENTRY Diagnosis "IMSI" actual value starts with "310170...": Carry out **Work Procedures 1, 2, 3** (Work Procedure 3 is dependent on results of Work Procedure 2), **and 4**.

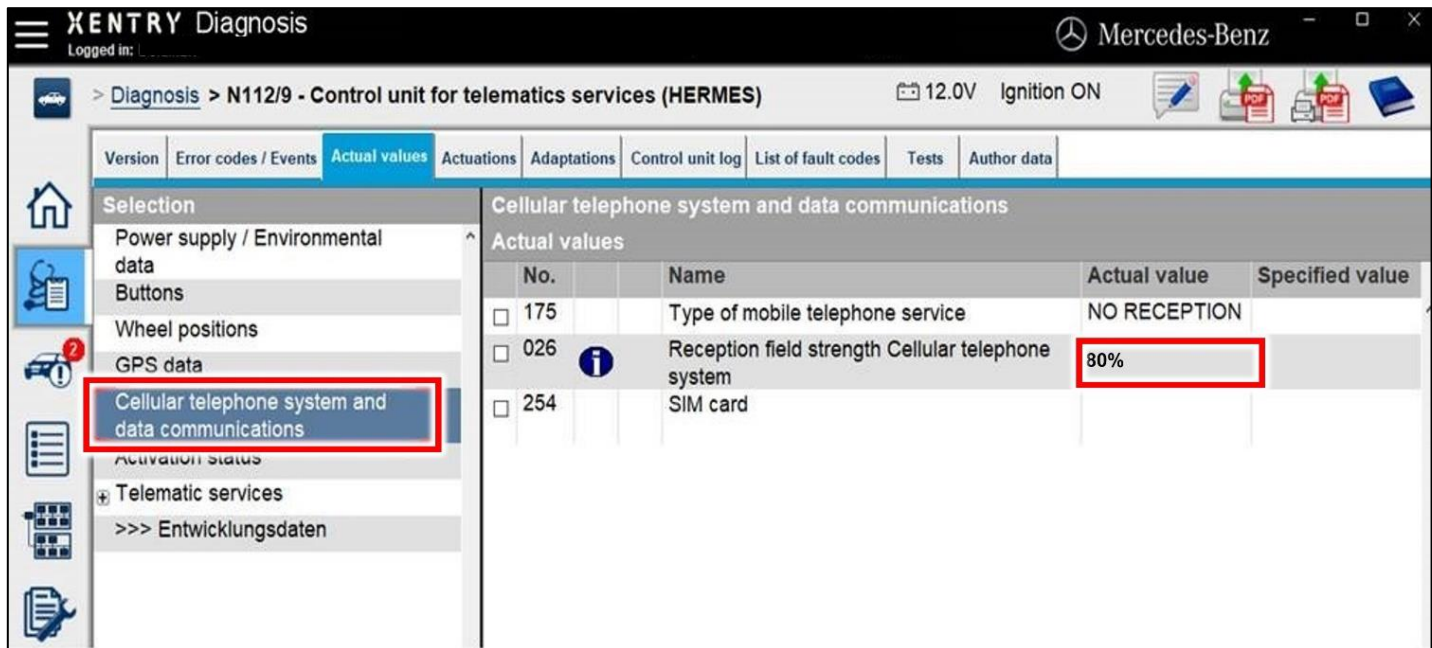
Figure 3

i The current actual value of the "Reception field strength Cellular telephone system" **must be 80% or above (Figure 3)**.

i If the current actual value of the "Reception field strength Cellular telephone system" is **below 80%, position the vehicle outside** to improve mobile reception. The poorer mobile reception is, the higher the probability that the over-the-air (OTA) update of the SIM card data in the HERMES control unit (N112/9) will not be successful.

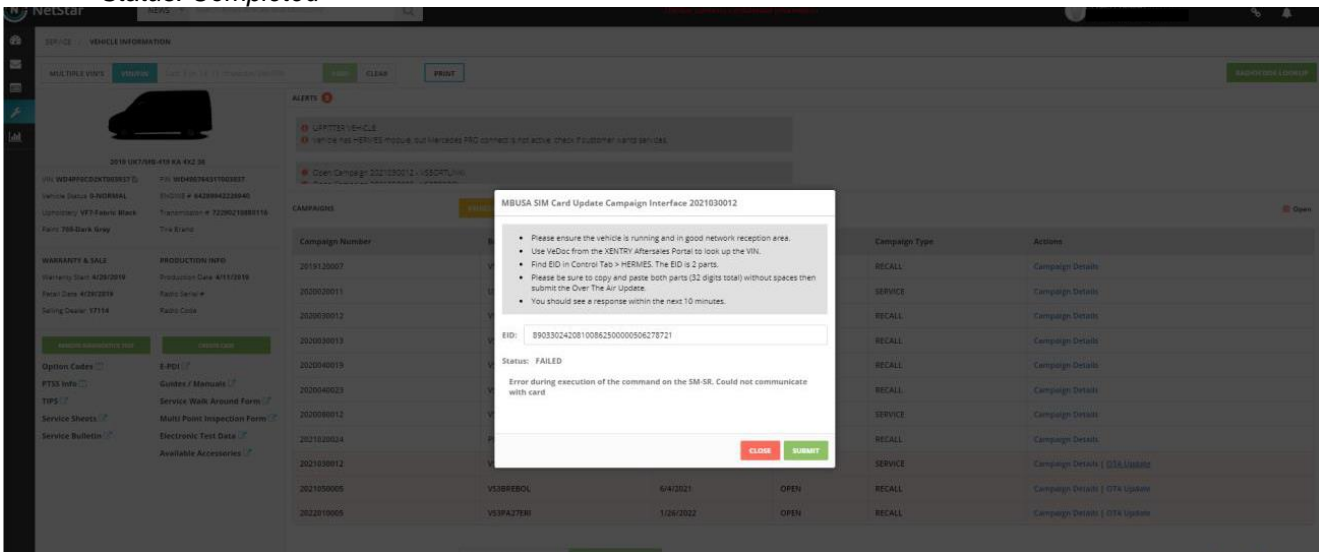
Figure 12 (screen on "NetStar" if the OTA update was not successful)
 Status: Failed – Error during execution of the command on the SM-SR. Could not communicate with card.

- The OTA procedure must be attempted a second time if the first attempt fails. Wait at least 7 minutes after the first attempt before retrying. If the data of the SIM card in the HERMES control unit (N112/9) is **not updated** successfully OTA after the second attempt: Carry out **Work Procedures 3 and 4**.
- If the data of the SIM card in the HERMES control unit (N112/9) is **updated** successfully OTA: Carry out only **Work Procedure 4**.
