Recall Campaign Bulletin

Campaign No. 2023110006, July 2024

SUBJECT: **Various Models**
Model Year 2019 – 2022

SIM Card Communication Module – Wave 3

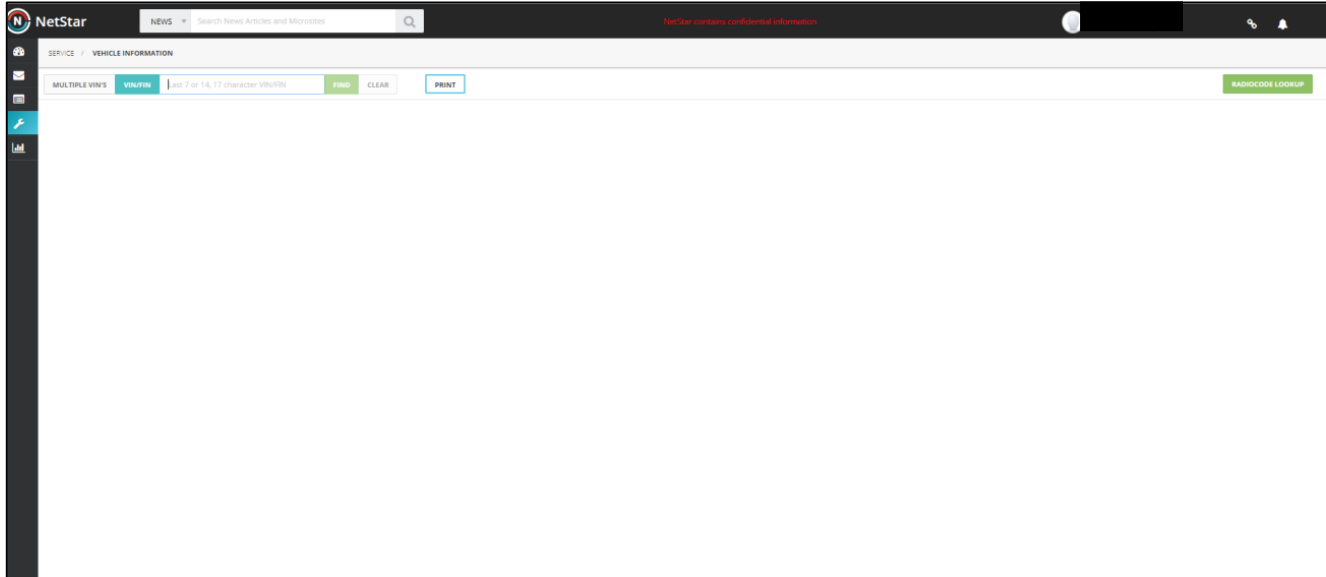
Figure 4

1. Log in to "NetStar" and call up the Vehicle Master Inquiry (VMI) screen (Figure 4).

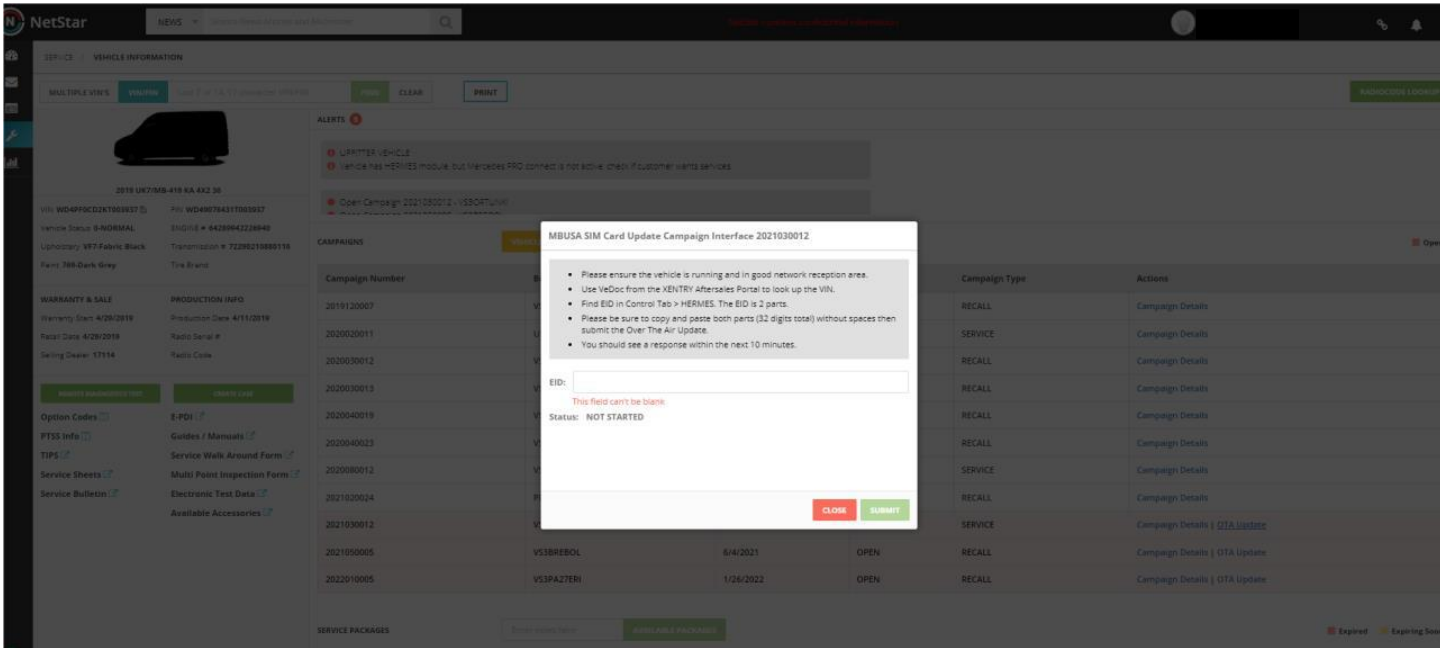
Figure 6

i A pop-up window requesting an EID number for the OTA update will appear (Figure 6).

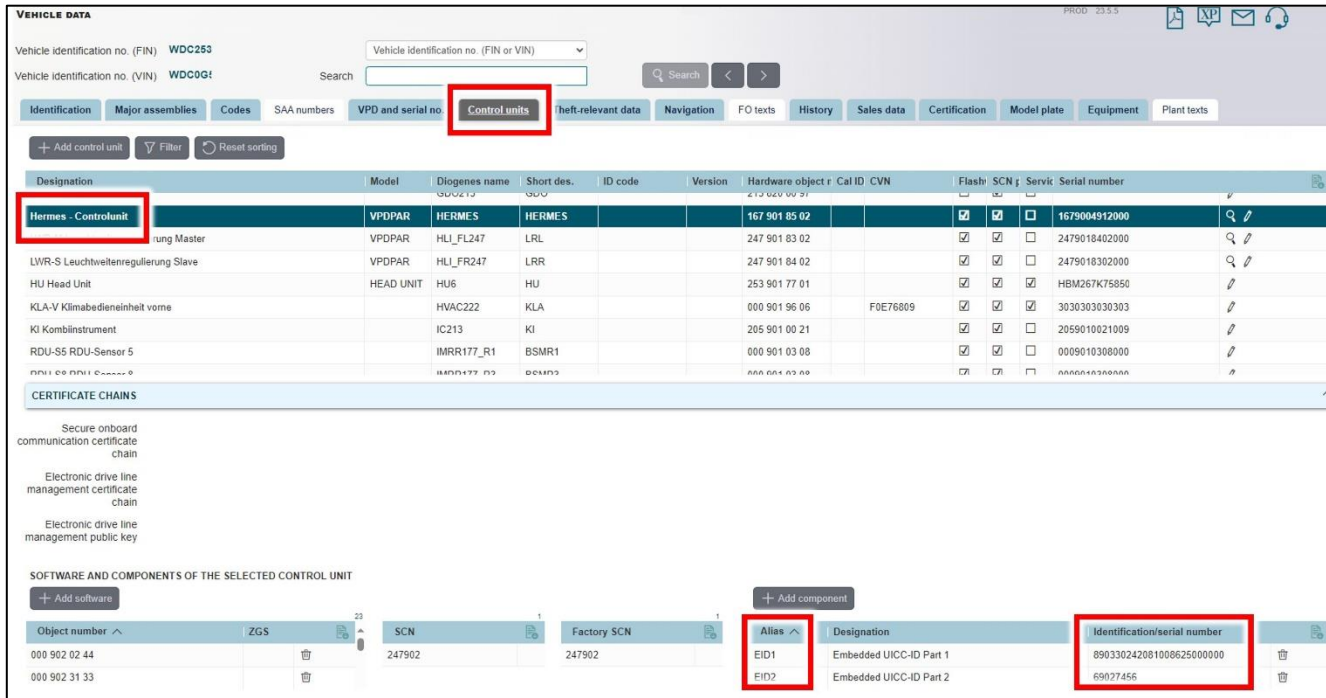
Figure 7

i To do this, enter the VIN, "Search", select "Control units", and click on "Hermes - control unit" (Figure 7).

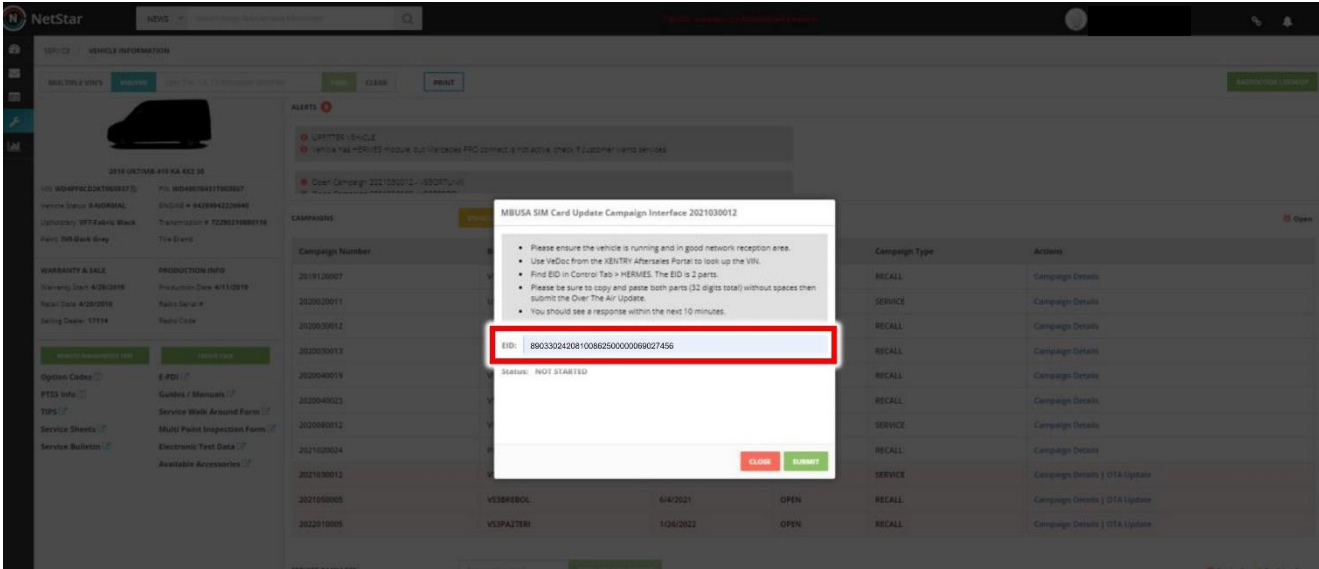
Figure 8 – EID1 + EID2 input

5. Enter the valid EID number and click on "Submit" (Figure 8).

i To do this, enter the **EID1 + EID2** numbers from VeDoc **without spaces or special characters** as shown. (e.g.: 89033024208100862500000069027456 – **EXAMPLE ONLY**).

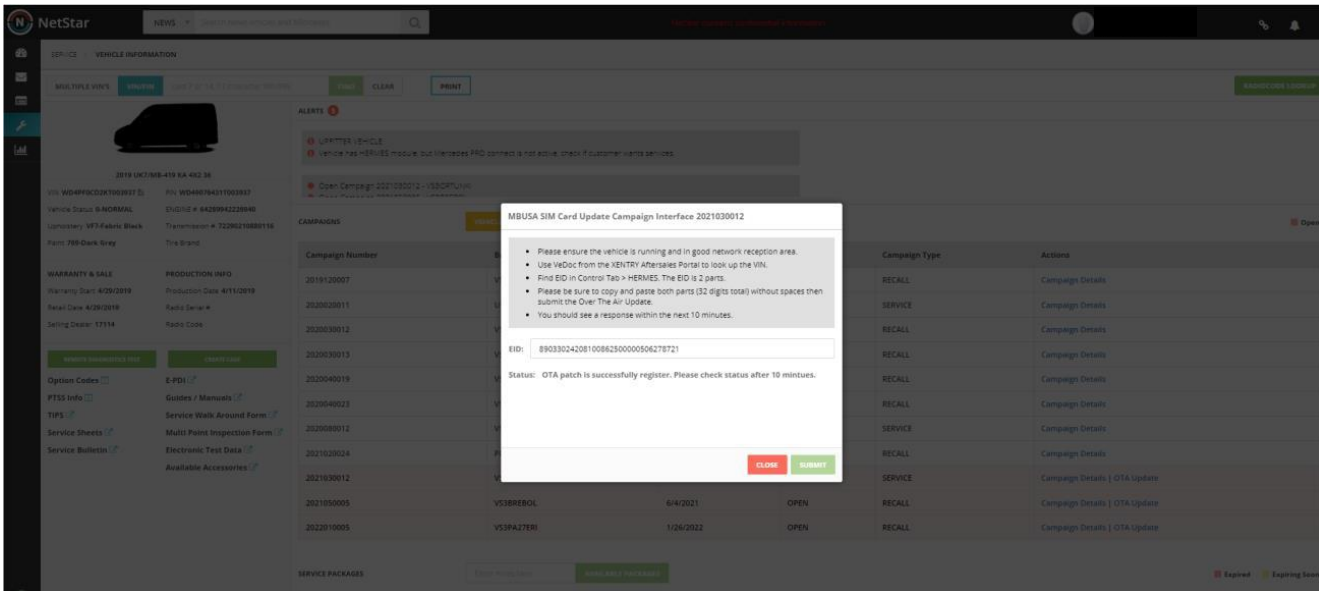
Figure 9 (screen on "NetStar" after the OTA update has been registered successfully)
Status: OTA patch is successfully registered. Please check status after 10 minutes

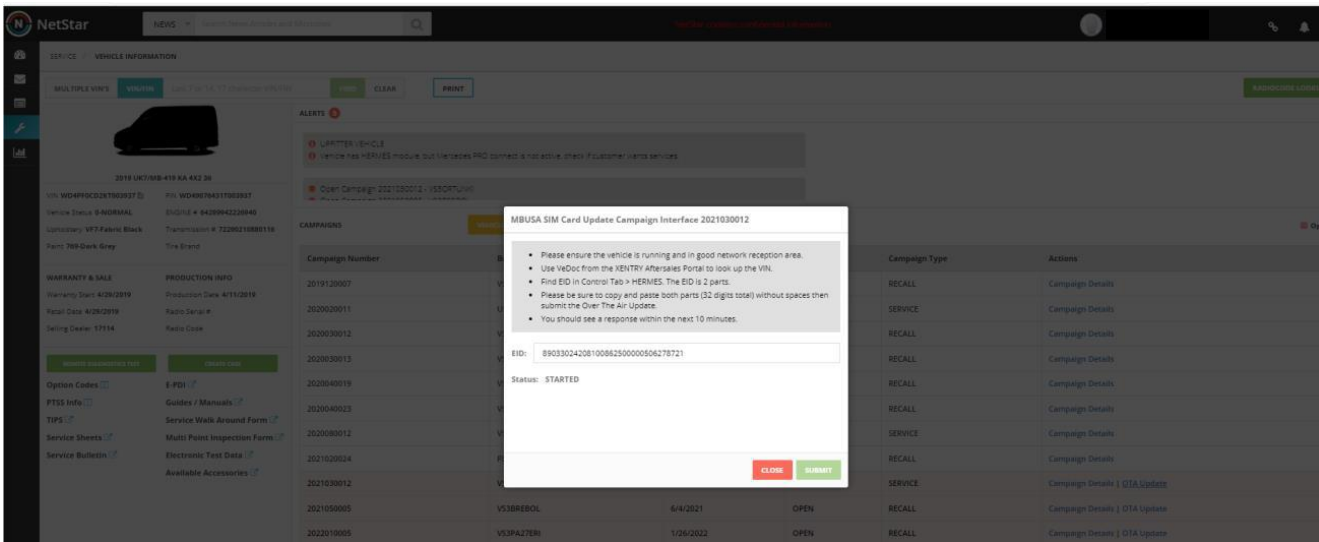
Figure 10 (screen on "NetStar" if "OTA update" is clicked again during the OTA update process)
 Status: Started

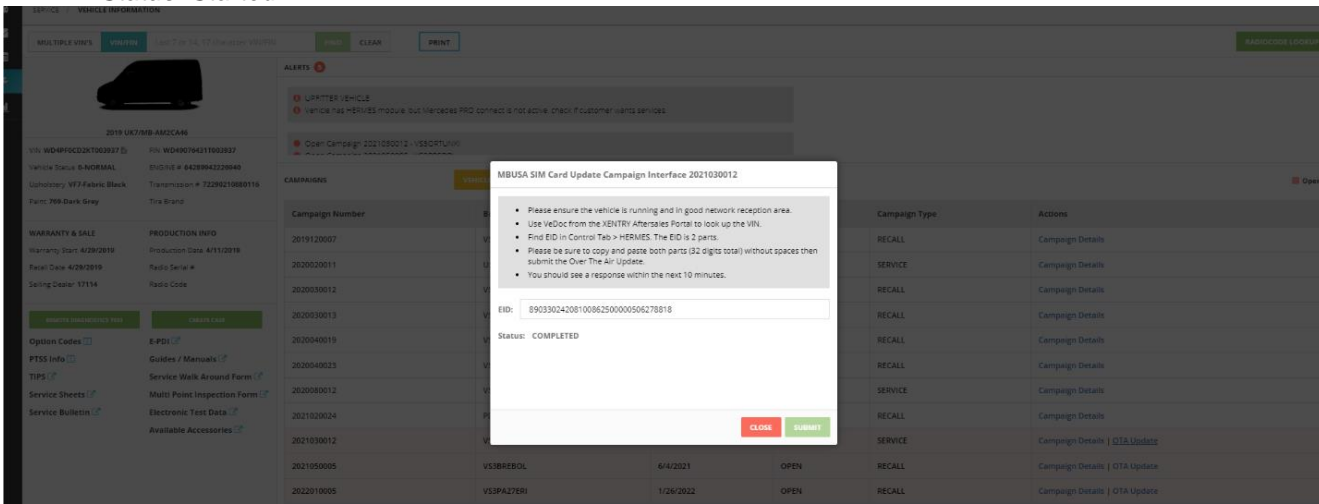
Figure 11 (screen on "NetStar" if the OTA update was successful)
 Status: Completed
