Safety Recall Launch Notification

Campaign #	NHTSA ID	Description	Update Communication Module SIM Card Software – Wave 6
2023110006	22V365	23P5497319

Recall Campaign Bulletin

CAMPAIGN NO.	2023110006
CAMPAIGN DESC.	23P5497319
NHTSA ID	22V365
SUBJECT	SIM Card Communication Module – Wave 6
MODEL(S)	A-Class, C-Class, CLA, CLS, E-Class, G-Class, GLA, GLB, GLC, GLE/GLS, AMG GT 4-door, S-Class, and SLC vehicles (177, 205, 117, 118, 257, 213, 238, 463, 247, 156, 253, 166, 292, 167, 290, 217, 222 and 172 platform)
MODEL YEAR(S)	2017 – 2022
CAMPAIGN POPULATION	19,980

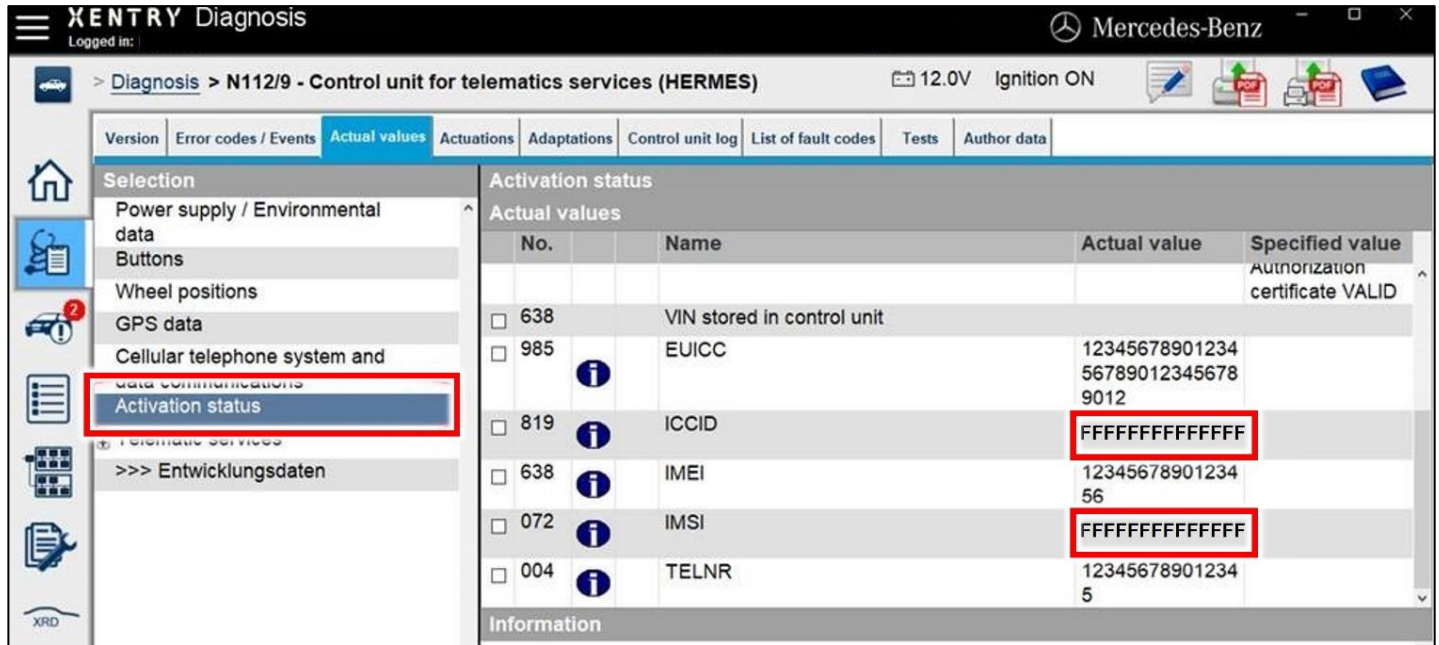
Figure 1

- If XENTRY Diagnosis displays “FFFFFFFFFFFFFF” for the “ICCID” and “IMSI” actual values (Figure 1): Carry out only **Work Procedures 3 and 4**.
NOTE: This must be documented in the Repair Order text!
- If XENTRY Diagnosis “IMSI” actual value starts with “90140...” (Figure 2): **End Measure**.
NOTE: This must be documented in the Repair Order text!
- If XENTRY Diagnosis “IMSI” actual value starts with “310170...”: Carry out **Work Procedures 1, 2, 3** (Work Procedure 3 is dependent on results of Work Procedure 2), **and 4**.

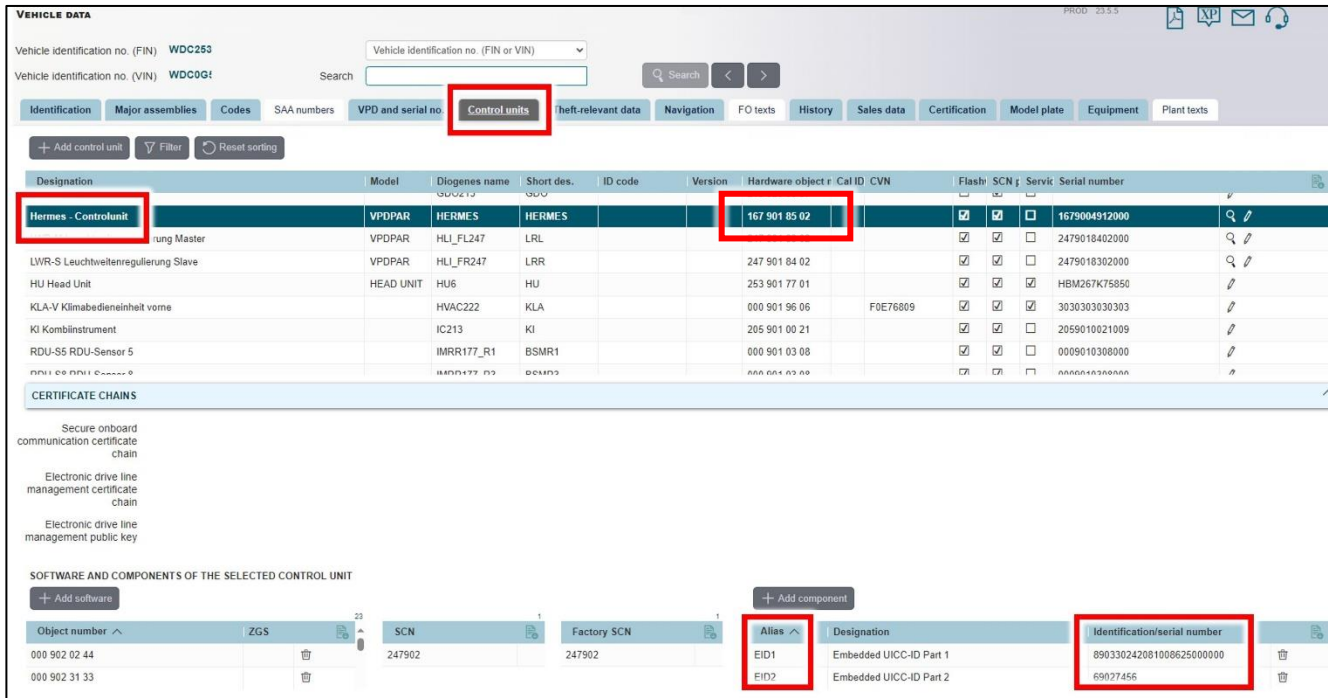
Figure 6**

** Make note of the HERMES Hardware object number for determining replacement part number! (e.g. Figure 6 – Hardware object number is 167 901 85 02)

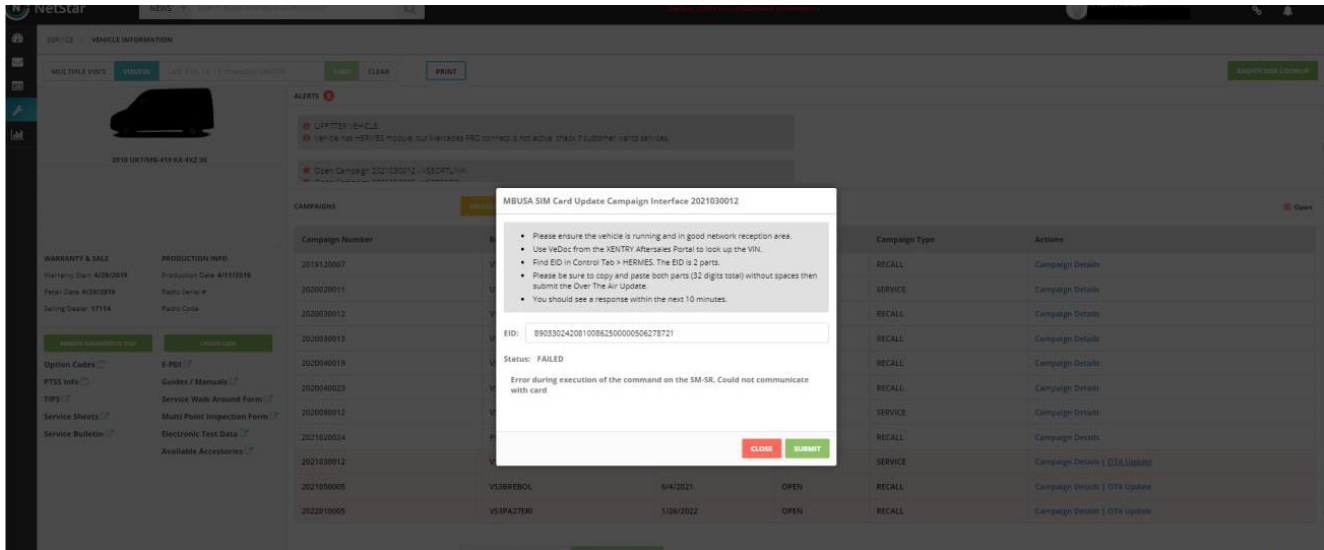
Figure 11 (screen on “NetStar” if the OTA update was not successful)
 Status: Failed – Error during execution of the command on the SM-SR. Could not communicate with card.

- a. The OTA procedure must be attempted a **second time if the first attempt fails**.
 Wait at least 7 minutes after the first attempt before retrying. If the SIM Card data in HERMES control unit (N112/9) **does not update** successfully OTA after the second attempt: Perform Work Procedures 3 and 4.
- b. If the SIM Card data in HERMES control unit (N112/9) **updates** successfully OTA: Perform Work Procedure 4 only.

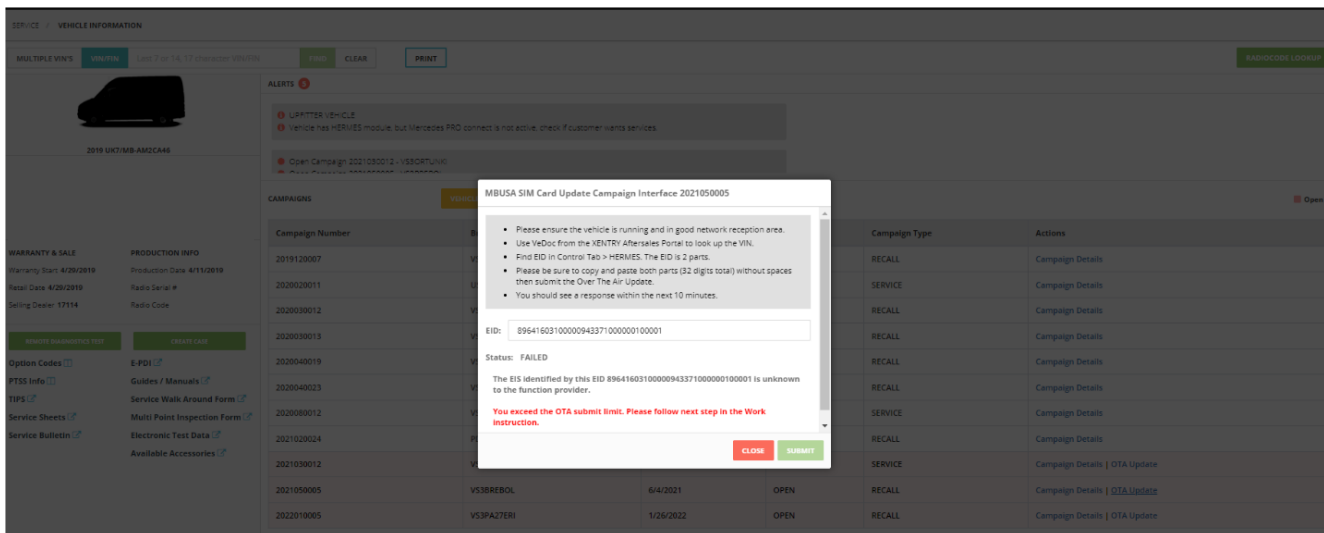
Figure 12 (screen on “NetStar” if two consecutive OTA updates were not successful)
 Status: Failed – The EIS identified by this EID ##### is unknown to the function provider.
 You exceed the OTA submit limit. Please follow next step in the work instructions
