**Update Communication Module
SIM Card Software - Wave 3**

Campaign No. 2023110006, July 2024

Revision A: 9/13/2024

SIM Card Communication Module – Wave 3

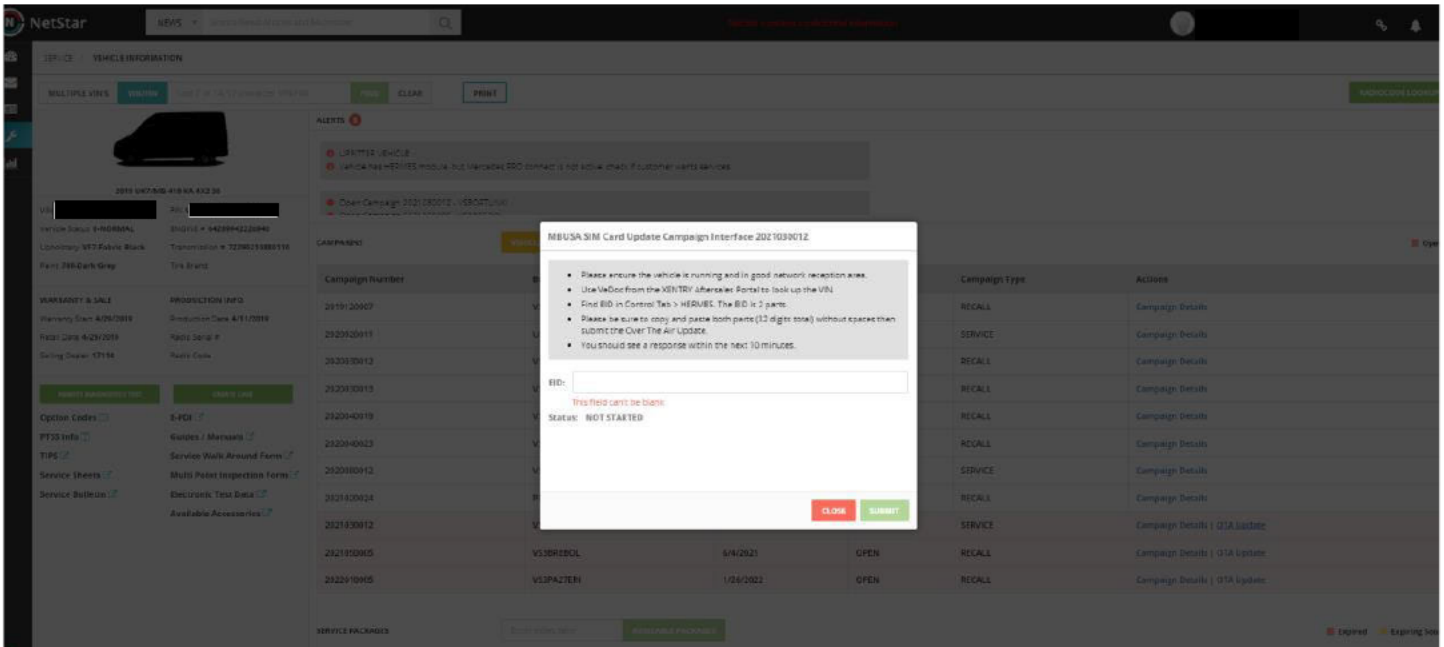
Figure 5

i A pop-up window requesting an EID number for the OTA update will appear (Figure 5).

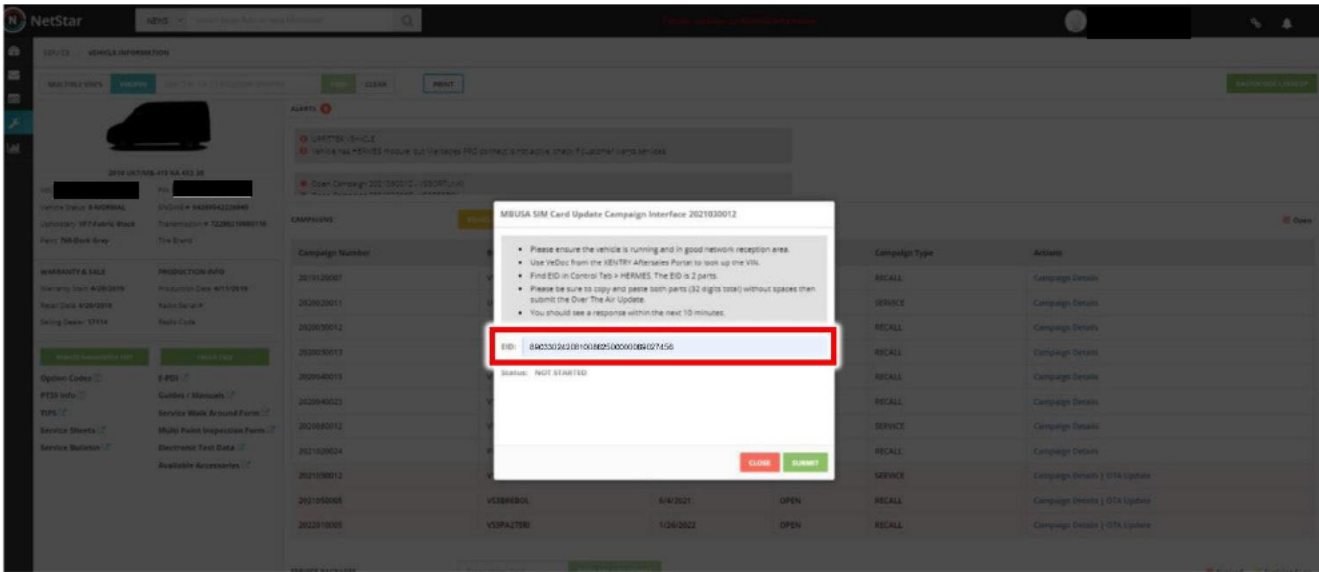
Figure 7 – EID1 + EID2 input

5. Enter the valid EID number and click on "Submit" (Figure 7).

i To do this, enter the **EID1 + EID2** numbers from VeDoc without spaces or special characters as shown. (e.g.: 89033024208100862500000069027456 – EXAMPLE ONLY).

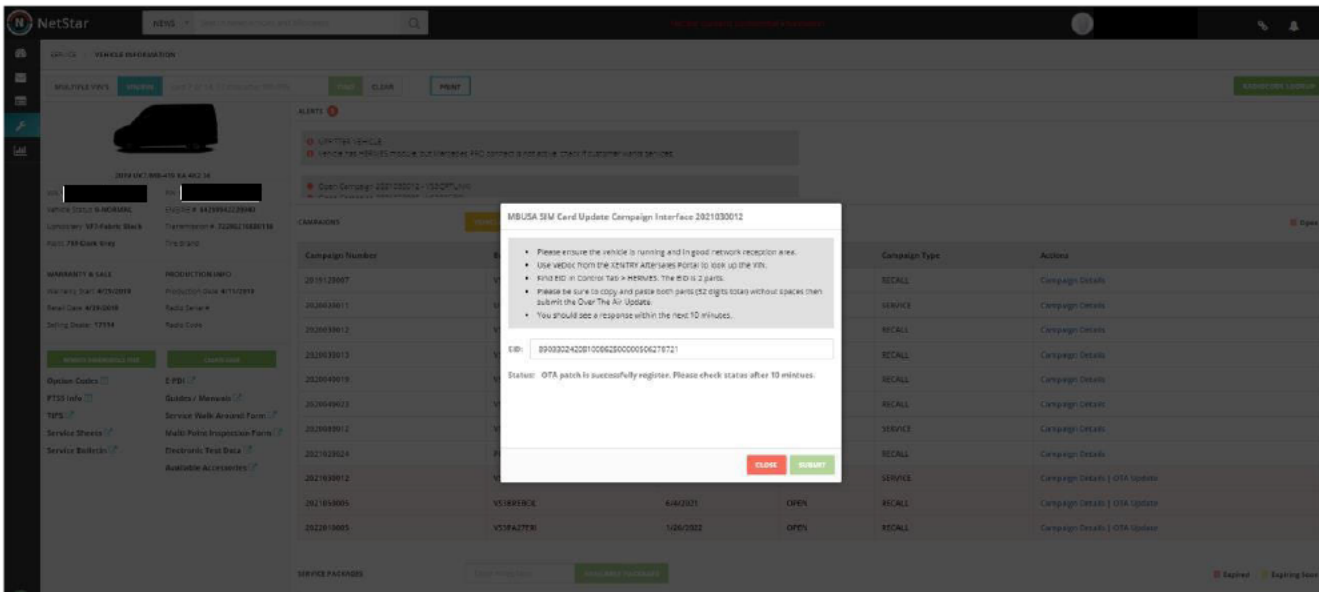
Figure 8 (screen on "NetStar" after the OTA update has been registered successfully)
 Status: OTA patch is successfully registered. Please check status after 10 minutes

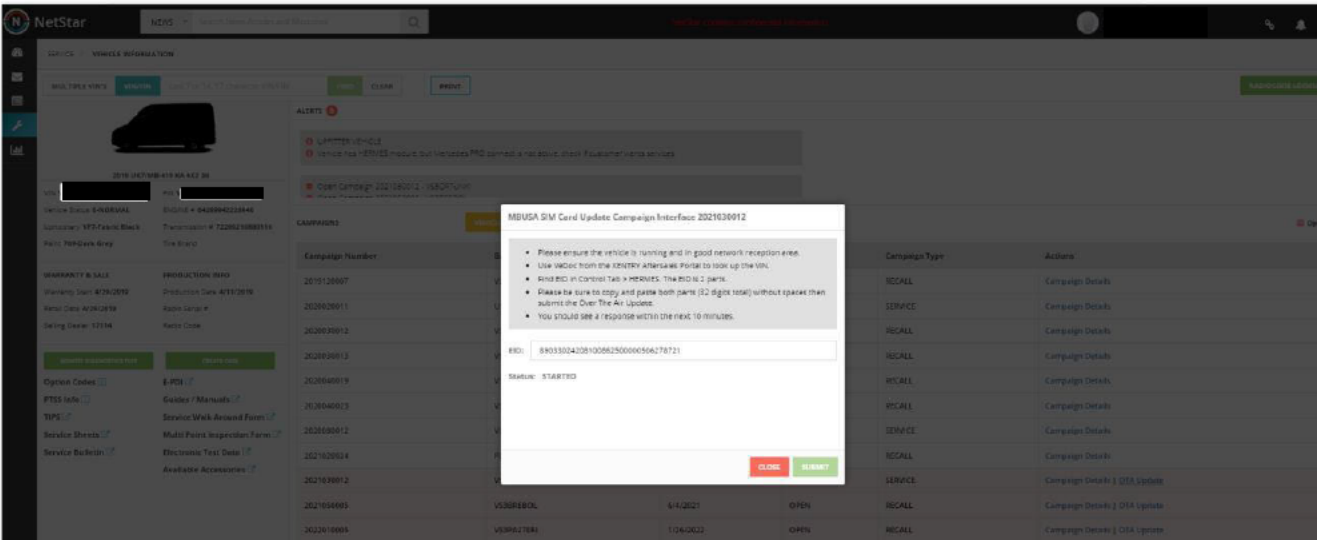
Figure 9 (screen on "NetStar" if "OTA update" is clicked again during the OTA update process)
 Status: Started

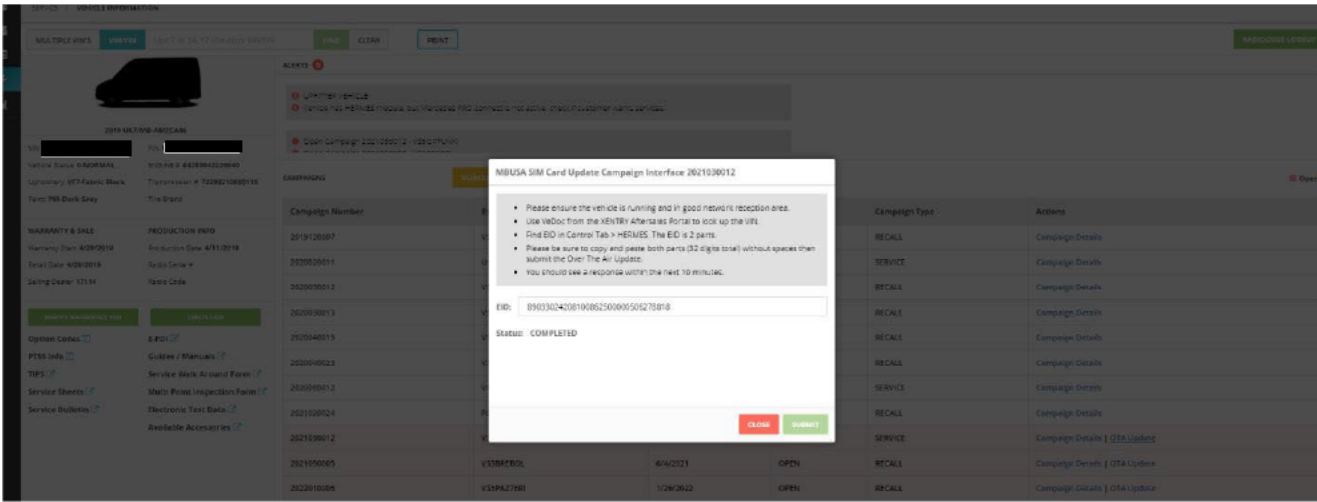
Figure 10 (screen on "NetStar" if the OTA update was successful)
 Status: Completed

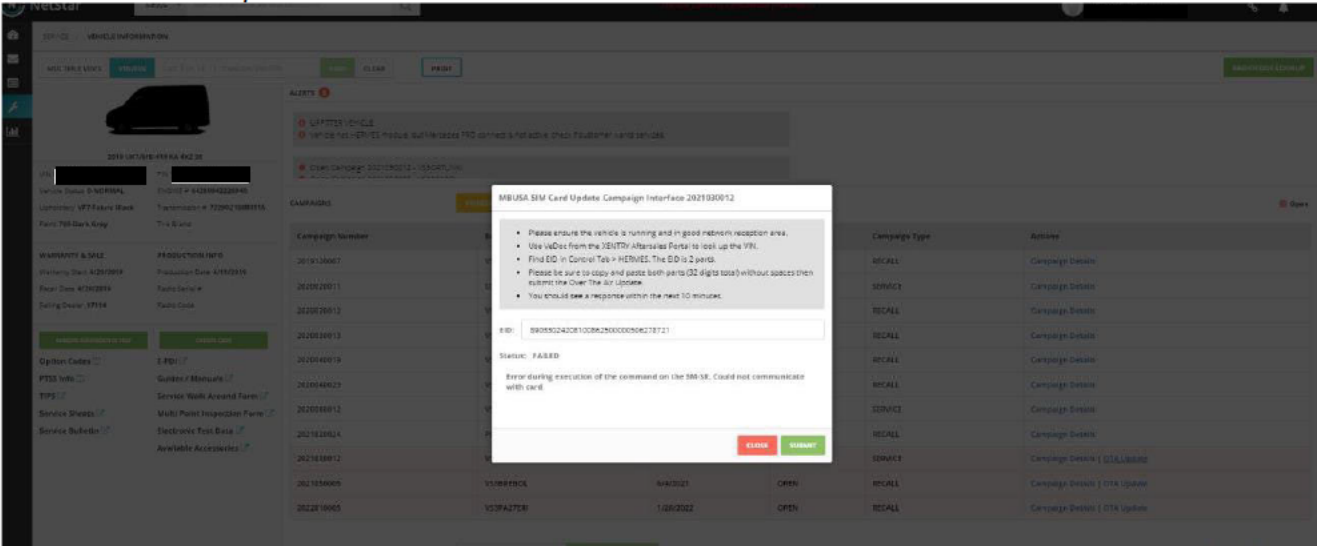
Figure 11 (screen on "NetStar" if the OTA update was not successful)
 Status: Failed – Error during execution of the command on the SM-SR. Could not communicate with card.

- If the data of the SIM card in the HERMES control unit (N112/9) is *not* updated OTA successfully after approx. 7 minutes: Carry out **Work Procedures 3 and 4**.
- If the data of the SIM card in the HERMES control unit (N112/9) is updated OTA successfully: Carry out only **Work Procedure 4**.
