March 2026
FL938A-E
NHTSA #22V-405
Transport Canada #2022-300
REVISED NOTICE

Subject: Steering Gears

Models Affected: Specific model years 2022-2023 Freightliner Cascadia and Freightliner Custom Chassis MT45, and MT45G vehicles, manufactured June 9, 2021, through May 23, 2022, and equipped with an RH Sheppard steering gear.

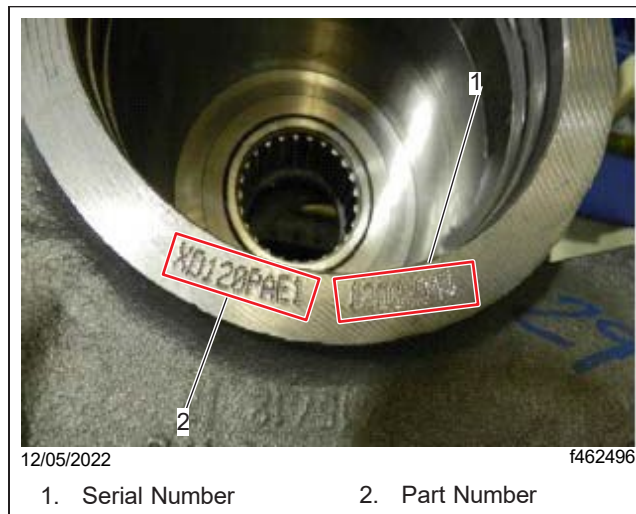
Fig. 1, Steering Gear Identification

1. Check the base label (Form WAR259) for a completion sticker for FL938 (Form WAR260) indicating this work has been done. The base label is usually located on the passenger door about 12 inches (30 cm) below the door latch. If a sticker is present, no work is needed. If there is no sticker, proceed with the next step.
2. Park the vehicle on a level surface, shut down the engine, and set the parking brake. Chock the tires.
3. Locate the steering gear on the front left frame rail of the vehicle.
4. Locate the serial number on the steering gear. See **Fig. 1**.
