May 2023  
FL938A-E  
NHTSA #22V-405  
Transport Canada #2022-300  
REVISED BULLETIN

## Subject: Steering Gears

**Models Affected:** Specific model years 2022-2023 Freightliner Cascadia and Freightliner Custom Chassis MT45, and MT45G vehicles, manufactured June 9, 2021, through May 23, 2022, and equipped with an RH Sheppard steering gear.

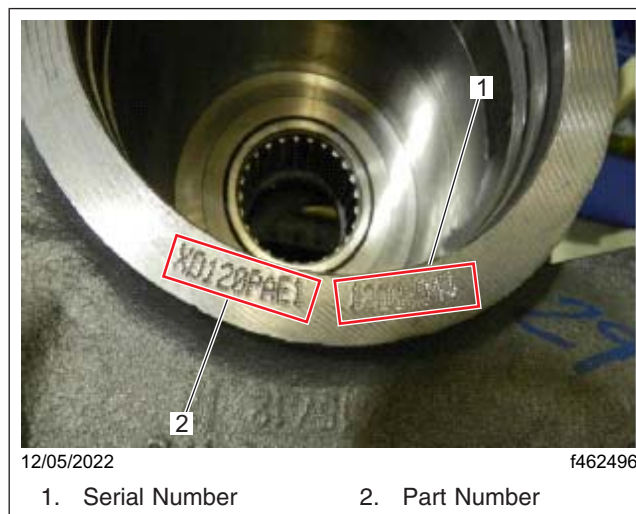
**Fig. 1, Steering Gear Identification**

1. Check the base label (Form WAR259) for a completion sticker for FL938 (Form WAR260) indicating this work has been done. The base label is usually located on the passenger door about 12 inches (30 cm) below the door latch. If a sticker is present, no work is needed. If there is no sticker, proceed with the next step.
2. Park the vehicle on a level surface, shut down the engine, and set the parking brake. Chock the tires.
3. Locate the steering gear on the front left frame rail of the vehicle.
4. Locate the serial number on the steering gear. See **Fig. 1**.

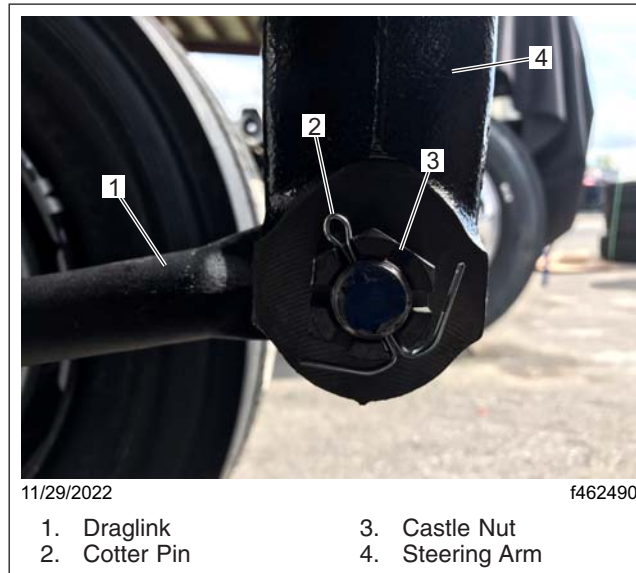
**Fig. 5, Cotter Pin Removal**

2. Remove the cotter pin from the castle nut at the steering arm-to-draglink connection. See [Fig. 5](#).

29. If the cotter pin hole is not accessible, advance the castle nut to the nearest slot, and install the cotter pin. Bend the split side of cotter pin around the nut as shown in [Fig. 5](#).

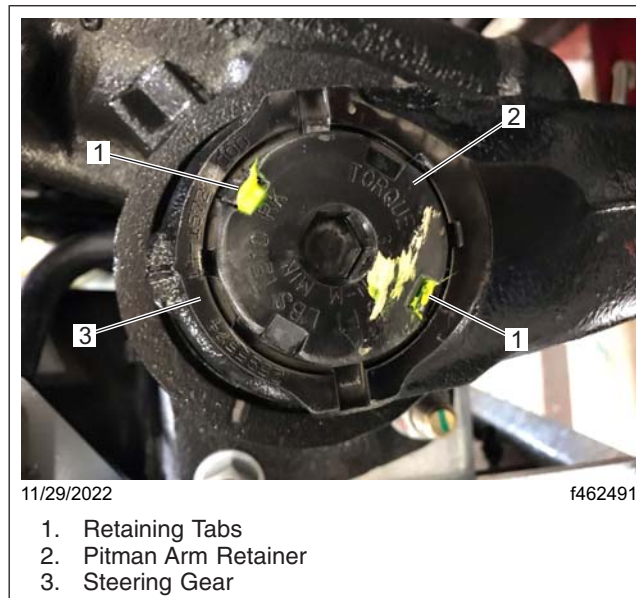
**Fig. 6, Bending the Pitman Arm Retaining Tabs**

3. Use a 1-1/8 inch socket to remove the castle nut. Retain the castle nut for installation in the later step. Remove the draglink from the pitman arm.
4. At the pitman arm-to-steering gear connection, use a punch to bend the retaining tabs out of the pitman arm retainer. See [Fig. 6](#).

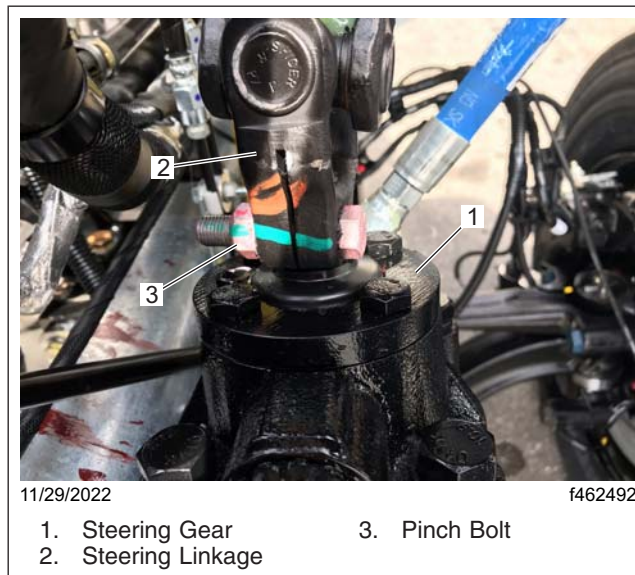
**Fig. 7, Pinch Bolt Removal**

5. Lubricate the face of the retainer with a clean chassis lube.
6. Disconnect the pitman arm from the steering gear.
  - 6.1 Slide the pitman arm puller over the pitman arm. Align the hole in the puller with the Allen socket in the retainer.
  - 6.2 Insert the Allen drive socket through the puller and into the retainer socket. Use an impact wrench to back off the retainer. The retainer will act as a jackscrew to disconnect the pitman arm from the steering gear.
7. Use a 5/8-inch wrench and a 11/16-inch socket to remove the pinch bolt that attach the steering linkage to the top of the steering gear. Discard the fasteners. See **Fig. 7**.

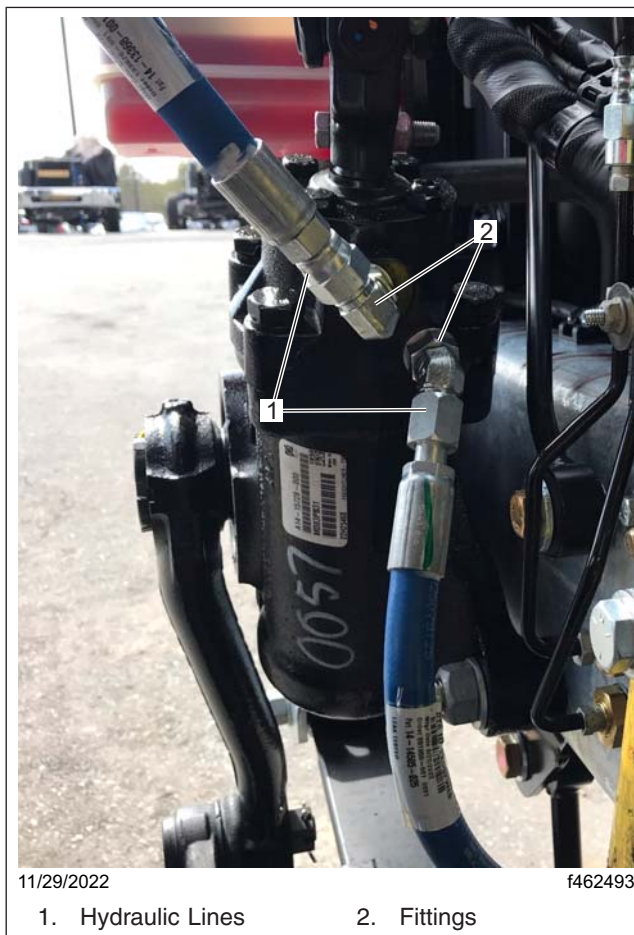
**Fig. 8, Hydraulic Lines Removal**

9. Use a 7/8-inch wrench to loosen and remove the hydraulic lines from the fittings on the rearward-facing side of the steering gear. See [Fig. 8](#)

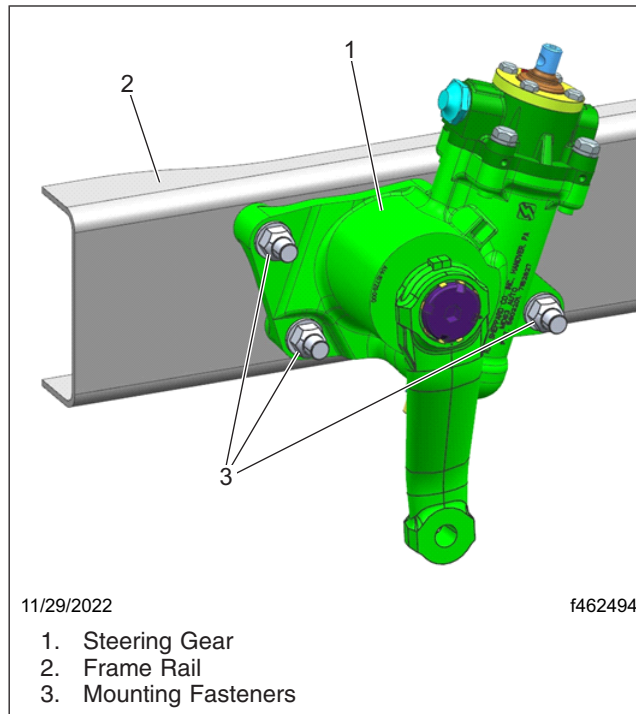
**Fig. 9, Steering Gear Removal**

11. Use a 1-1/8 inch socket and wrench to remove the three bolts and washers that attach the steering gear to the rail. Discard the fasteners. See [Fig. 9](#).
12. Remove the steering gear.

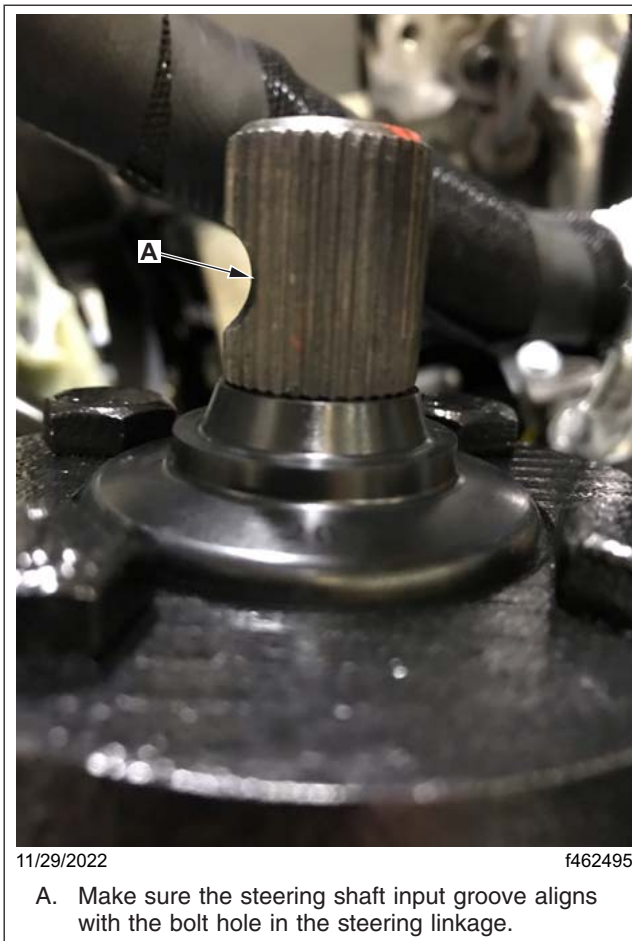
**Fig. 10, Steering Linkage Installation**

19. Make sure the bolt hole in the steering linkage, and the groove on the steering gear input shaft align properly. Install the steering linkage on top of the gear. See [Fig. 10](#).

20. Install the new bolt (14-18773-001) and the nut (14-18774-000) on the steering shaft. Tighten the nut 43 lbf·ft (58 N·m).

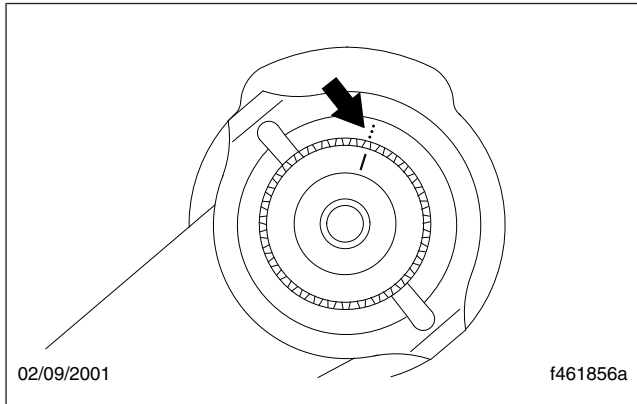
**Fig. 11, Aligning the Timing Marks**

21. Align the timing marks on the pitman arm with the timing marks on the sector shaft, then install the pitman arm on the sector shaft. The timing marks will appear as shown in [Fig. 11](#) and [Fig. 12](#).
