Ford Motor Company  
P. O. Box 1904  
Dearborn, Michigan 48121

August 19, 2022

**SUBJECT:** **NEW VEHICLE DEMONSTRATION / DELIVERY HOLD**  
**Compliance Recall 22C13**  
Certain 2022 Model Year Aviator and Explorer Vehicles  
Inspect Engine Frame Rail Assembly

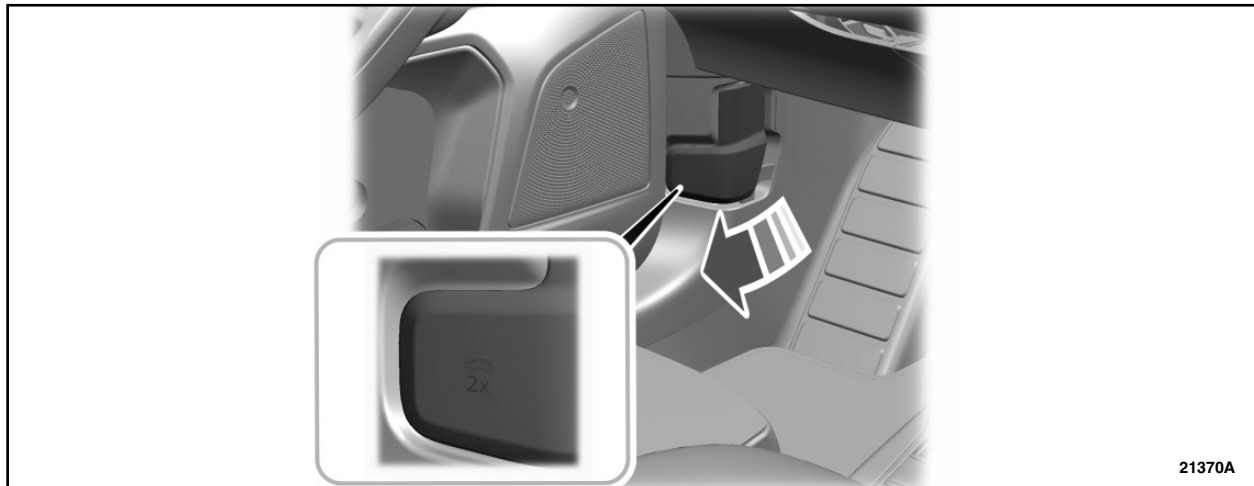
**FIGURE 1**

1. Open the LH (left-hand) front door.
2. Fully pull the hood release lever and let it completely retract. See Figure 1.

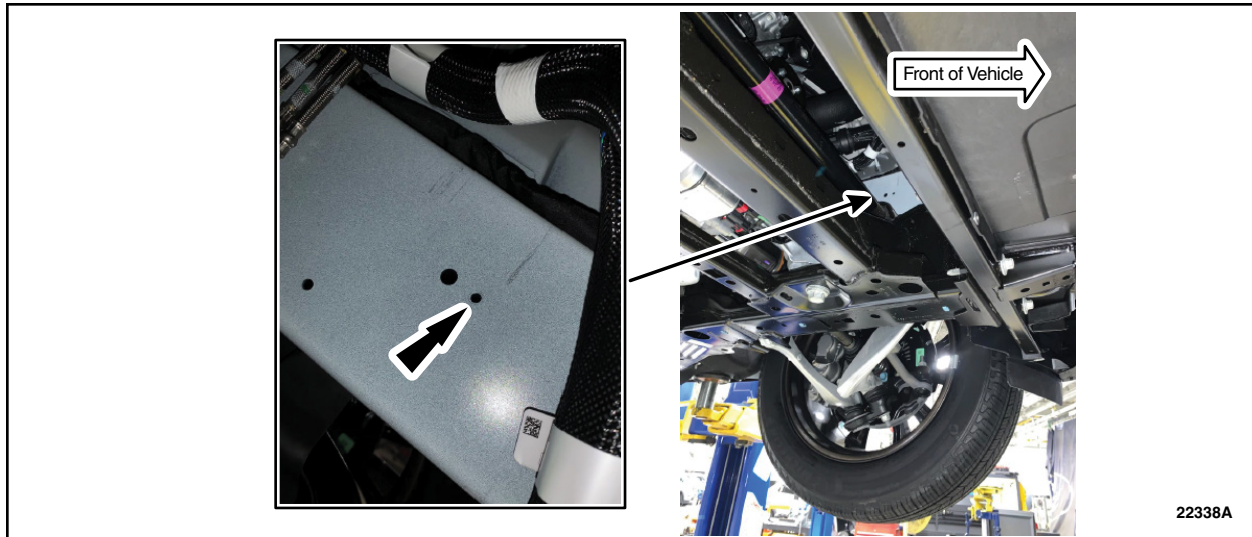
**FIGURE 2**

5. In the engine compartment, locate the existing hole on the inboard side of the LH frame rail.  
See Figure 2, showing the hole from underneath the vehicle for better clarity.

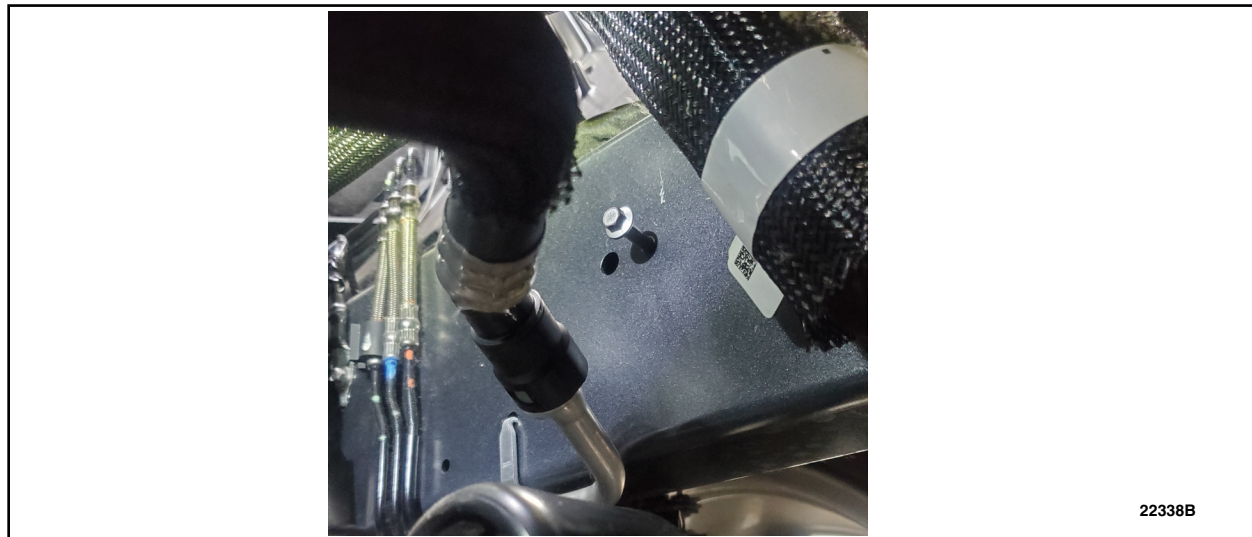
**FIGURE 3**

6. Hand start the bolt part number W505255-S450 into the existing hole. See Figure 3.

7. Using a digital torque wrench, tighten and torque the bolt to 5.9 lb. ft (8 Nm).

8. Did the bolt successfully torque to 5.9 lb. ft (8 Nm)?

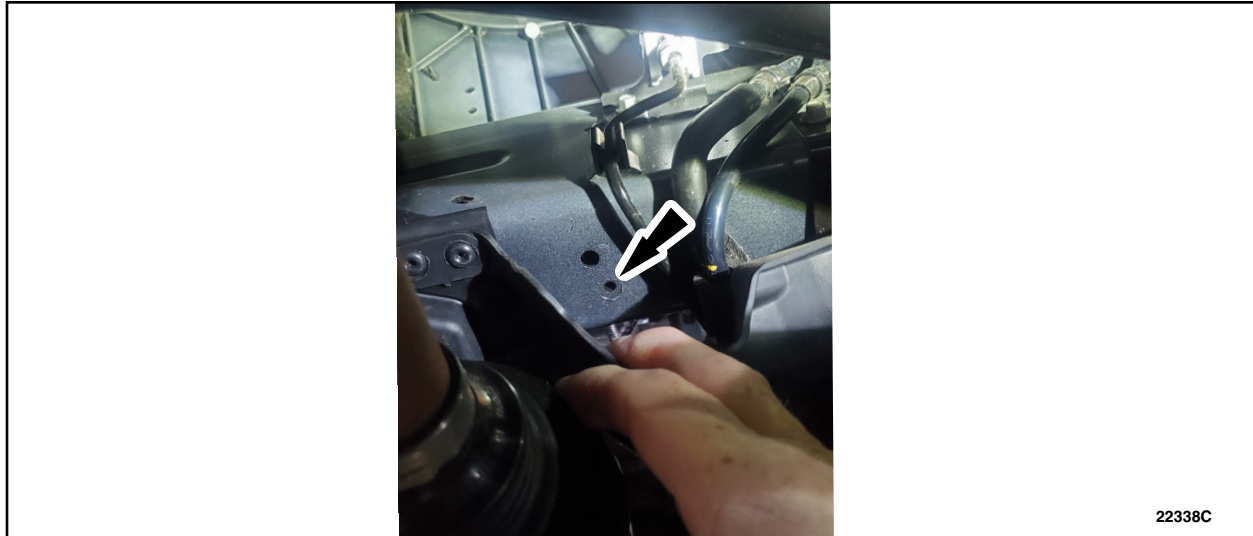
**FIGURE 4**

9. With the vehicle in NEUTRAL, position it on a hoist. Please follow Workshop Manual (WSM) procedures in Section 100-02.
10. Locate the existing hole on the bottom of the RH (right-hand) frame rail, just above the CV axle. See Figure 4.

11. Repeat steps 6-7 for the RH frame rail.
12. Did the bolt successfully torque to 5.9 lb. ft (8 Nm)?
  - Yes – Passes inspection, proceed to step 13.
  - No – Fails inspection. Remove the bolt from the hole, then proceed to step 13.
13. Did either one or both of the bolts fail to successfully torque to 5.9 lb. ft (8 Nm)?
  - Yes – Contact the SSSC to request a Webster Hardness Tester. Once a hardness tester has been received, proceed to step 14.
  - No – Proceed to step 18.

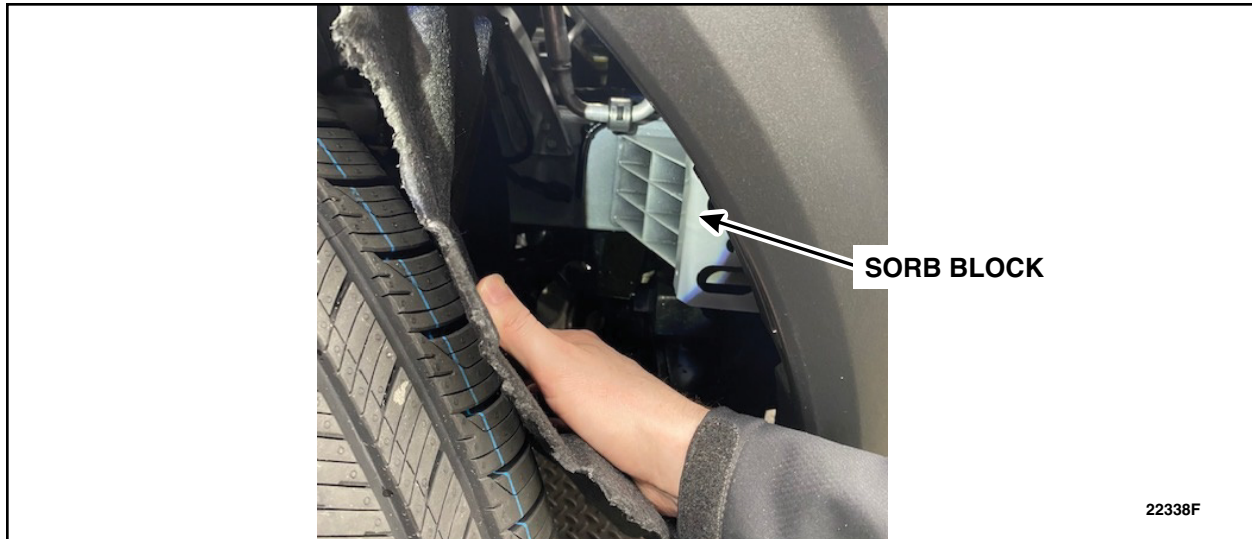
**FIGURE 5**

14. Locate the SORB block. See Figure 5.

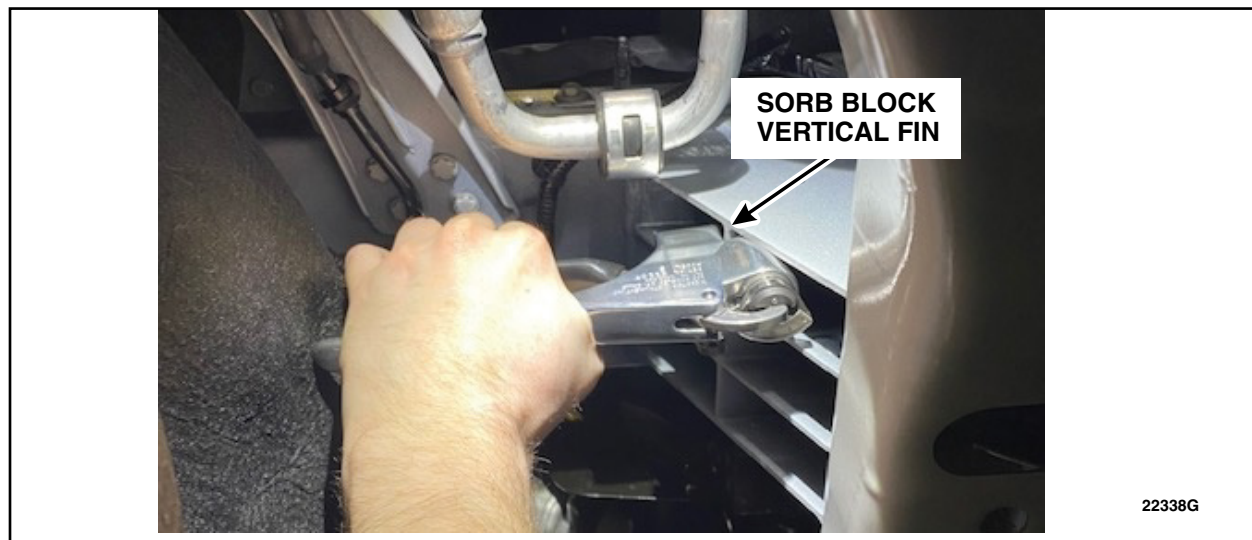
**FIGURE 6**

15. Place the hardness tester on the SORB block vertical fin and actuate the handle with the same force that was used on the gauge bar. See Figure 6.

16. What is the hardness tester gauge reading?

Less than 12 – Fails inspection. Proceed to step 17.

12 or greater – Passes inspection. Return the hardness tester, then proceed to step 18.

17. Contact SSSC for further instructions regarding frame rail replacement and hardness tester return.

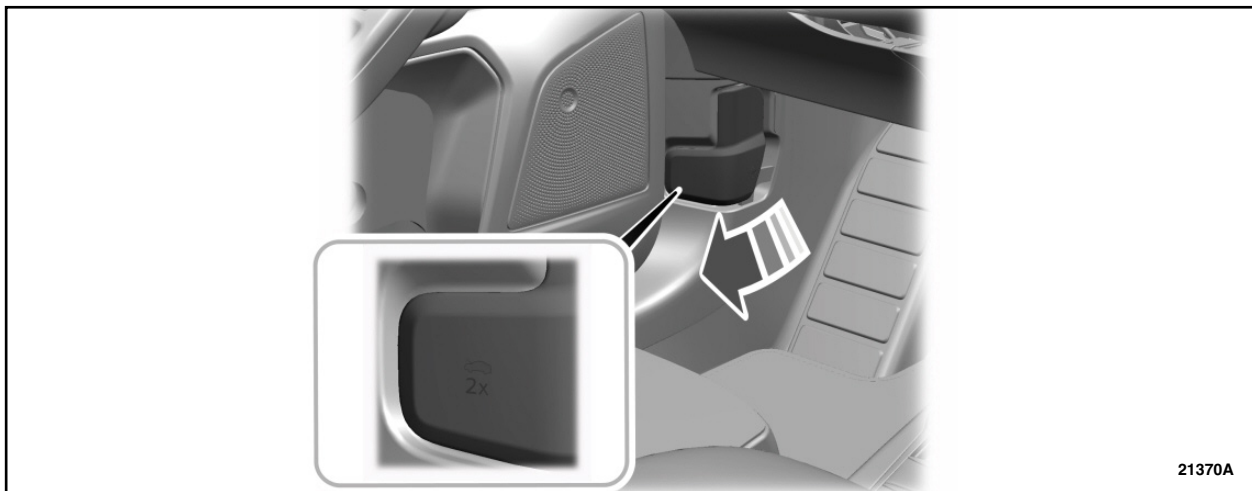
**FIGURE 7**

19. Open the LH (left-hand) front door.
20. Fully pull the hood release lever and let it completely retract. See Figure 7.

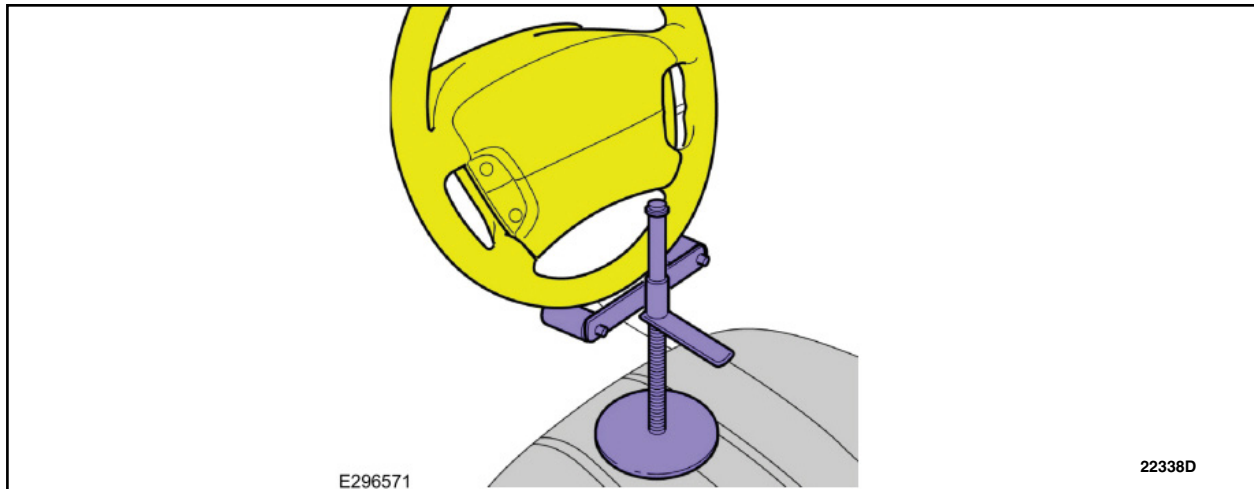
**FIGURE 8**

23. Using a holding device, hold the steering wheel. See Figure 8.

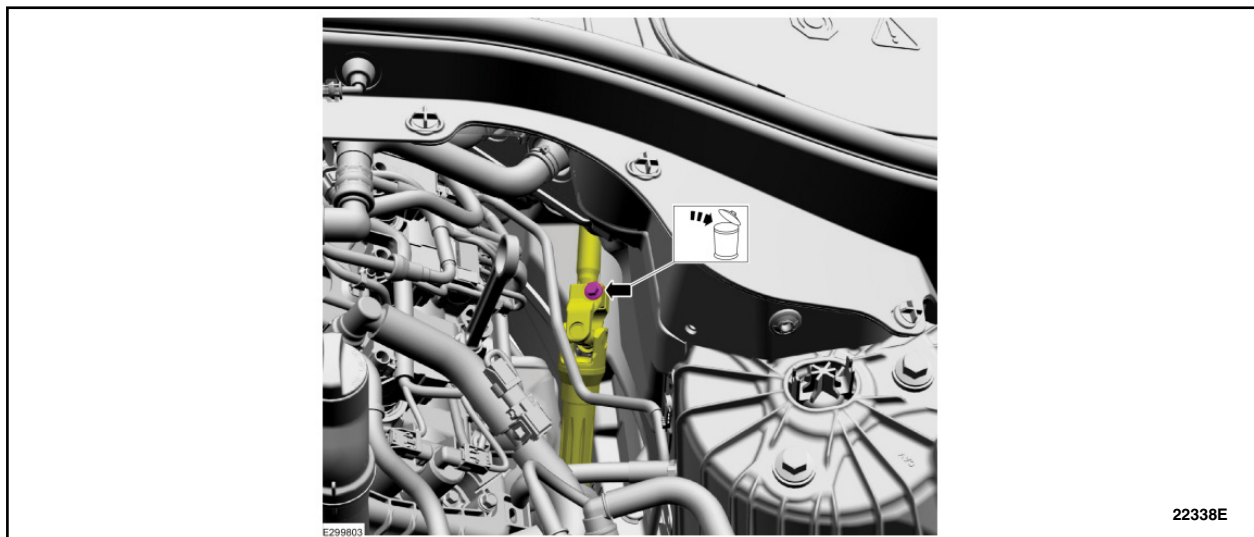
**FIGURE 9**

24. Remove and discard the steering shaft bolt, then separate and position aside the steering shaft. See Figure 9.

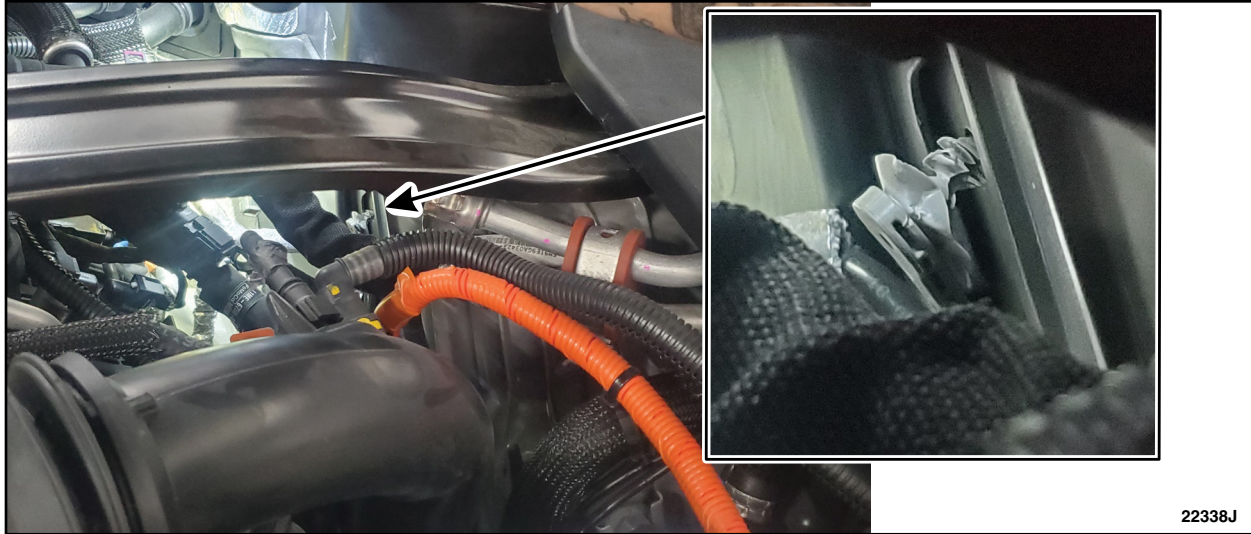
**FIGURE 10**

25. Remove the push pin retainer and position aside the harness. See Figure 10.

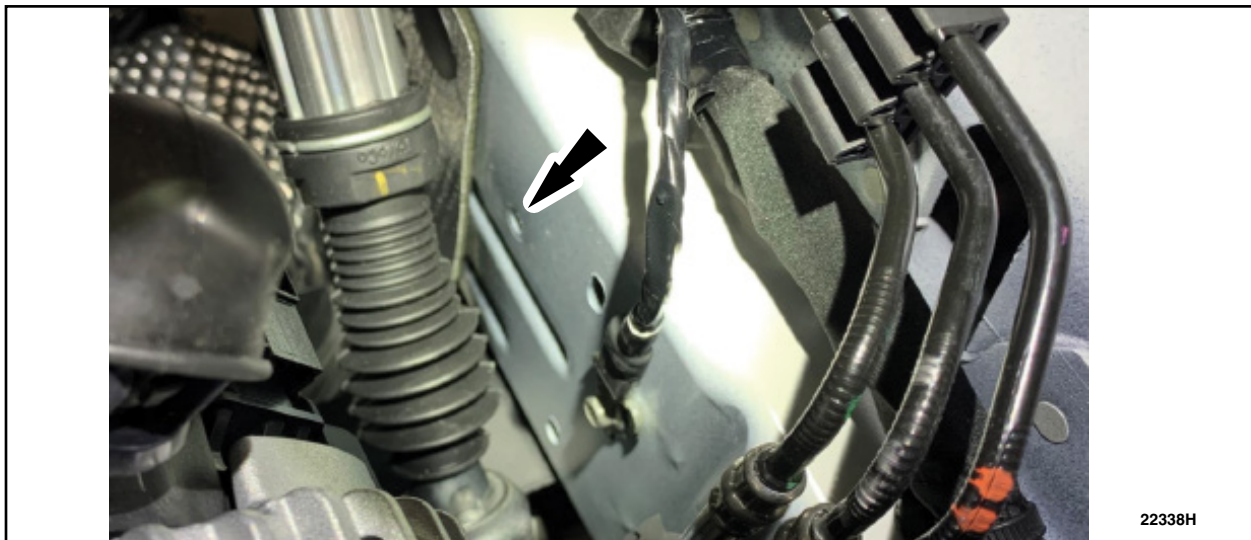
**FIGURE 11**

26. Locate the existing hole on the inboard side of the LH frame rail. See Figure 11.

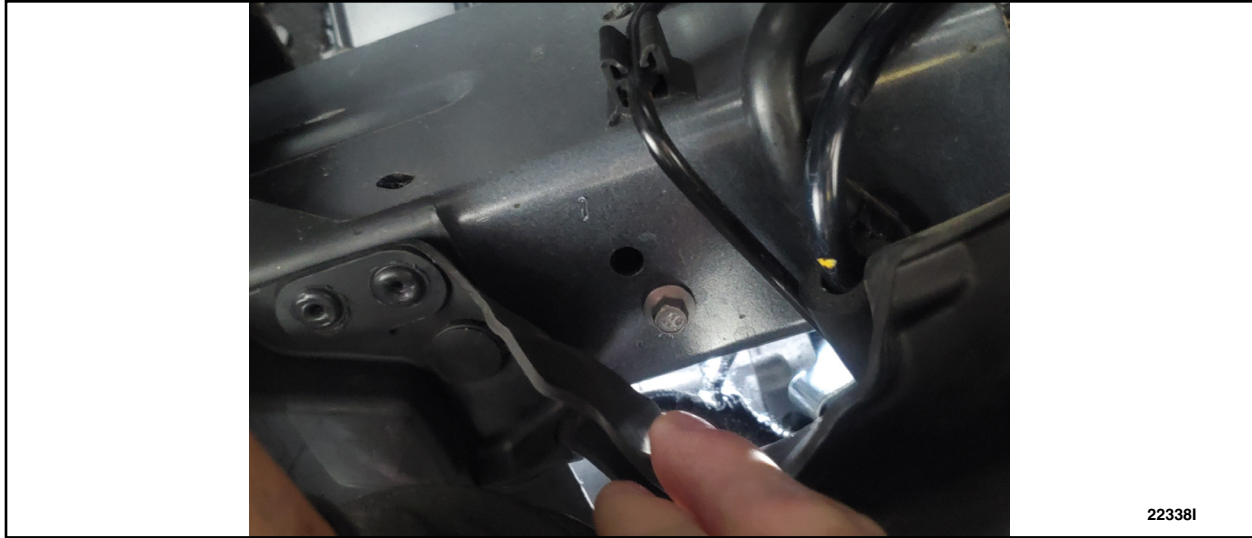
**FIGURE 12**

27. Hand start the bolt part number W505255-S450 into the existing hole. See Figure 12.

28. Using a digital torque wrench, tighten and torque the bolt to 5.9 lb. ft (8 Nm).

29. Did the bolt successfully torque to 5.9 lb. ft (8 Nm)?

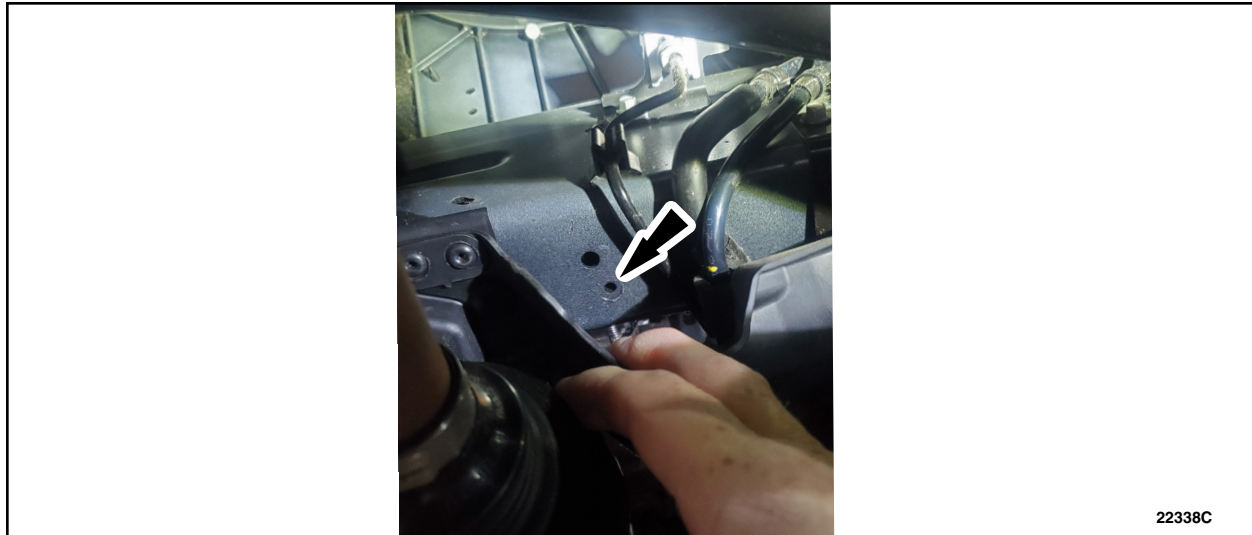
**FIGURE 13**

33. Locate the existing hole on the bottom of the RH (right-hand) frame rail, just above the CV axle.  
See Figure 13.

34. Repeat steps 27-28 for the RH frame rail.
35. Did the bolt successfully torque to 5.9 lb. ft (8 Nm)?
- Yes – Passes inspection, proceed to step 36.
  - No – Fails inspection. Remove the bolt from the hole, then proceed to step 36.
36. Did either one or both of the bolts fail to successfully torque to 5.9 lb. ft (8 Nm)?
- Yes – Contact the SSSC to request a Webster Hardness Tester. Once a hardness tester has been received, proceed to step 37.
  - No – Proceed to step 41.

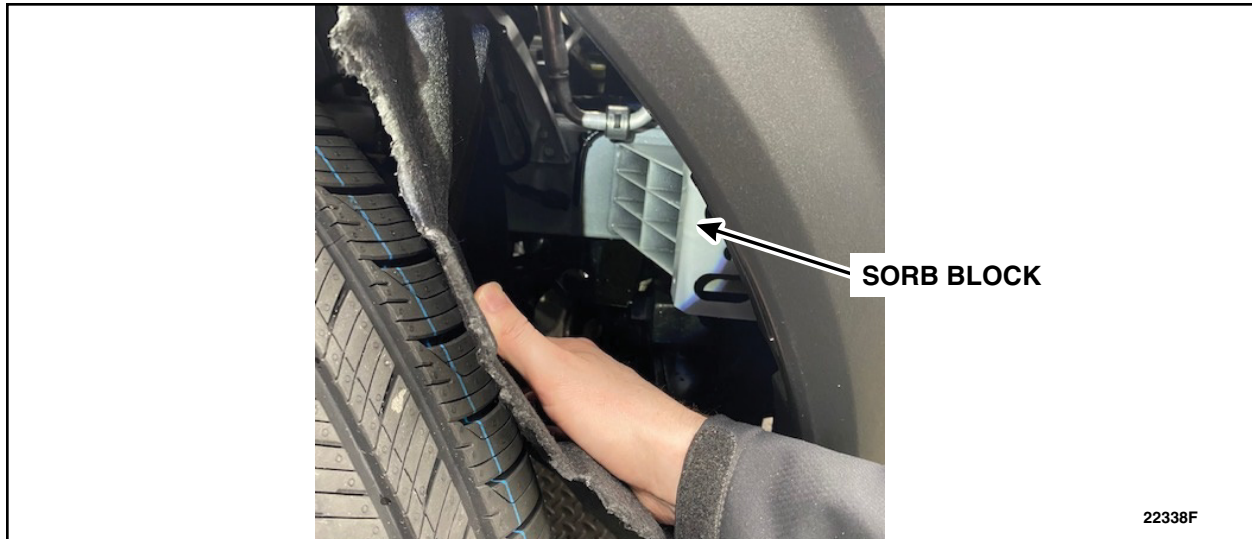
**FIGURE 14**

37. Locate the SORB block. See Figure 14.

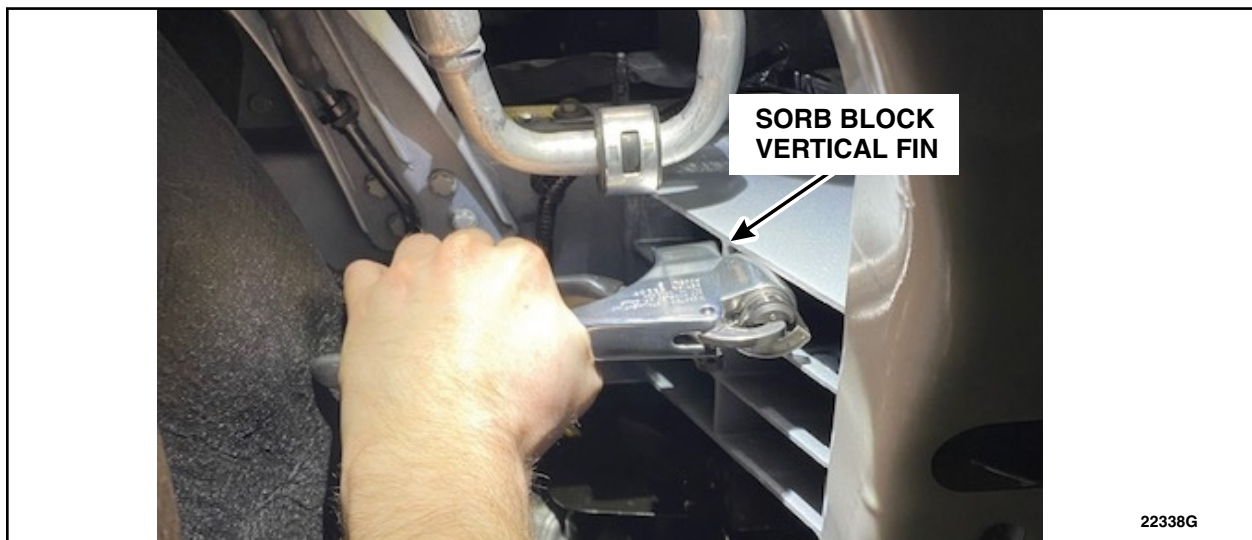
**FIGURE 15**

38. Place the hardness tester on the SORB block vertical fin and actuate the handle with the same force that was used on the gauge bar. See Figure 15.

39. What is the hardness tester gauge reading?

Less than 12 – Fails inspection. Proceed to step 40.

12 or greater – Passes inspection. Return the hardness tester, then proceed to step 41.

40. Contact SSSC for further instructions regarding frame rail replacement and hardness tester return.
