TO: Mercedes-Benz Dealer Principals, General Managers, Sales Managers, Service Managers, Parts Managers	FROM: Gregory Gunther, Department Manager, Vehicle Compliance and Analysis, Engineering Services
RE: <b>Recall Campaign Launch Notification</b> <b>Inspect Thread Tow Points MY22 EQS-Class</b> <b>(297 platform)</b>	DATE: August 19, 2022

# Recall Campaign Bulletin

SUBJECT: **Model EQS-Class (297 platform)**  
**Model Year 2022**

## **Inspect Thread Tow Points**

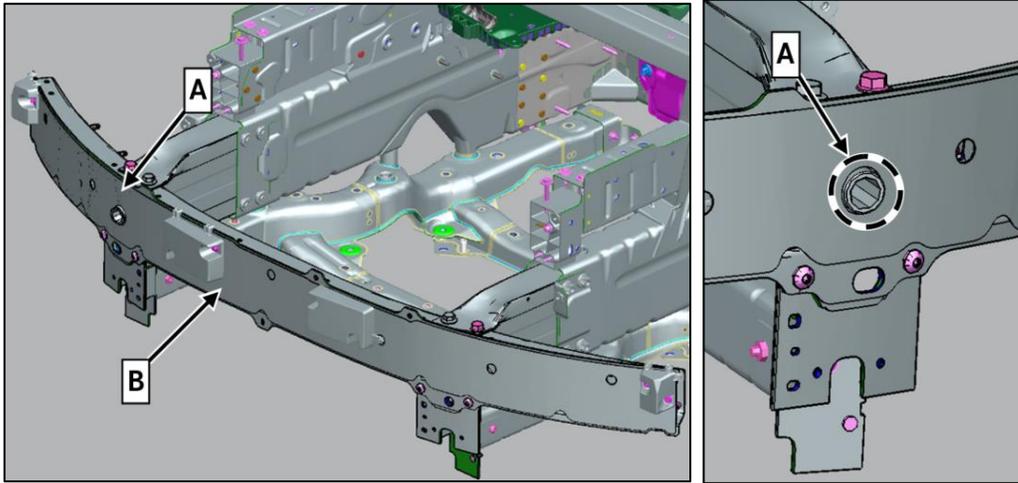
Figure 1

1. Screw towing eye (A) into front crossmember (B) by hand. It must be possible to rotate the towing eye up to the end stop completely by hand.

**i** Rotate the towing eye at least 9 revolutions in the crossmember (B).

- i** If the thread in front crossmember is damaged.
- i** Perform sensor and camera calibration as needed according to vehicle specific WIS requirements.

1. Replace crossmember under front bumper
  - i** For basic data, see AR88.30-P-1064EQS

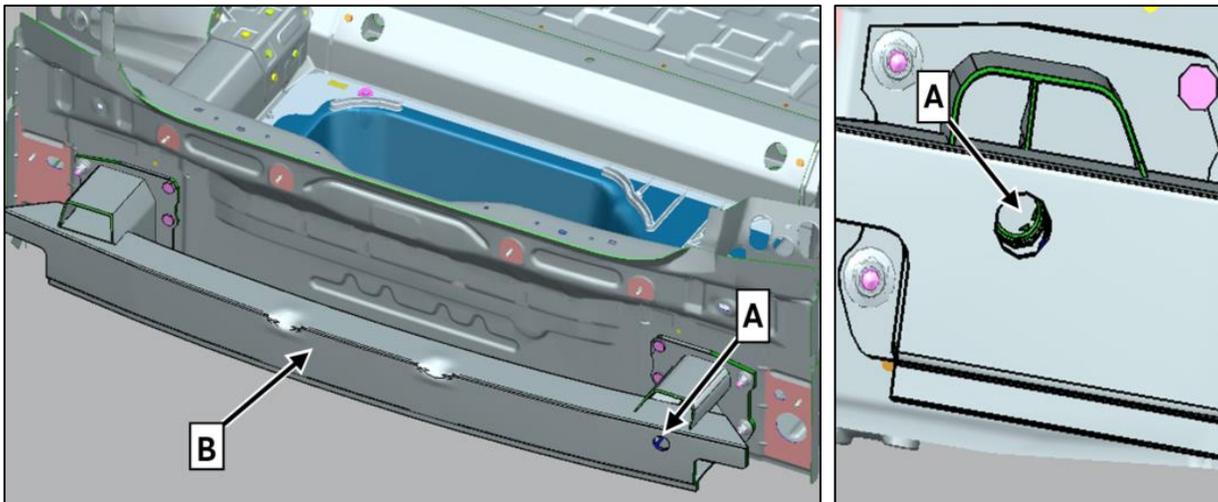
Figure 2

2. Screw towing eye (A) into rear crossmember (B) by hand. It must be possible to rotate the towing eye up to the end stop completely by hand.

**i** Rotate the towing eye at least 9 revolutions in the crossmember (B).

**i** For vehicles with **code 550** (trailer hitch) this process is **not required**.

- i** If the thread in rear crossmember is damaged.

1. Replace crossmember under rear bumper
  - i** Basic data for rear bumper AR88.20-P-2250EQS.
  - Nm** Rear crossmember nut on rear-end floor **55 Nm**.
