TO: Mercedes-Benz Dealer Principals, General Managers, Sales Managers, Service Managers, Parts Managers	FROM: Gregory Gunther, Department Manager, Vehicle Compliance and Analysis, Engineering Services
RE: Recall Campaign Launch Notification Check Transmission Wiring Harness Connector MY 19-22 4-Matic CLS-Class, E-Class, and GT-Class (257, 213, 238, and 290 platform)	DATE: September 30, 2022

Recall Campaign Bulletin

Campaign No. 2022080010, September 2022

Check Transmission Wiring Harness Connector

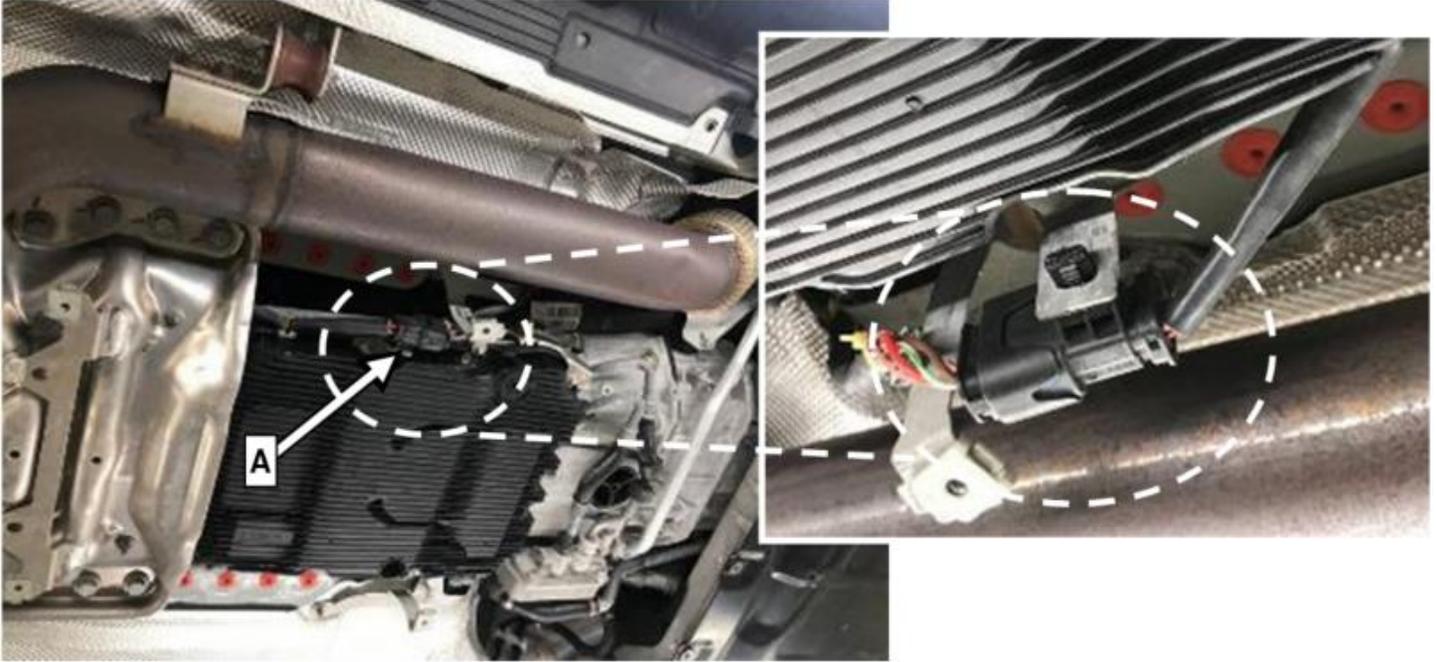
Figure 1

1. Remove rear underfloor paneling under transmission.
2. Disconnect electrical connector **X279** (A, figure 1) from the oil pan on the right side.

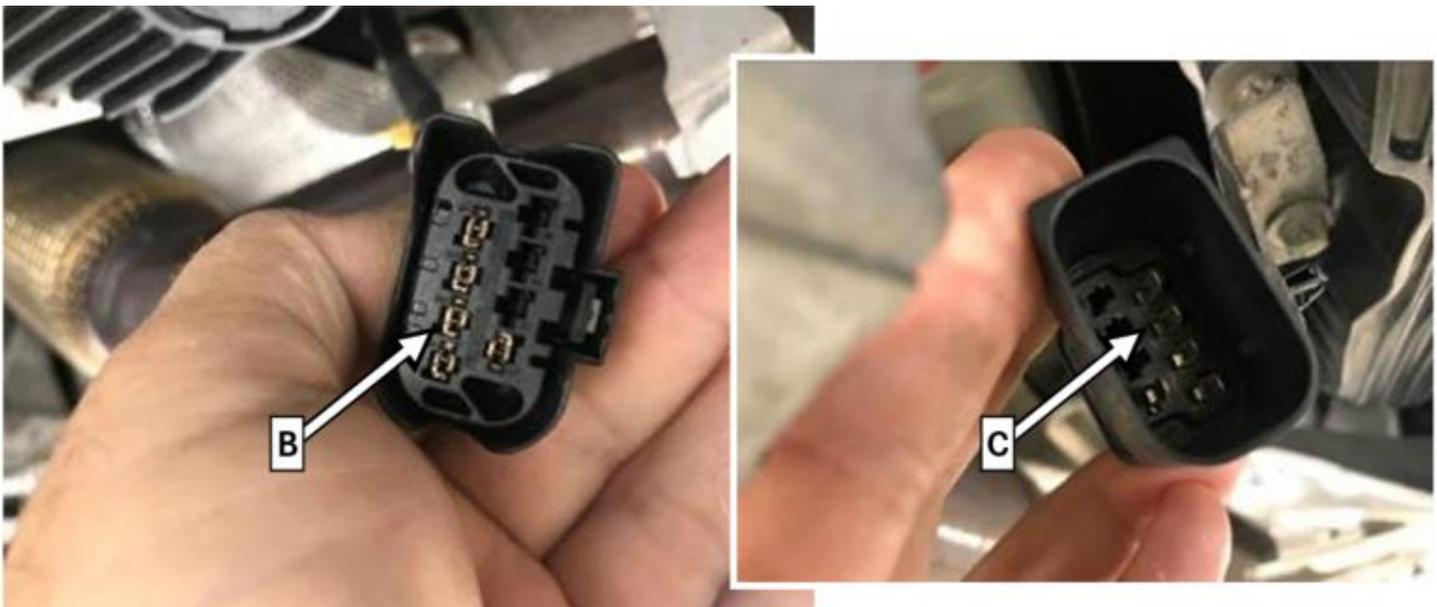
Figure 2

3. Check insides of the connector (B, figure 2 – vehicle side) and (C, figure 2 – transfer case side) for corrosion and other damage or noticeable problems.

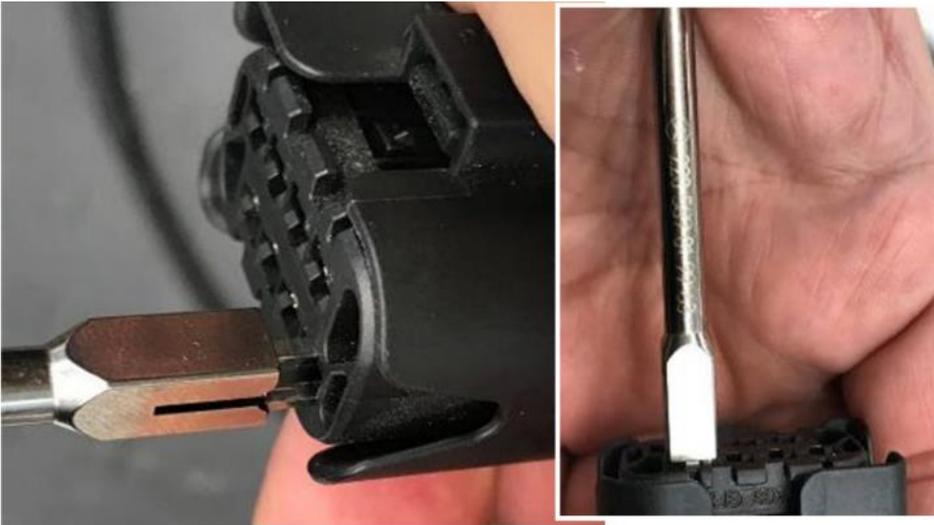
Figure 3

4. Check pins from the **vehicle side** wiring harness (B, figure 2) with the special tool **W 220 589 01 99 63** (figure 3). **Unpin** each individually, check for corrosion and damage such as wire melting or wire sealing lips (figure 4), **and then pin back in**. DO NOT remove all pins at once.

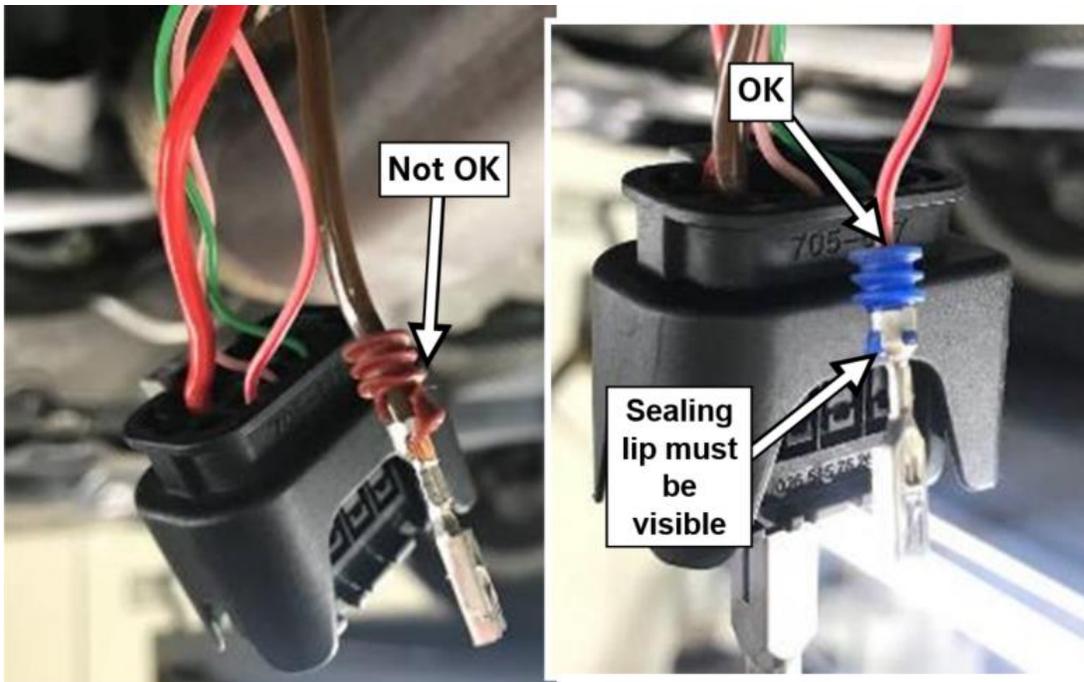
Figure 4 (*not OK* and OK sealing element)

- i** Equivalent commercially available unpinning tools can be used.
- i** **All pins may not** be unpinned from the plug housing **simultaneously**.
- i** The **pins must audibly engage** when reinserted.
- i** No damage or noticeable problems may be visible.
- i** No sealing elements may be damaged or melted at the cables.
- i** Sealing elements must be properly crimped in the cable lug.
- i** See OK figure. Sealing lip must be visible.
- i** Figure 4 shows a *not OK* and OK sealing element!

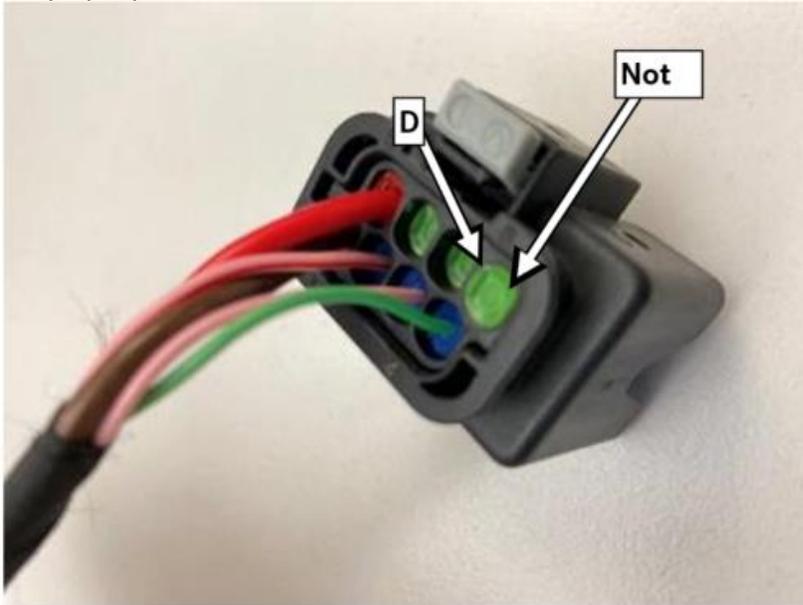
Figure 5

5. Check green blind plugs (D, figure 5) on the rear side of the connector for proper seating, rework if necessary.

i If the connector and the blind plug has no damage and are out of place, the blind plugs need to be pressed into its proper position.

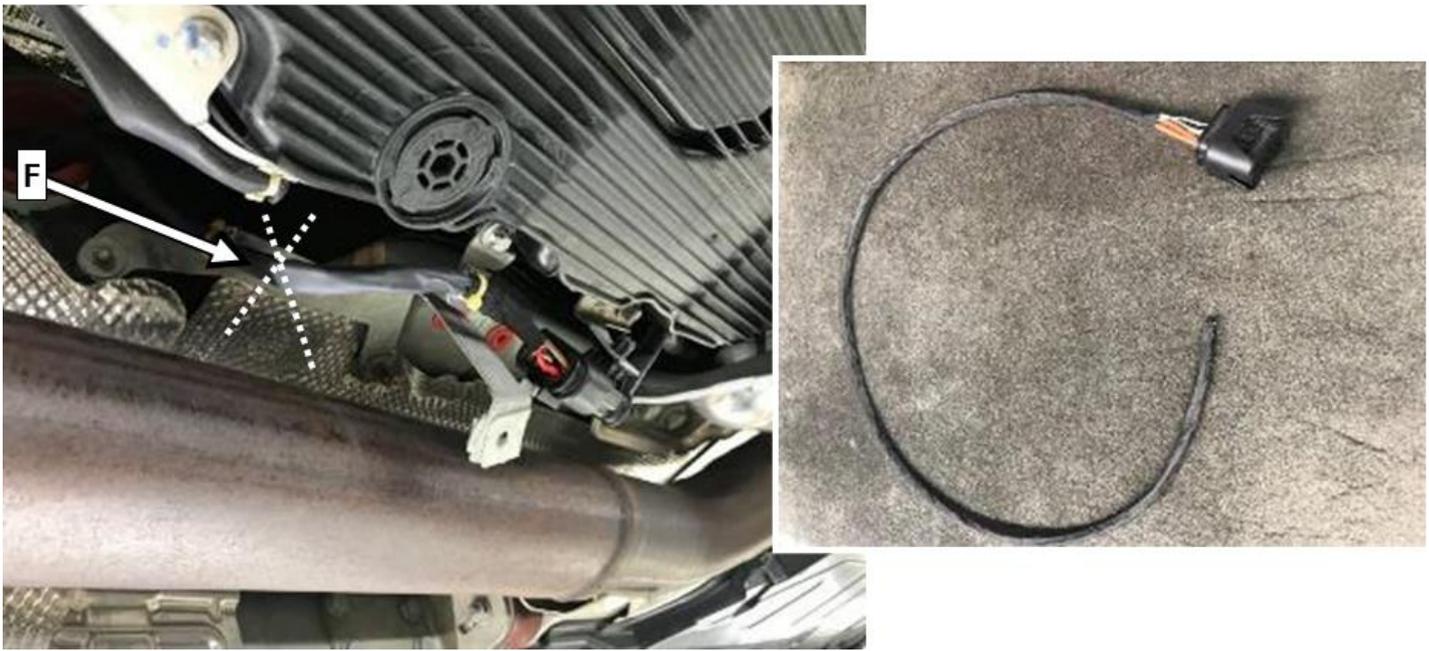
Figure 9

i If **damage** to the pins, cables, sealing, or plug housing is present, the vehicle-side wiring harness must be always repaired with the **repair wiring harness**.

2. Disconnect the vehicle-side wiring harness in the denoted area (F, figure 9), strip and connect it with the repair wiring harness using a line connector.

i **Repair wiring harness by means of a line connector, see AR00.19-P-0100-09A.**

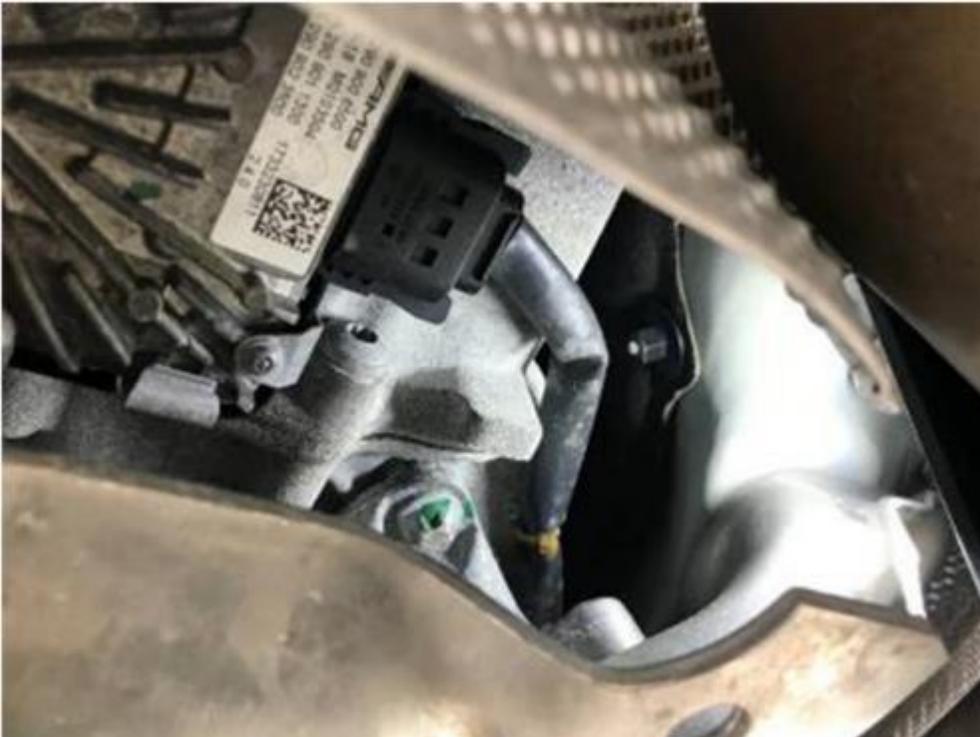
Figure 10

i If the **transfer case wiring harness** is damaged, it must be completely replaced.

2. Unclip the transfer case-side wiring harness on the bracket of the automatic oil pan, unclip the transfer case and disconnect it from the variable transfer case control unit.

3. Replace transfer case-side wiring harness.
 4. Assemble in reverse order.
 5. Attach additional bracket as described in work procedure A and fasten wiring harness.
-
