Recall Campaign Bulletin

Campaign No. 2022080010, September 2022

SUBJECT: **Various Models**
Model Year 2019-2022

Check Transmission Wiring Harness Connector

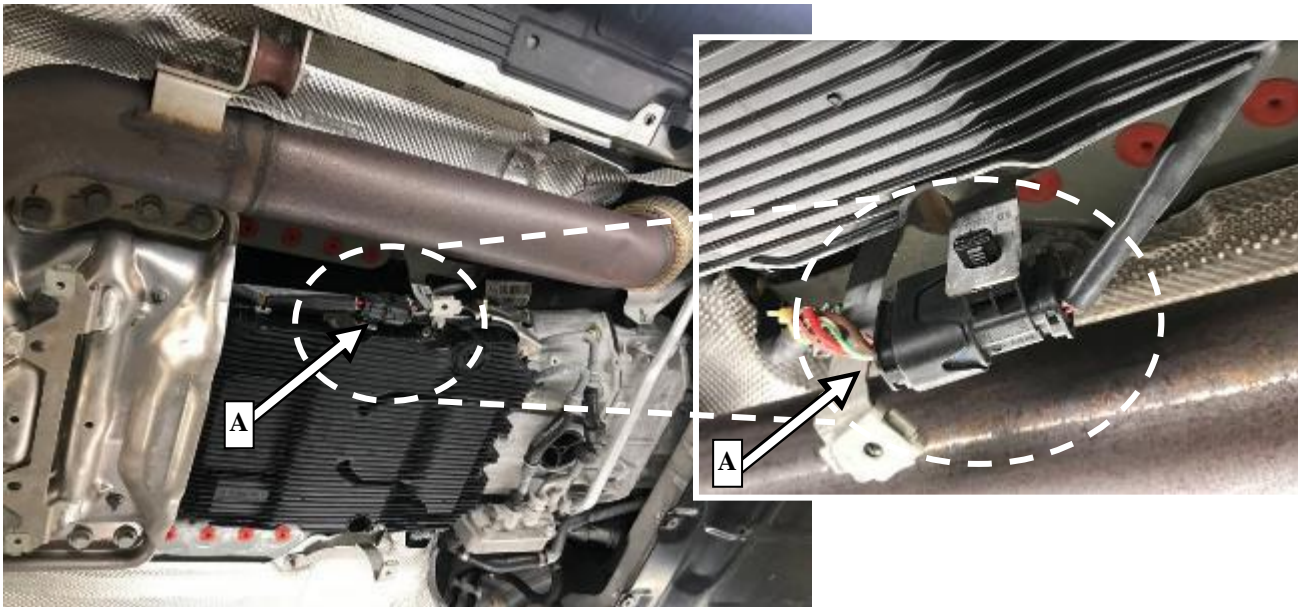
Figure 1

2. Disconnect electrical connector **X279** (A, Figure 1) from right oil pan.

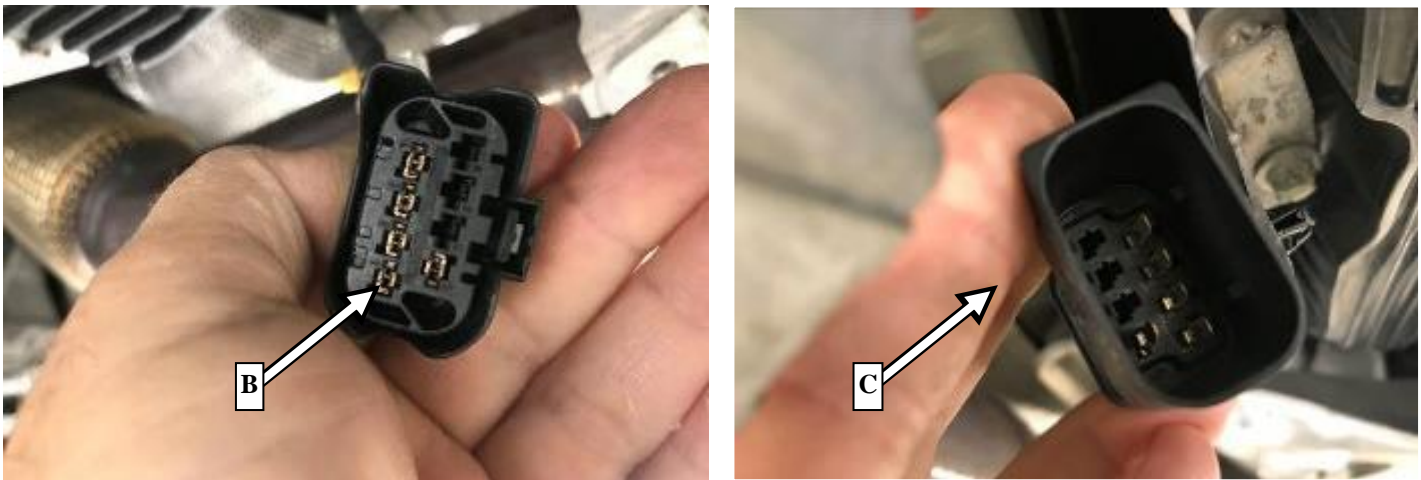
Figure 2

3. Check insides of connector coupling on vehicle-side wiring harness **A 290 540 99 14** (B, Figure 2) and transfer case wiring harness **A 213 540 32 69** (C, Figure 2) for corrosion and other damage or noticeable problems.

- a. If corrosion or moisture is detected, the vehicle-side wiring harness (A 290 540 99 14) must be repaired and the transfer case wiring harness (A 213 540 32 69) **must always be replaced**.
- b. If OK, **remove pins** from **vehicle-side** wiring harness (B, Figure 2) using special tool **W 220 589 01 99 63** (Figure 3) individually and **one after the other**, check for corrosion and damage, **and reinsert pins**.

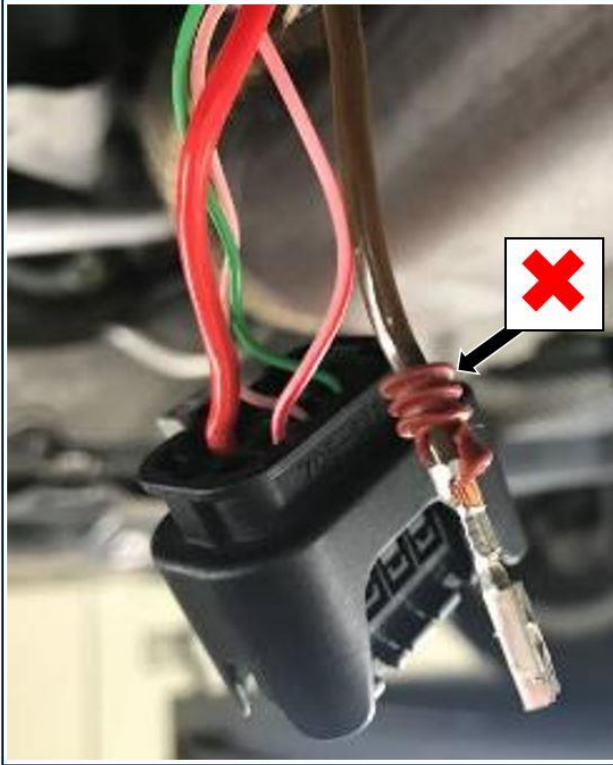
Figure 4: (Sealing element not OK)

i **Figure 4 (not OK image) shows a defective sealing element.**

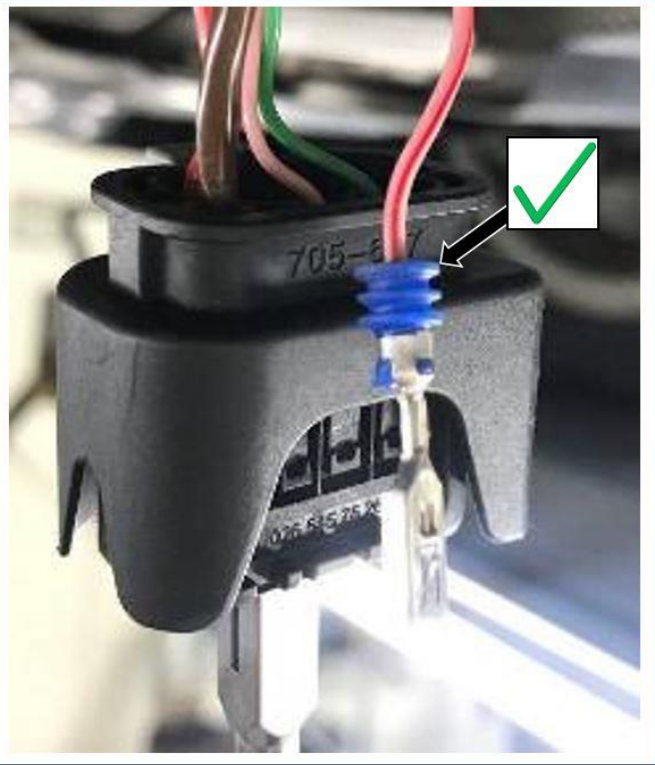
Figure 5: (Sealing element OK)

i Sealing lip must be visible, **see Figure 5 (OK image)**.

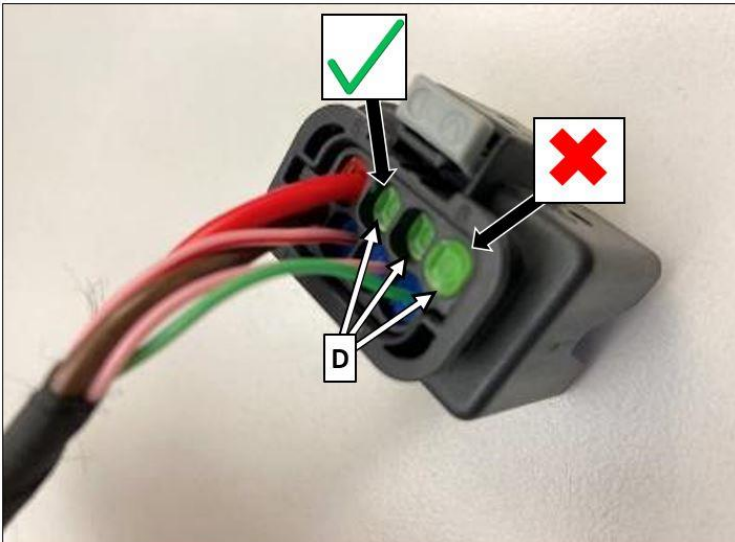
4. Check green blind plugs (D, Figure 6) on rear of plug.

5. **i** A green blind plug that is not seated correctly must be **pressed in further** as per Figure 6 (OK image).
