TO: Mercedes-Benz Dealer Principals, General Managers, Sales Managers, Service Managers, Parts Managers	FROM: Gregory Gunther, Department Manager, Vehicle Compliance and Analysis, Engineering Services
RE: Recall Campaign Update Notification Check Transmission Wiring Harness Connector MY 19-22 4-Matic CLS-Class, E-Class, and GT-Class (257, 213, 238, and 290 platform)	DATE: October 6, 2022

Recall Campaign Bulletin

Campaign No. 2022080010, September 2022

Check Transmission Wiring Harness Connector

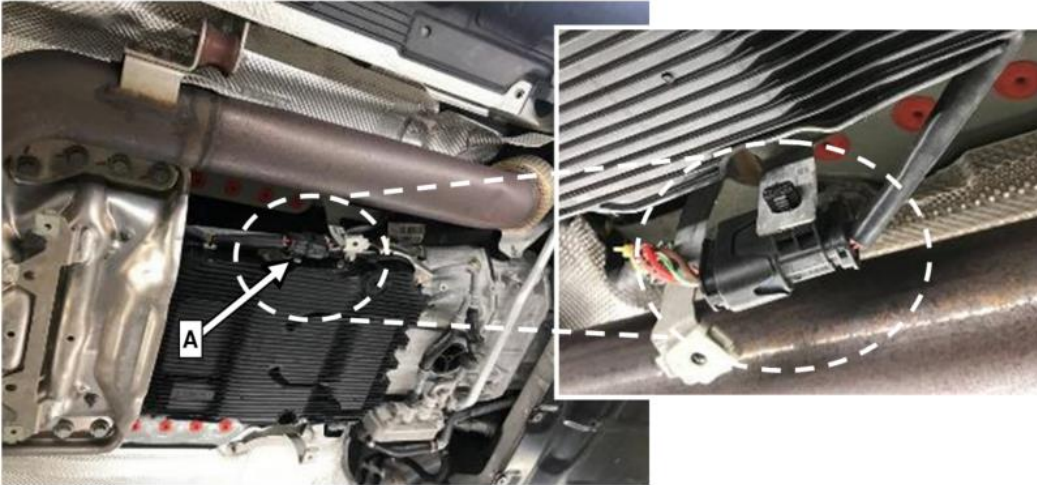
**Figure 1**

1. Remove rear underfloor paneling under transmission.
2. Disconnect electrical connector X279 (A, figure 1) from the oil pan on the right side.

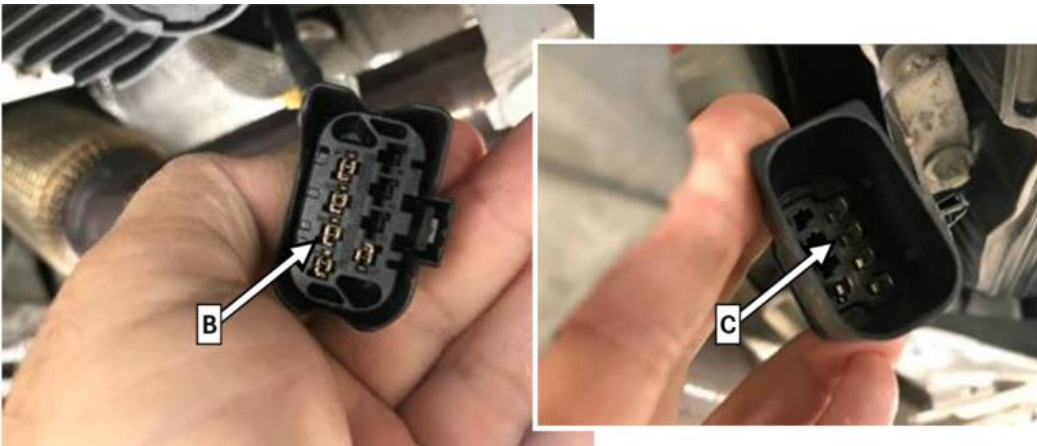
**Figure 2**

3. Check insides of the connector (B, figure 2 – vehicle side) and (C, figure 2 – transfer case side) for corrosion and other damage or noticeable problems.

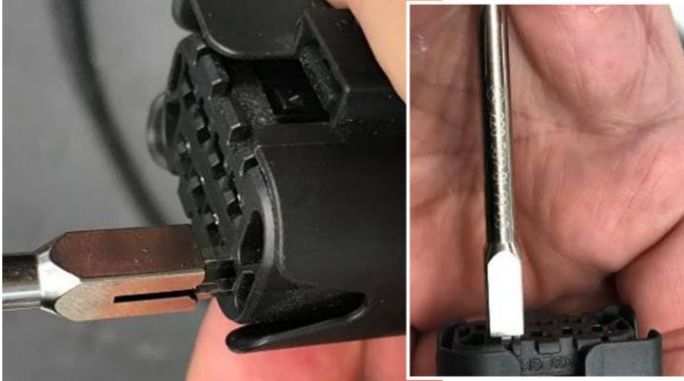
Figure 3

4. Check pins from the **vehicle side** wiring harness (B, figure 2) with the special tool **W 220 589 01 99 63** (figure 3). **Unpin** each individually, check for corrosion and damage such as wire melting or wire sealing lips (figure 4), **and then pin back in**. DO NOT remove all pins at once.

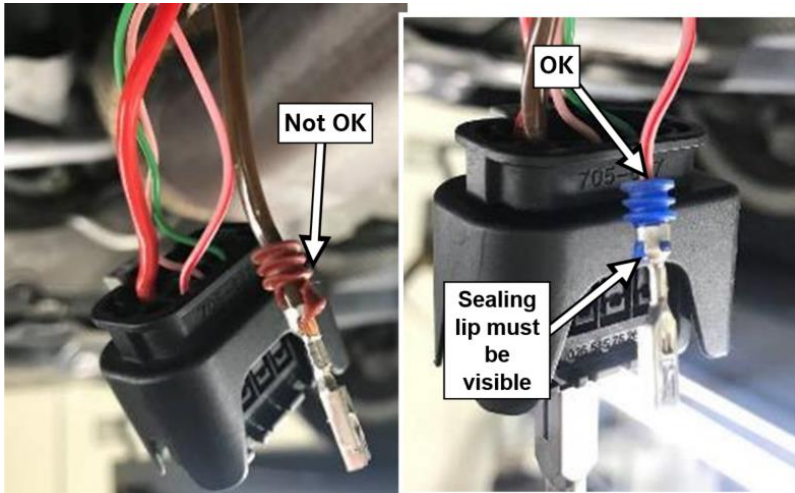
Figure 4 (*not OK* and OK sealing element)

No sealing elements may be damaged or melted at the cables.
-

Sealing elements must be properly crimped in the cable lug.
-

See OK figure. Sealing lip must be visible.
-

Figure 4 shows a *not OK* and OK sealing element!

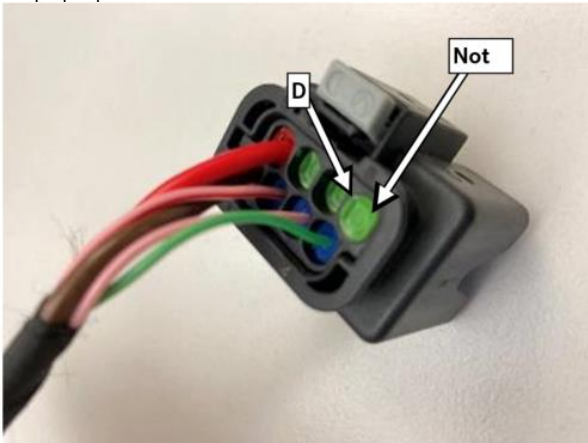
Figure 5

5. Check green blind plugs (D, figure 5) on the rear side of the connector for proper seating, rework if necessary.

i If the connector and the blind plug has no damage and are out of place, the blind plugs need to be pressed into its proper position.

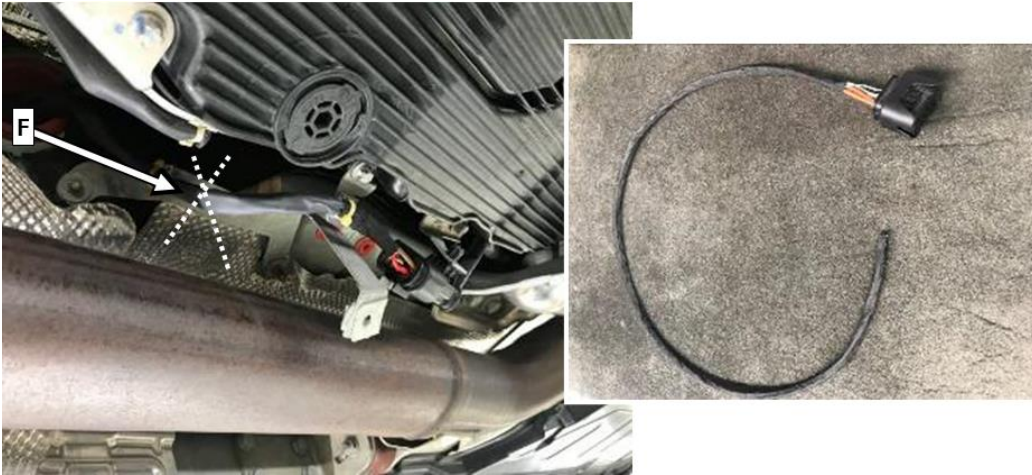
Figure 9

i If **damage** to the pins, cables, sealing, or plug housing is present, the vehicle-side wiring harness must be always repaired with the **repair wiring harness**.

2. Disconnect the vehicle-side wiring harness in the denoted area (F, figure 9), strip and connect it with the repair wiring harness using a line connector.

i Repair wiring harness by means of a line connector, see AR00.19-P-0100-09A.

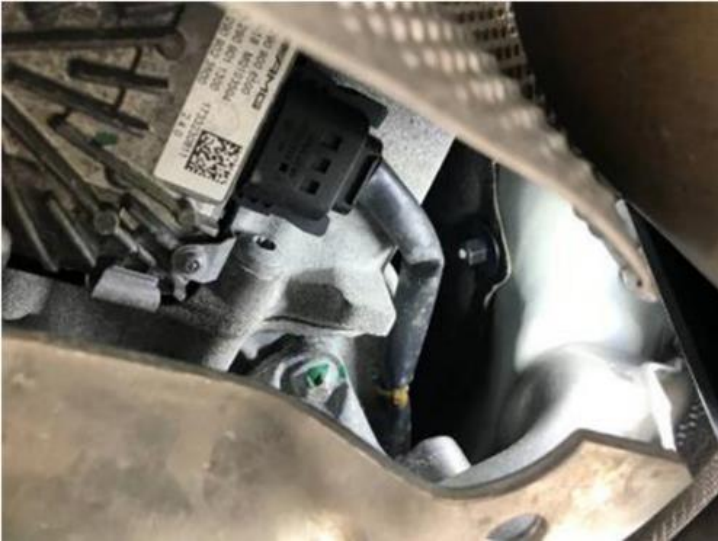
Figure 10

i If the **transfer case wiring harness** is damaged, it must be completely replaced.

2. Unclip the transfer case-side wiring harness on the bracket of the automatic oil pan, unclip the transfer case and disconnect it from the variable transfer case control unit.

i To disconnect the control unit the heat shield must be gently pushed down.
