USA RECALL CAMPAIGN

REF. NO. C24100080

REPLACEMENT OF BRAKE FLUID RESERVOIR CAP

MODEL YEARS 2019 - 2022

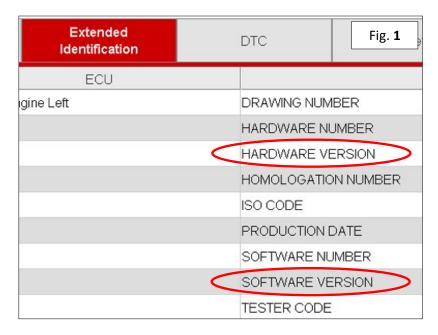
- > Save the identification parameter of the **NQS** node installed in the vehicle.
- ➤ Before downloading. make sure that there are not errors in the **NQS** ECU. <u>Resolve any problems reported by the control unit before proceeding with the download</u>.
- > Press "Activities" and follow all the steps for a normal software downloading procedure as prompted by the DEIS tester.
- > Check that the ECU software update procedure has been completed successfully by comparing the identification parameters of the ECUs against the parameters prior to the update. Select the NQS node. press the "Extended Identification" button and check that the "HARDWARE VERSION NUMBER" and "SOFTWARE VERSION" values match the software installed and that the "PRODUCTION DATE" value is the date in which the update was performed Fig. 1.

- > At the end of the procedure, remember to save the identification parameter for the selected node.
- > Check that there are NO errors in the NQS node.
