January 25, 2023

TO: All U.S. Ford and Lincoln Dealers

SUBJECT: **NEW VEHICLE DEMONSTRATION / DELIVERY HOLD**
Compliance Recall 22C20 - Supplement #1
Certain 2022 Model Year Maverick
Side Airbag Curtain Replacement

CERTAIN 2022 MODEL YEAR MAVERICK VEHICLES — DRIVER AND PASSENGER SIDE CURTAIN AIRBAG REPLACEMENT

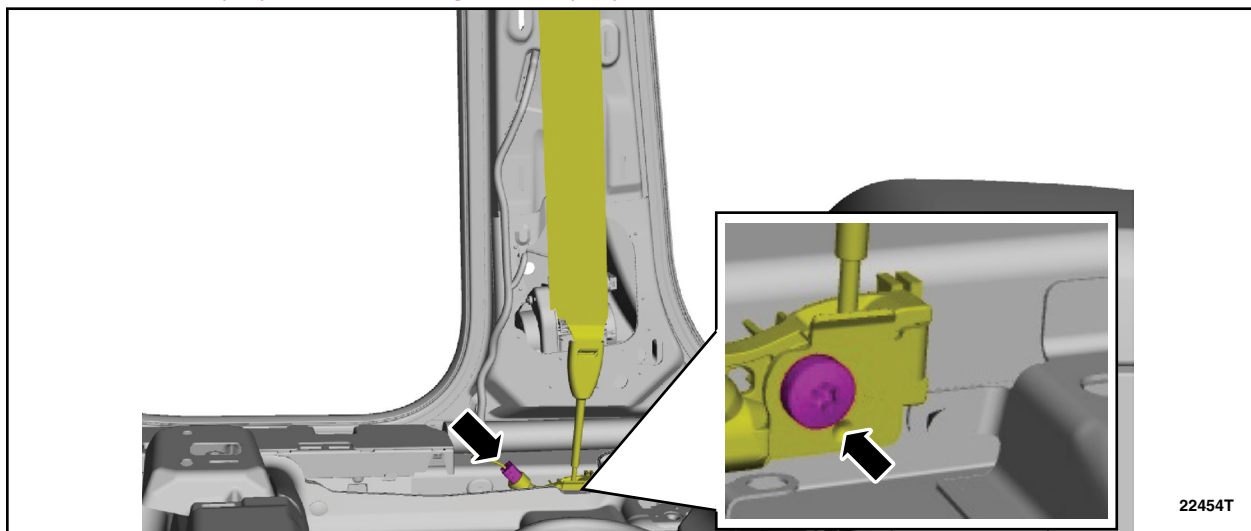
FIGURE 1

1. On both sides remove the A-pillar trim panels. Please follow the Workshop Manual (WSM) procedures in Section 501-05.
2. On both sides remove the B-pillar lower trim panels. Please follow the WSM procedures in Section 501-05.
3. Depower Supplemental restraint System (SRS). Please follow the WSM procedures in Section 501-20B.
4. Position the front seatbelt anchor and pretensioner aside, disconnect the front seatbelt anchor and pretensioner electrical connector and remove the front seatbelt anchor and pretensioner bolt. See Figure 1.

- Torque: 40 Nm (30 lb.ft).

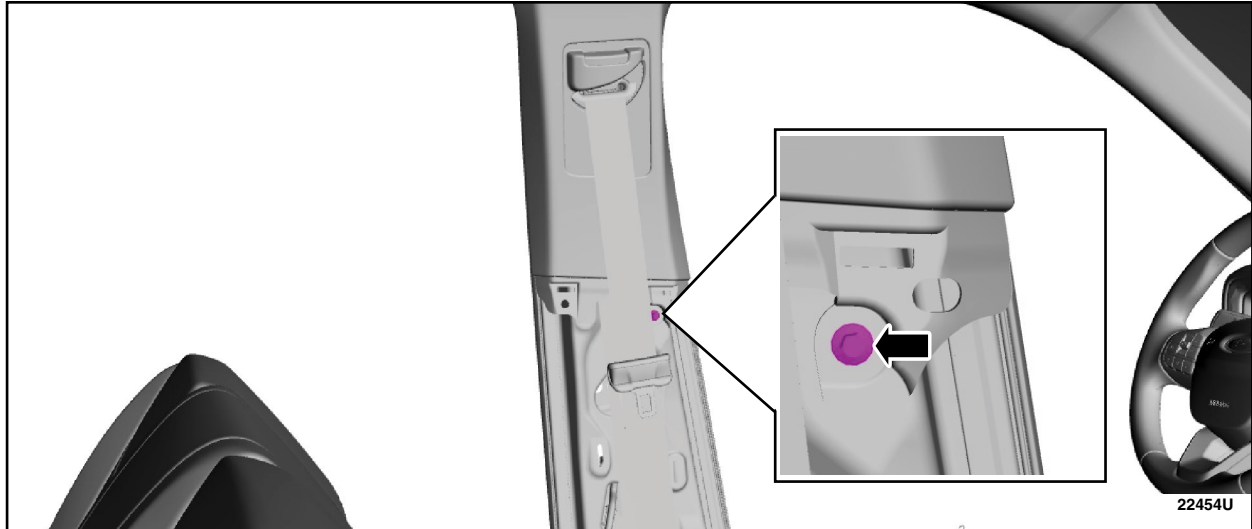
FIGURE 2

5. On both sides remove the B-pillar upper trim panel bolt. See Figure 2.

- Torque: 9 Nm (80 lb.in).

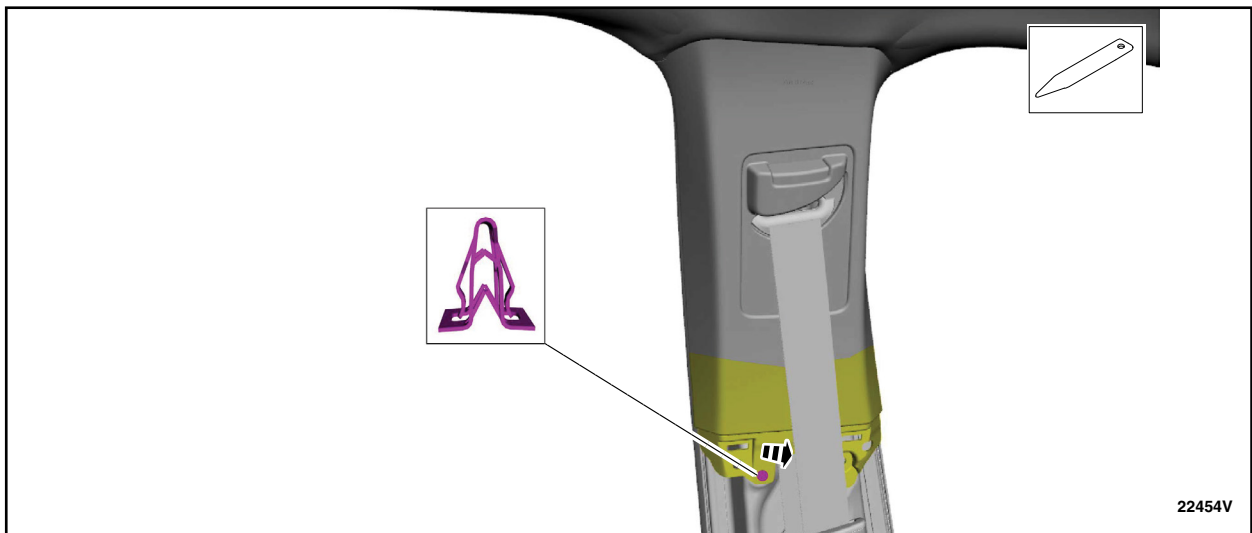
FIGURE 3

6. On both sides release the B-pillar upper trim panel lower clip. See Figure 3.

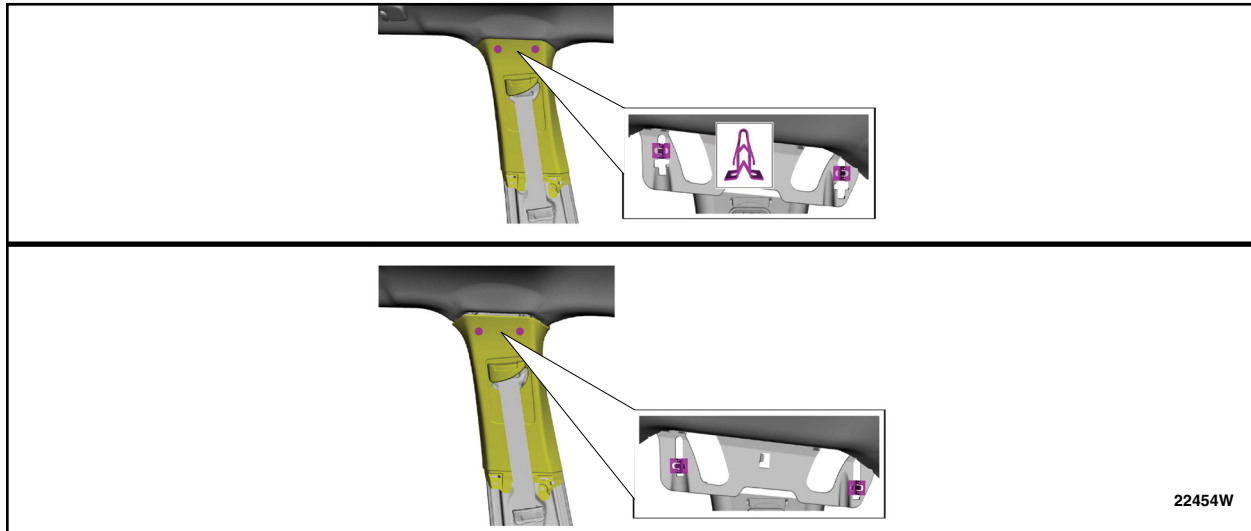
FIGURE 4

7. On both sides slide the B-pillar upper trim panel down, aligning the clips to the slots in the sheet metal. See Figure 4.

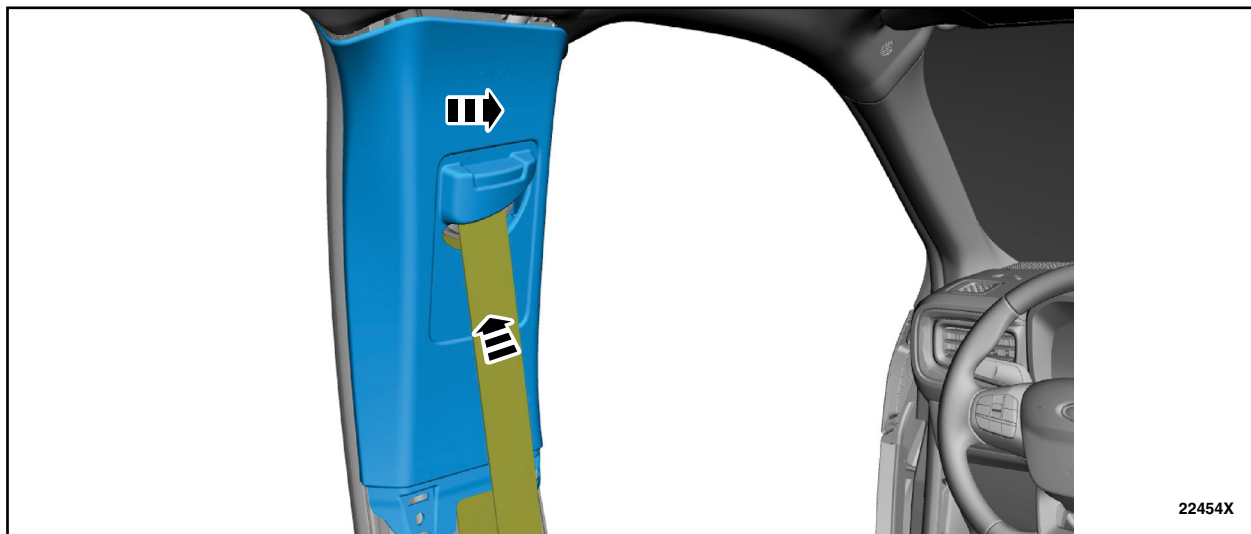
FIGURE 5

8. On both sides pull outward on the B-pillar upper trim panel, feed the front seatbelt retractor and pretensioner through the opening in the B-pillar upper trim panel and remove the B-pillar upper trim panel. See Figure 5.

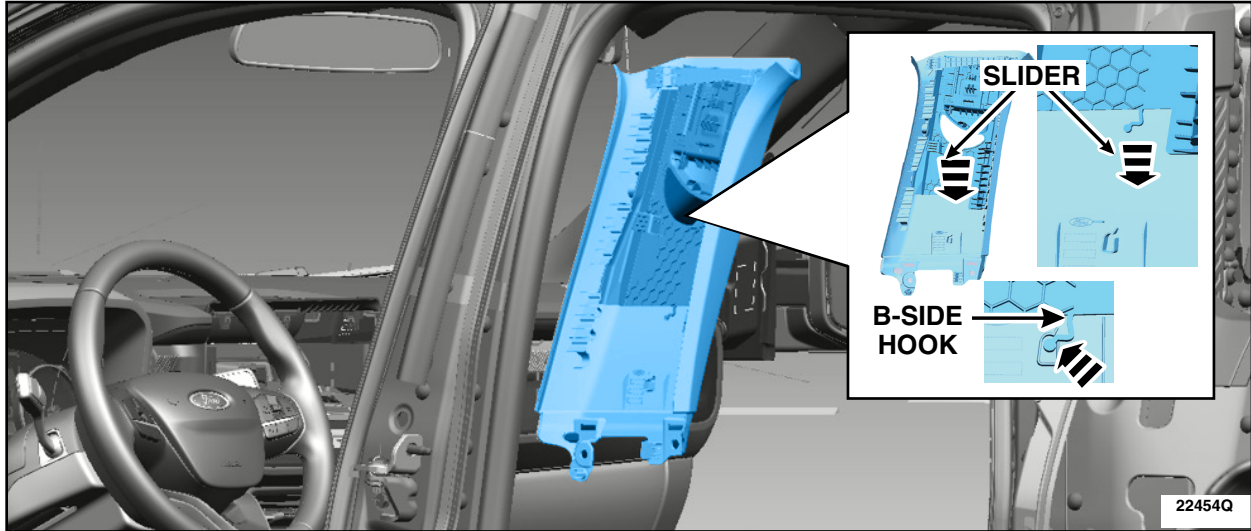
FIGURE 6

9. On both sides adjust the position of the B-pillar Slider downward, pull the slider down to the lower position and engage the B-side hook into the pocket. See Figure 6.

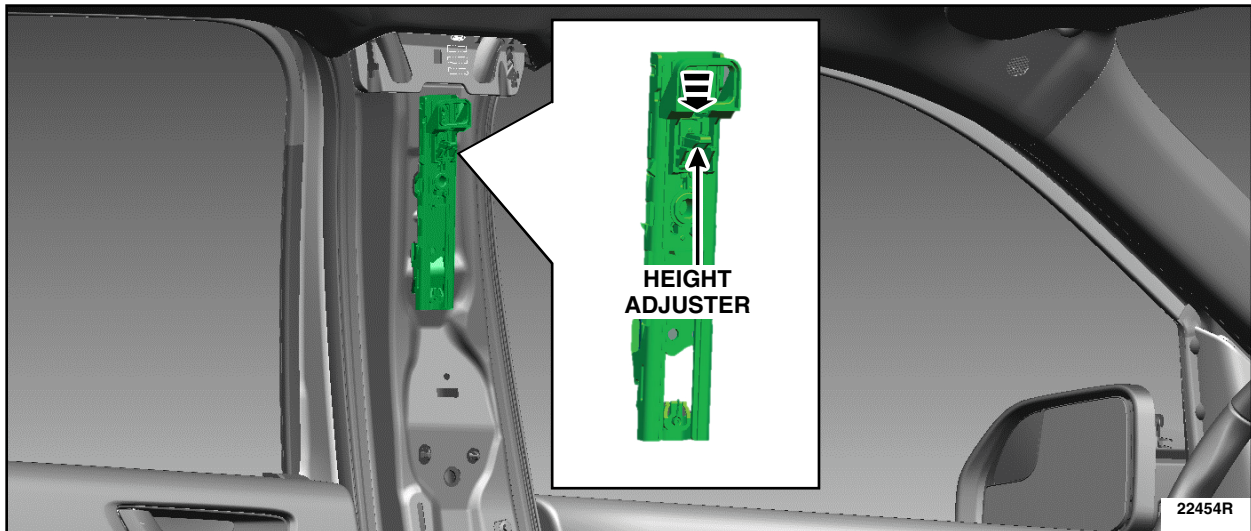
FIGURE 7

10. On both sides pull the height adjuster downward to the lower position and adjust the position of the height adjuster downward. See Figure 7.

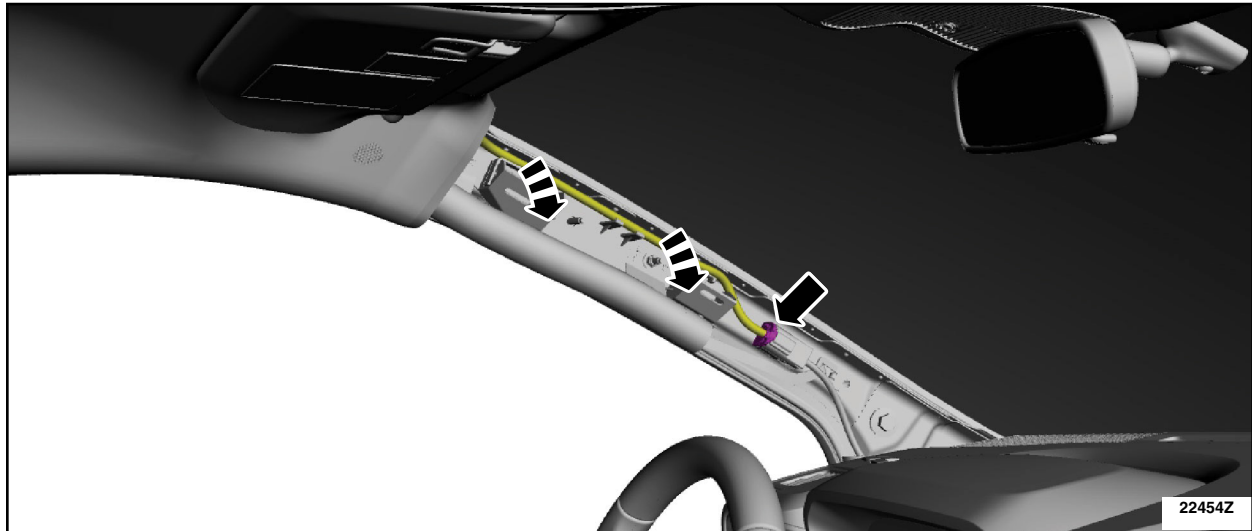
FIGURE 8

11. On the LH side disconnect the headliner wiring harness electrical connector, release the headliner wiring harness from the A-pillar and position the headliner wiring harness aside. See Figure 8.

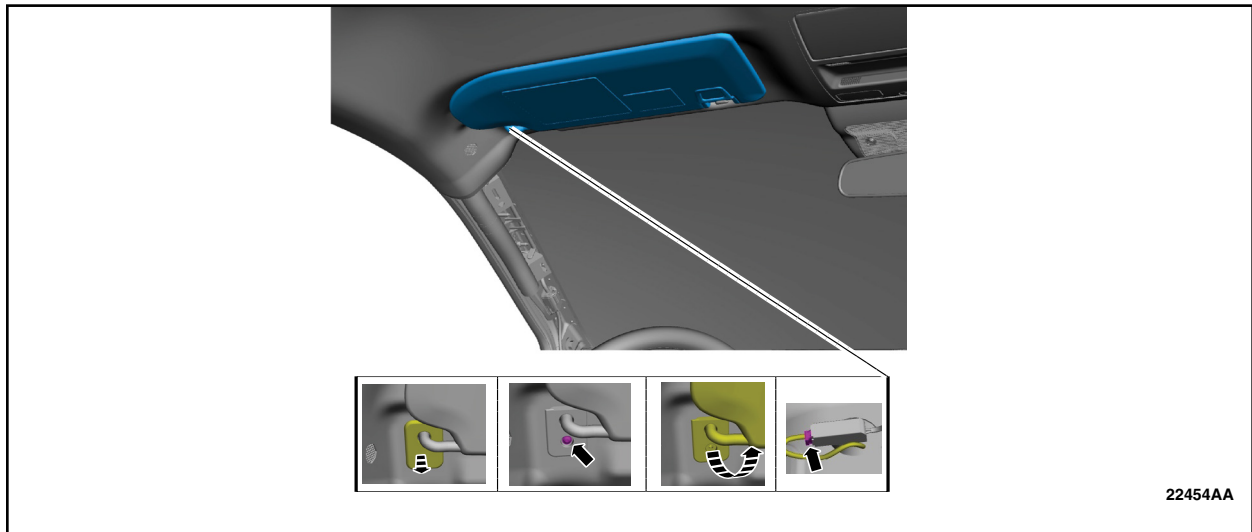
FIGURE 9

12. On both sides position the sun visor bolt cover aside, remove the sun visor bolt, rotate the sun visor end down and rearward to remove from headliner, if equipped disconnect the sun visor electrical connector and remove the sun visor. See Figure 9.

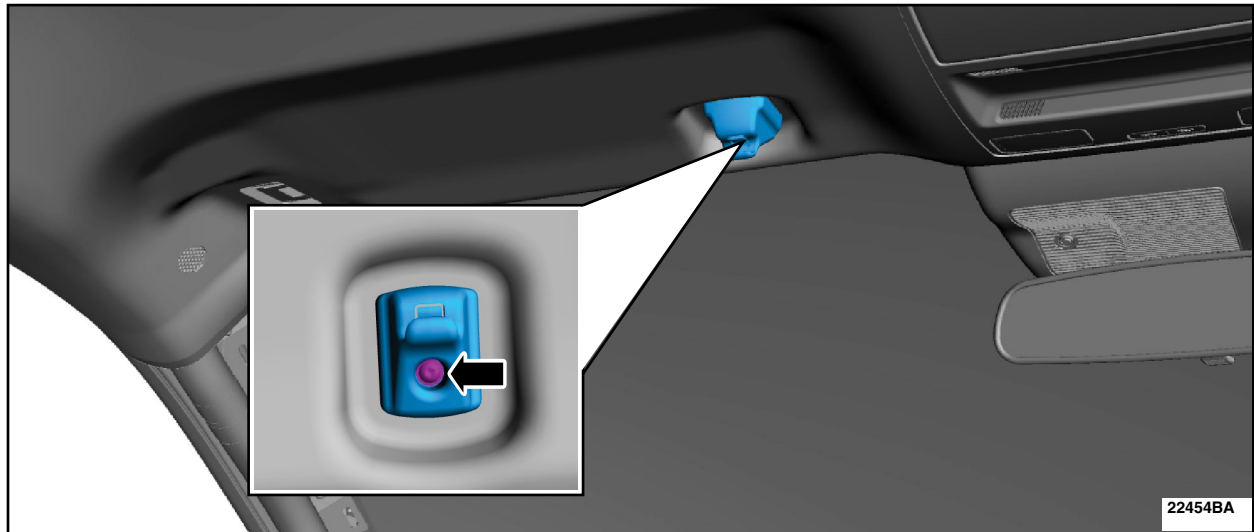
FIGURE 10

13. On both sides remove the bolt and the sun visor clip. See Figure 10.

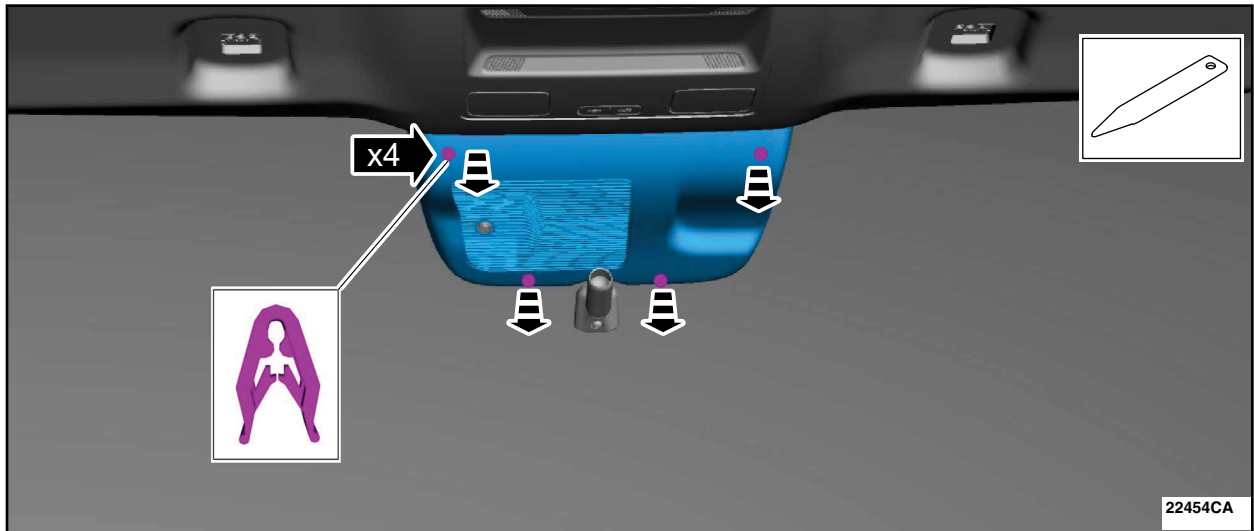
FIGURE 11

14. Release the clips and remove the Image Processing Module A (IPMA) cover. See Figure 11.

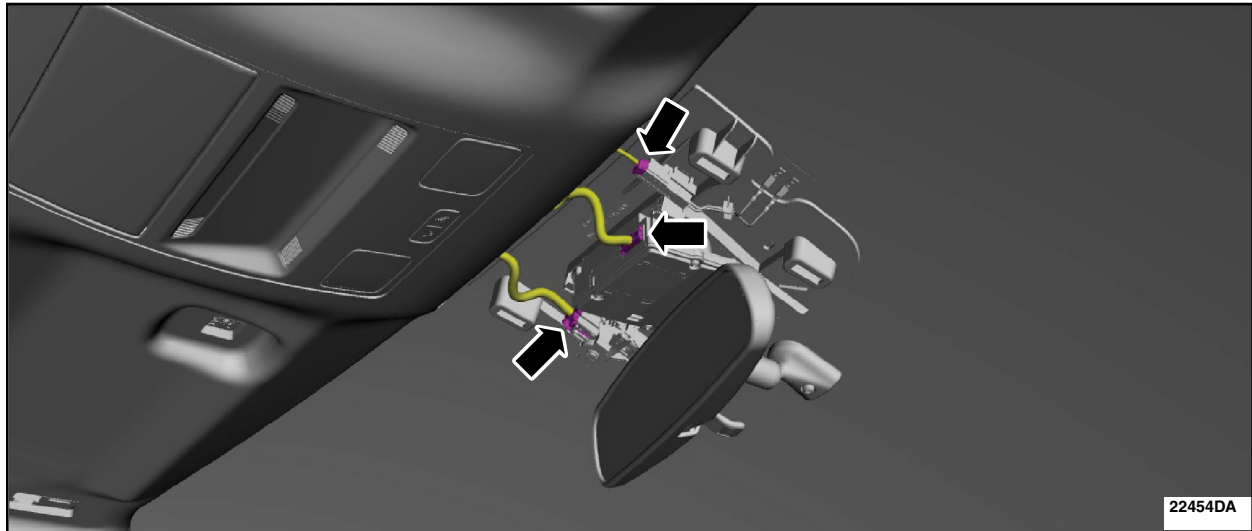
FIGURE 12

15. Disconnect the in-vehicle temperature and humidity sensor electrical connector, the IPMA electrical connector and the IPMA windshield heater grid electrical connector. See Figure 12.

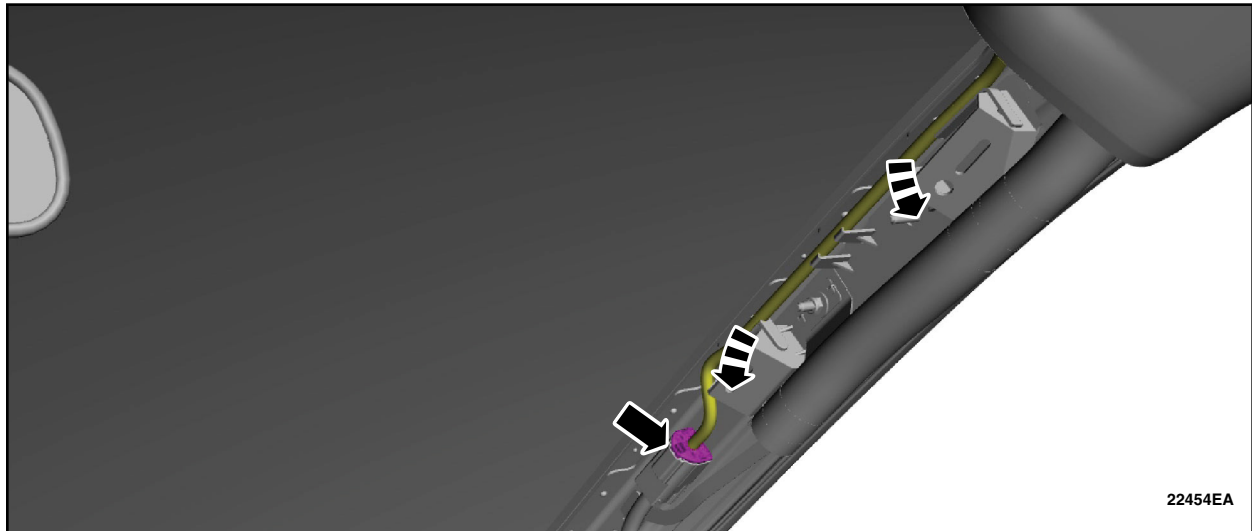
FIGURE 13

16. On the RH side disconnect the headliner wiring harness electrical connector, release the headliner wiring harness from the A-pillar and position the headliner wiring harness aside. See Figure 13.

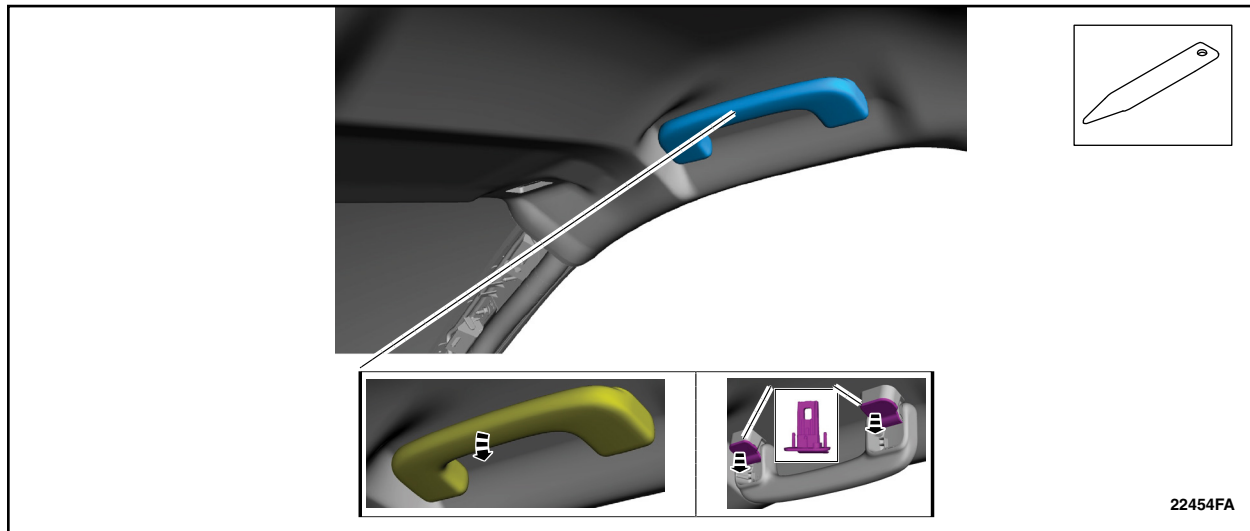
FIGURE 14

17. On the RH side position the front assist handle down, remove the front assist handle retainers and remove the front assist handle. See Figure 14.

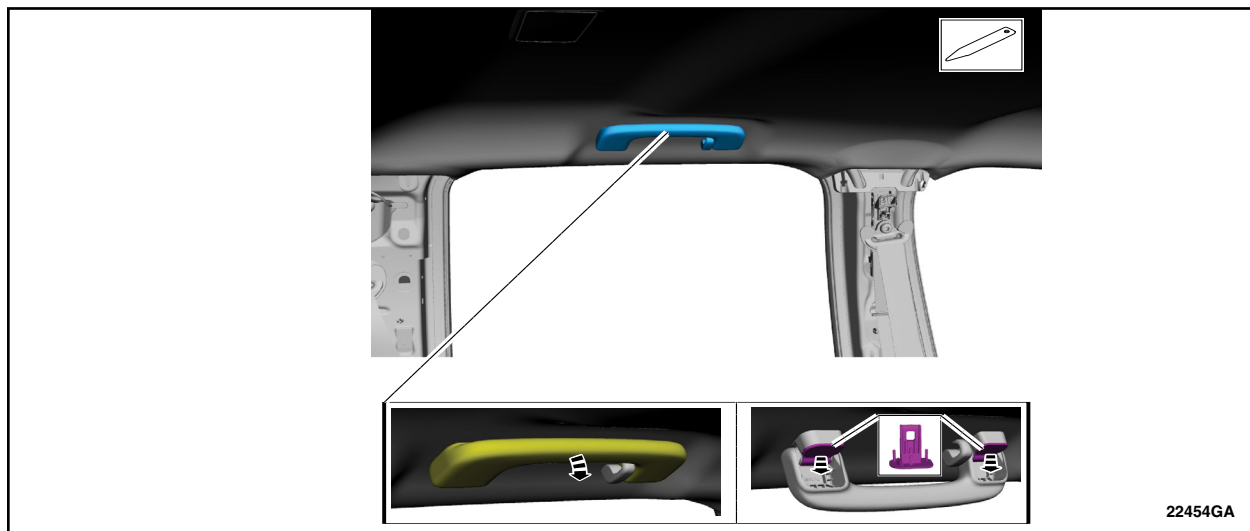
FIGURE 15

18. On both sides position the rear assist handle down, remove the rear assist handle retainers and remove the rear assist handle. See Figure 15.

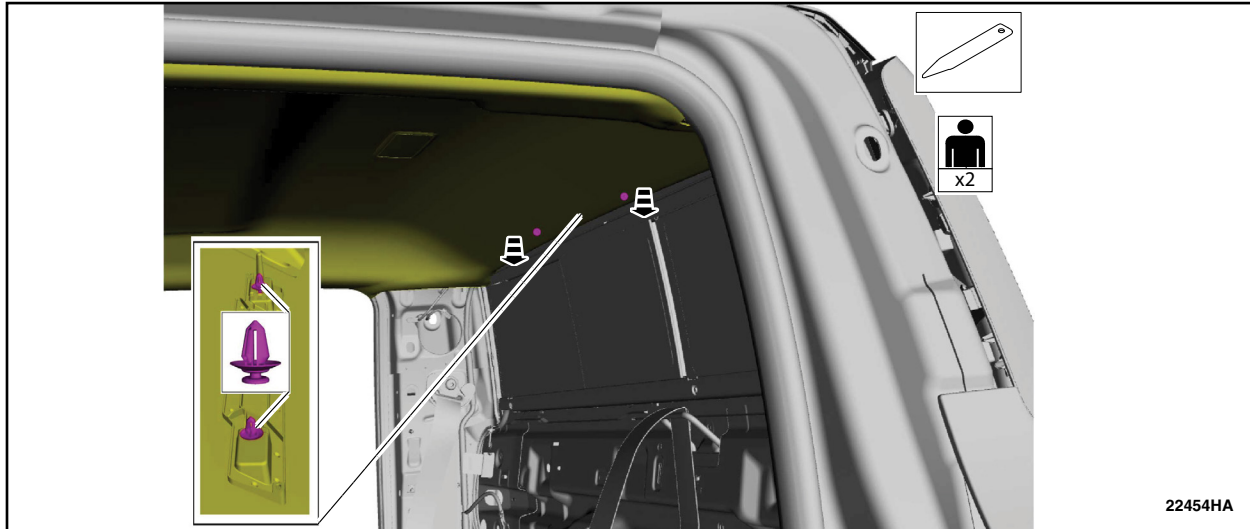
FIGURE 16

19. Release the headliner rear clips. See Figure 16.

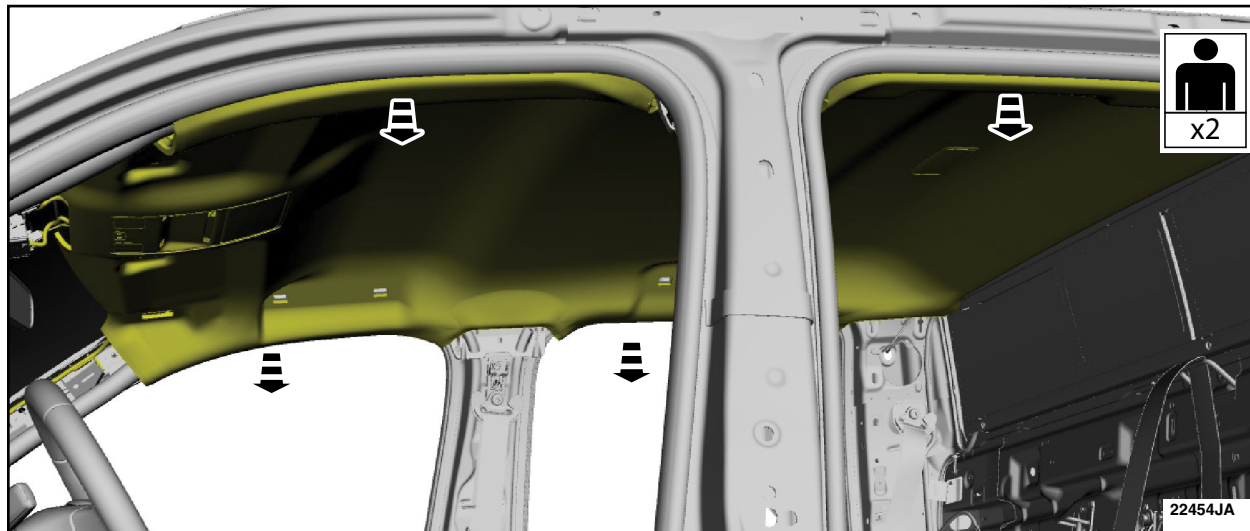
FIGURE 17

20. Lower the headliner. See Figure 17.

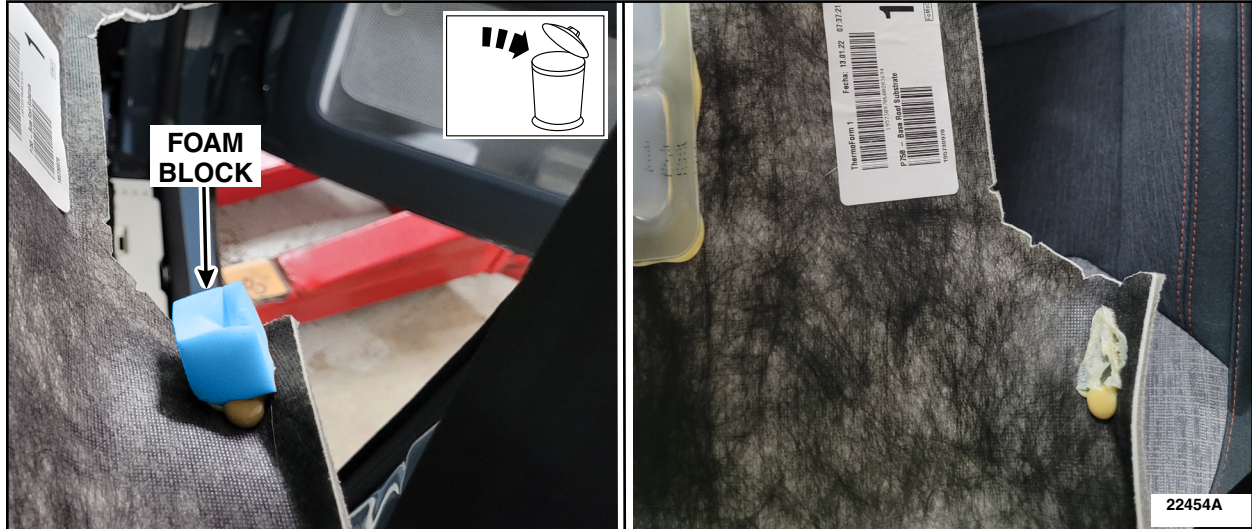
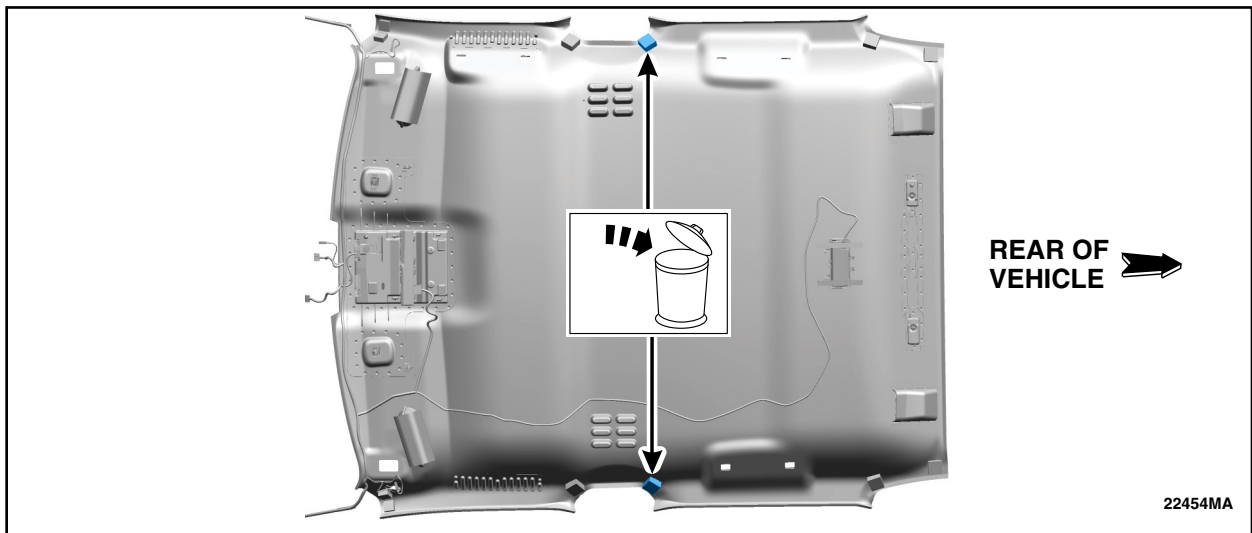
NEW ! 22. On both sides of the headliner, remove and discard the foam block located rearward of the B-Pillar upper trim panel. *See Figures 18 and 19.*

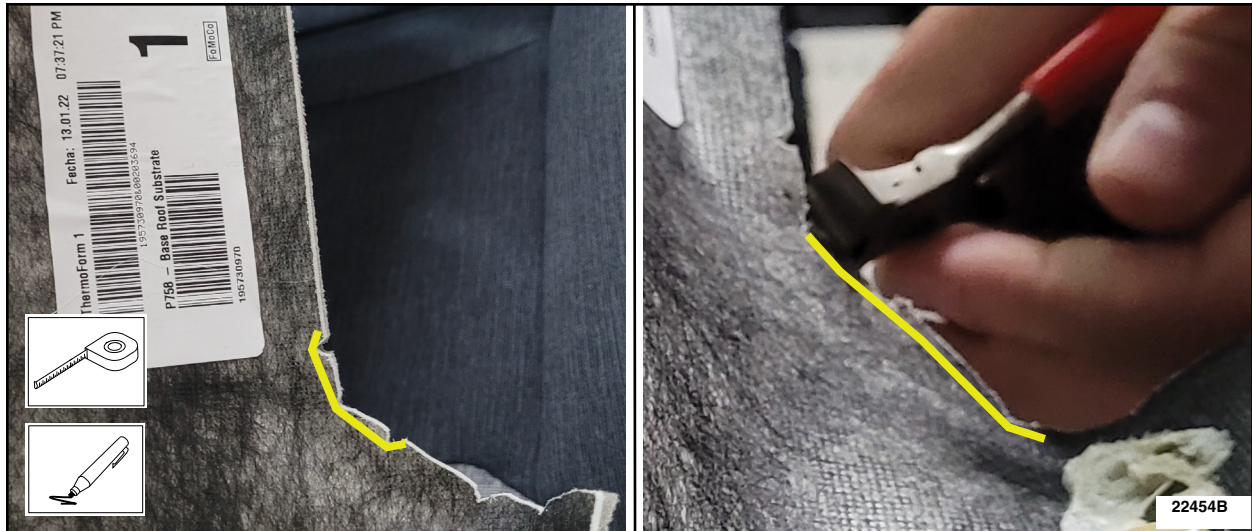
FIGURE 20

23. On both sides of the headliner, measure inward 0.11 in (3mm) across the three *triangular* notches from the edge of the headliner rearward of the B-Pillar upper trim panel and using a suitable tool remove the excess material *including the three triangular notches*. See Figure 20.

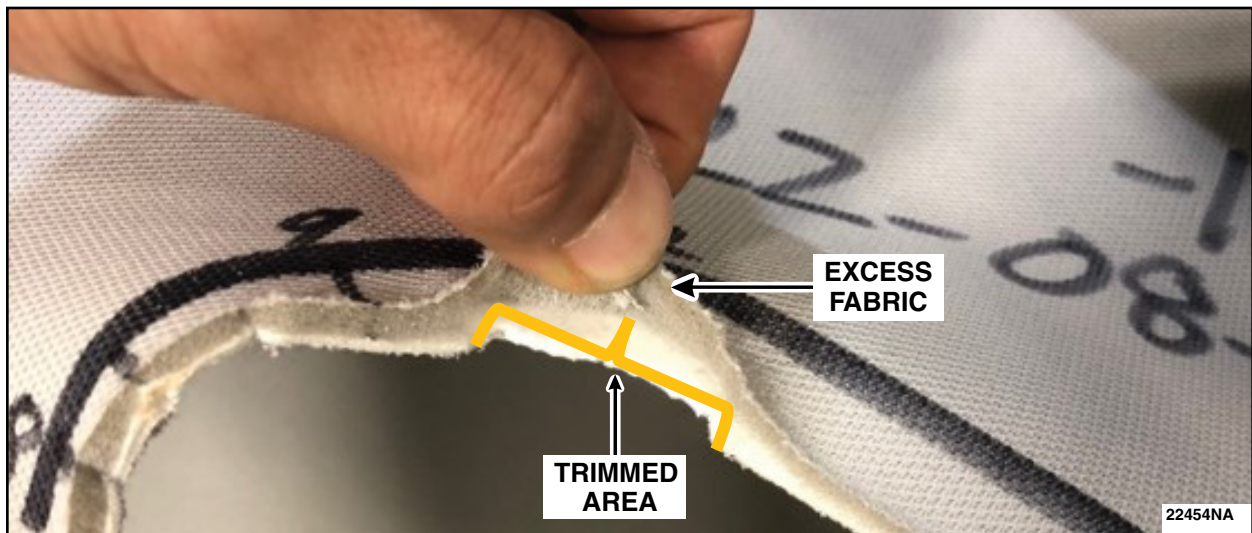
FIGURE 21

NOTE: Excess fabric is acceptable and will be covered when the B-Pillar is reinstalled. See Figure 21.

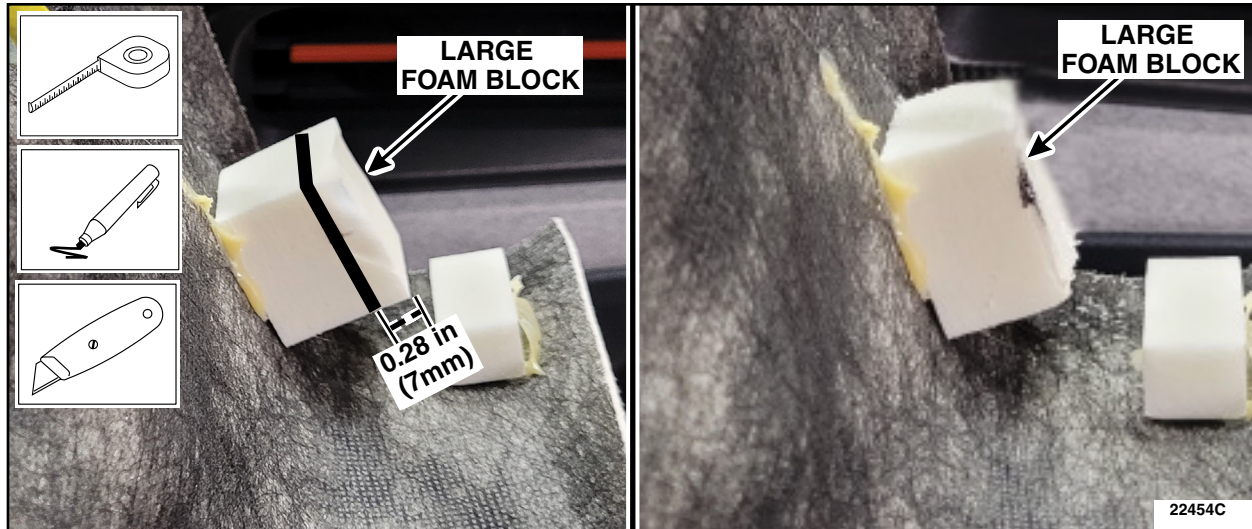
FIGURE 22

24. On both sides of the front of the headliner, locate the large foam block on the outboard edge of the headliner. Measure from the top of the foam block inward 0.28 in (7mm) and mark the foam block. Using a suitable tool cut from the marked area to the top of the foam block. See Figure 22.

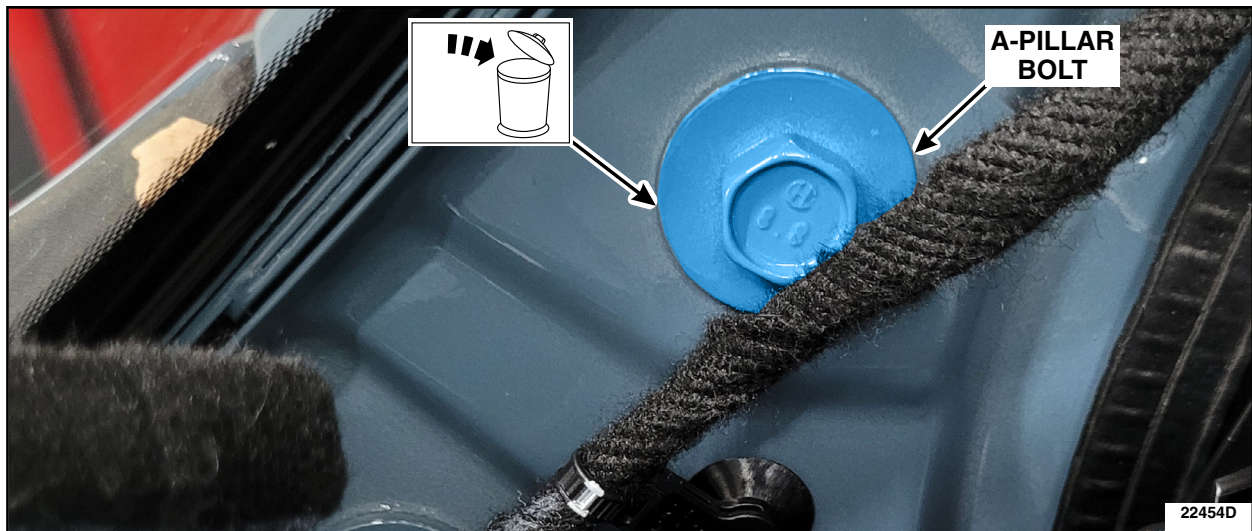
FIGURE 23

25. On both sides of the vehicle remove and discard the A-Pillar bolt. See Figure 23.

NOTE: This hole will be used when installing the *new* side curtain airbags.

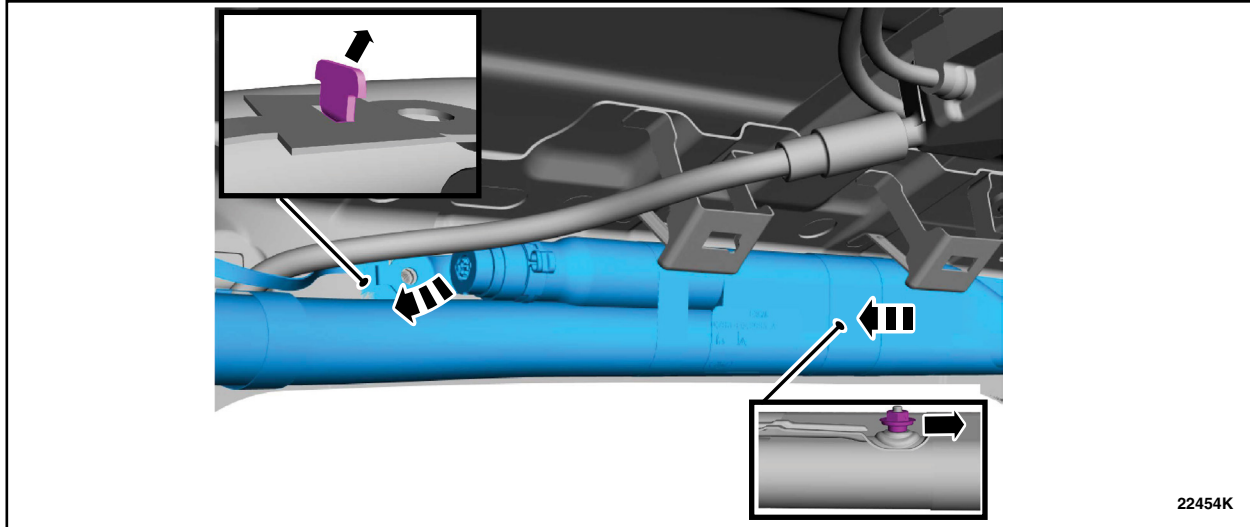
FIGURE 24

26. Slide the *new* side curtain airbag rearward, engaging the retainer to the sheet metal, then rotate the side curtain airbag and attach the retainer. See Figure 24.

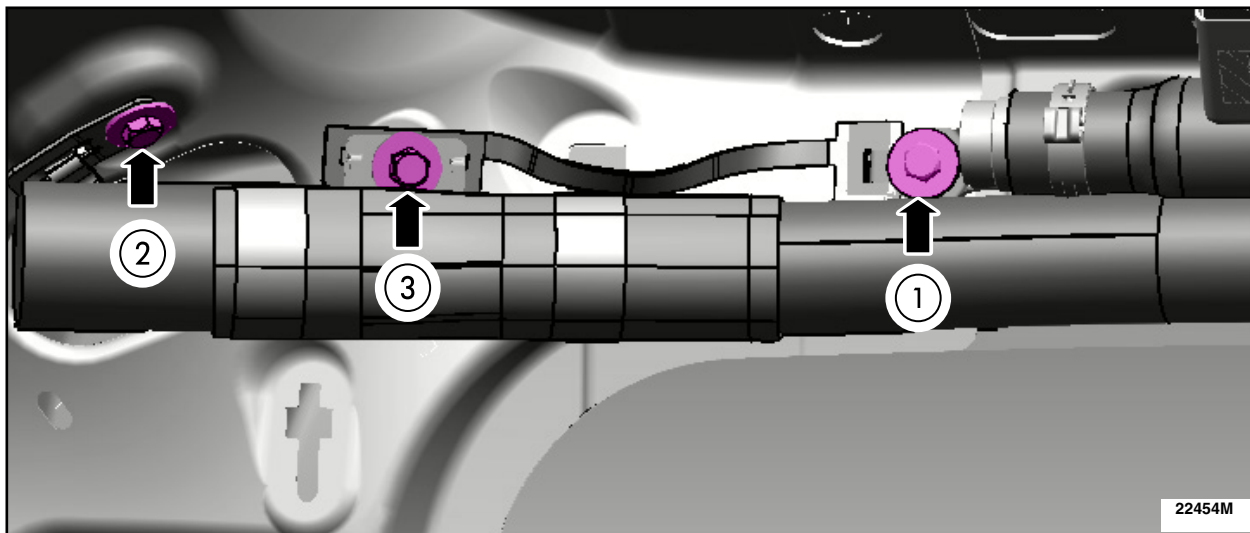
FIGURE 25

27. Install the side curtain airbag rear bolts *in the sequence shown*. See Figure 25.

- Torque: 9 Nm (80 in.lb).

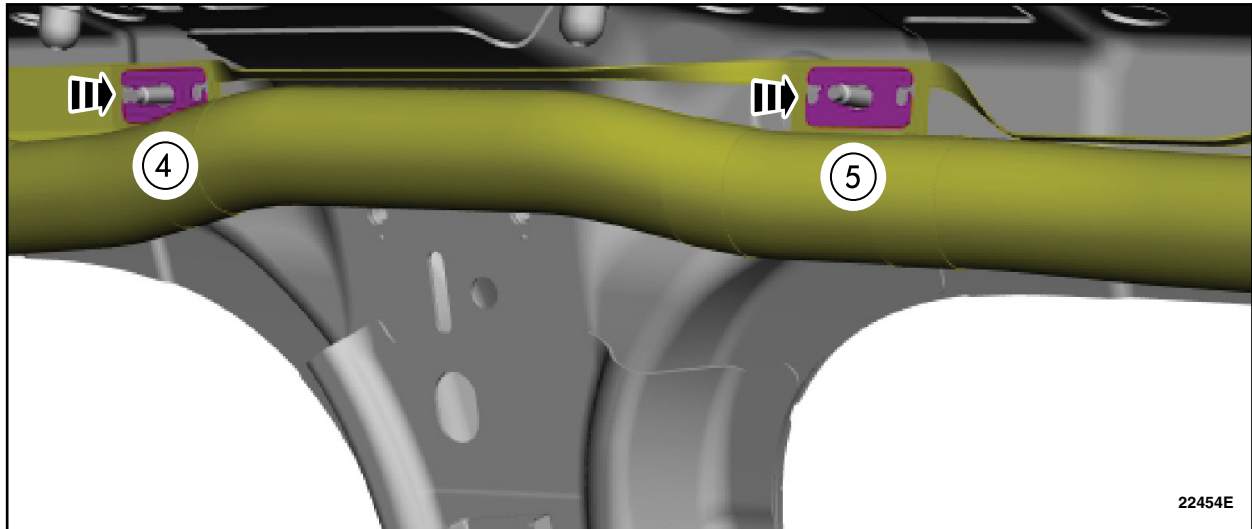
FIGURE 26

28. Attach the *new* side curtain airbag to the hangers *in the sequence shown*. See Figure 26.

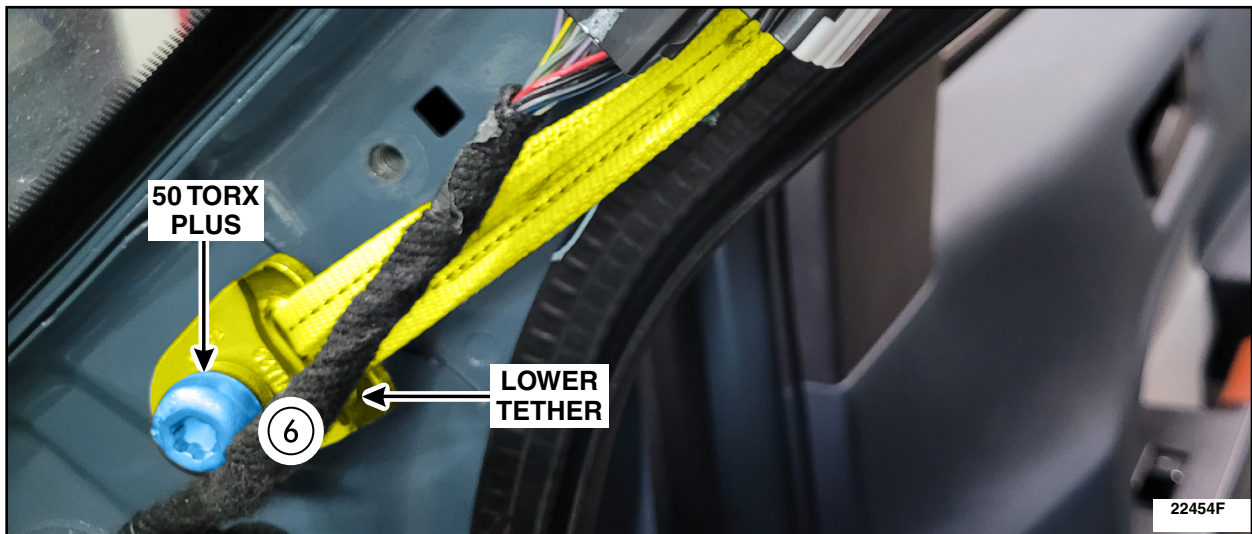
FIGURE 27

29. Using the *new* 50 torx plus bolt attach the *new* side curtain airbag lower tether *and hand tighten the bolt*. See Figure 27.

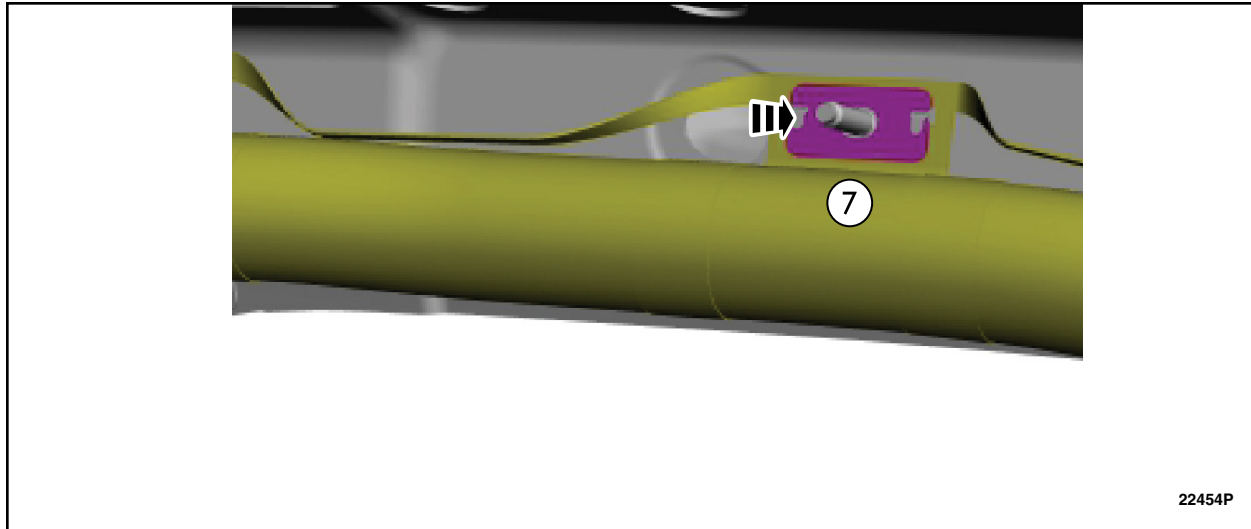
FIGURE 28

30. Attach the *new* side curtain airbag hanger. See Figure 28.

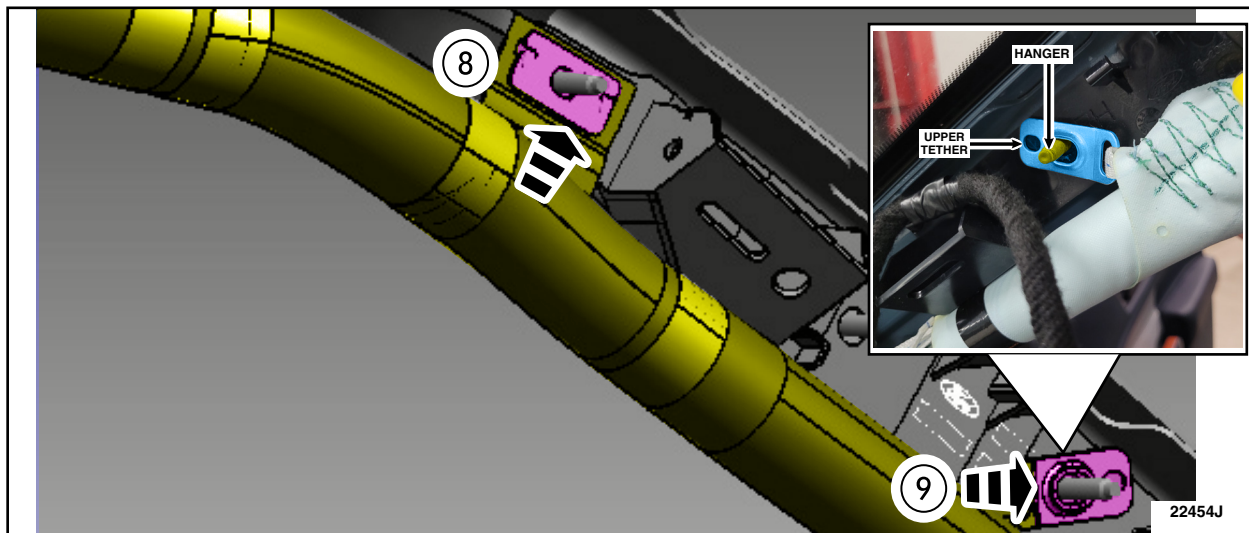
FIGURE 29

31. Attach the *new* side curtain airbag hangers. See Figure 29.

NOTE: Ensure that the upper tether is not twisted during installation.

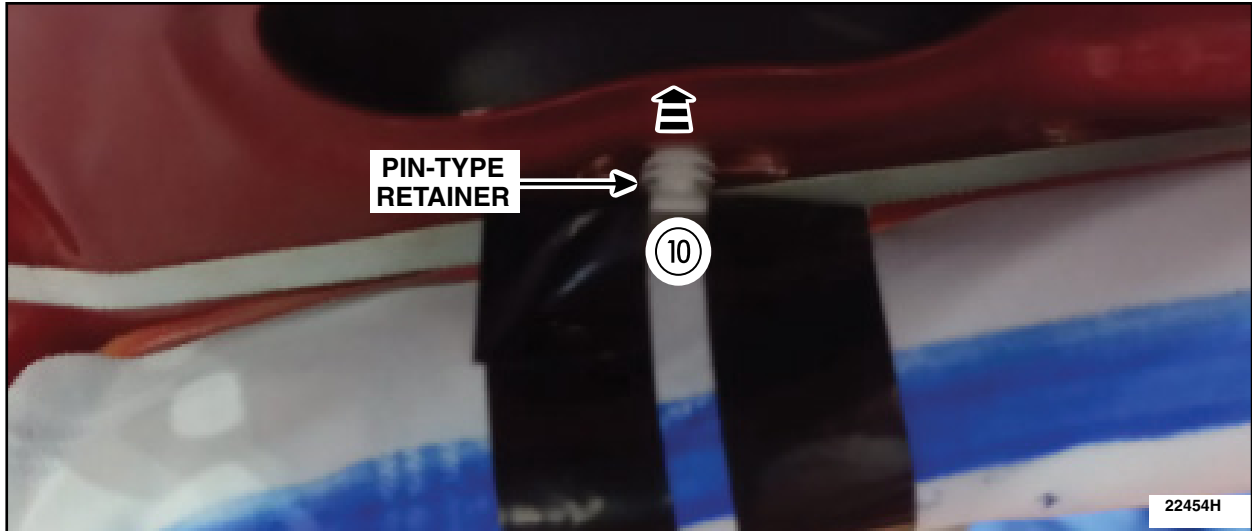
FIGURE 30

32. Attach the *new* side curtain airbag pin-type retainer. See Figure 30.

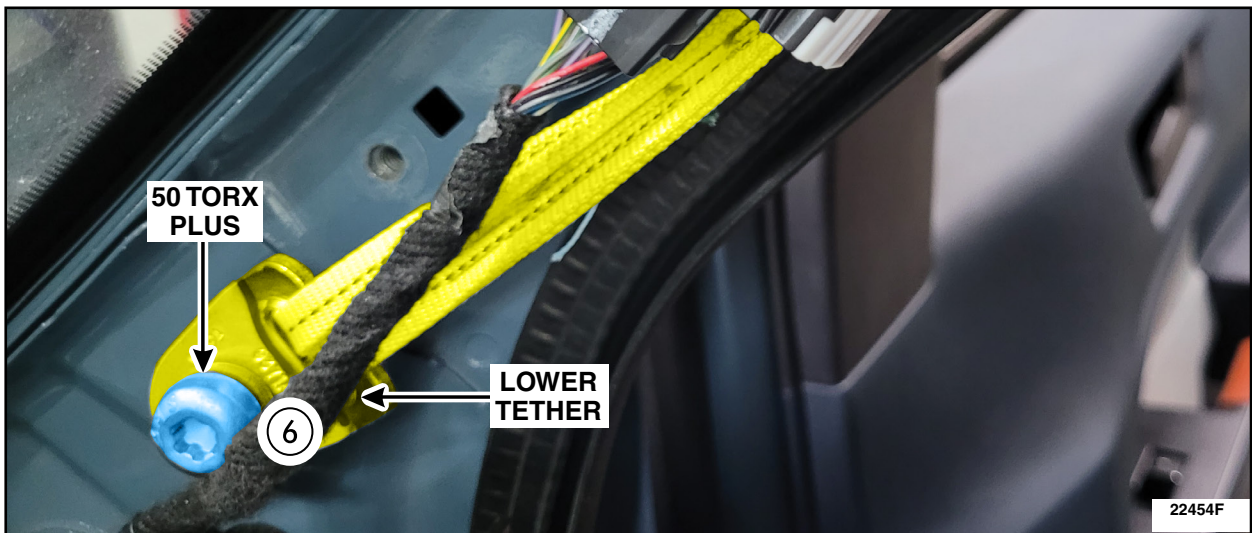
FIGURE 31

33. Using the new 50 torx plus bolt attach the new side curtain airbag lower tether. See Figure 31.

• Torque: 47.5 Nm (35 lb.ft).

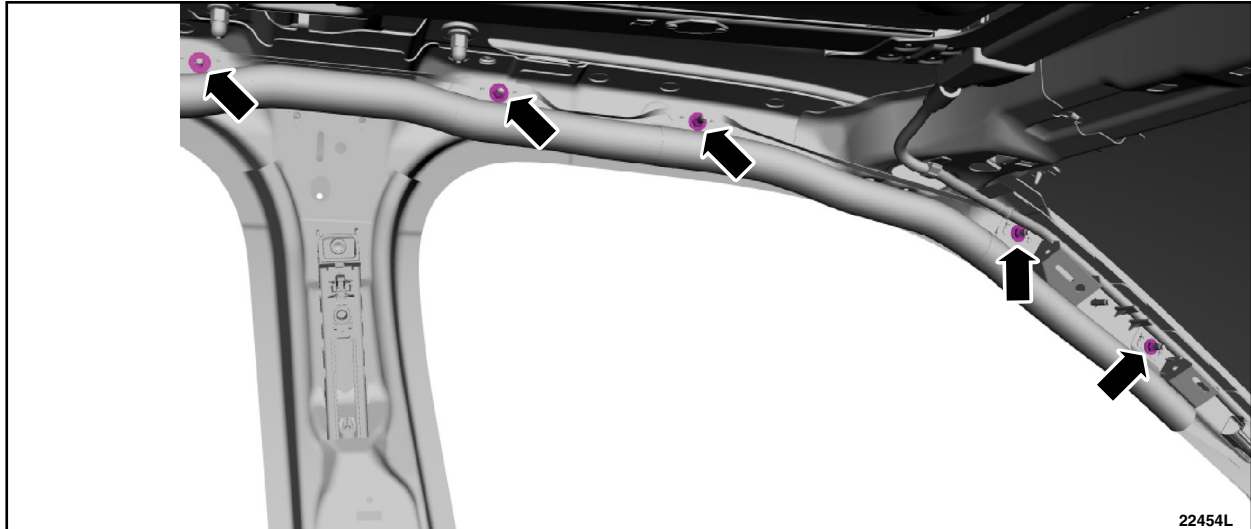
FIGURE 32

34. Install the side curtain airbag nuts. See Figure 32.

- Torque: 9 Nm (80 in.lb).
