January 25, 2023

TO: All U.S. Ford and Lincoln Dealers

SUBJECT: **NEW VEHICLE DEMONSTRATION / DELIVERY HOLD**
Compliance Recall 22C20 - Supplement #1
Certain 2022 Model Year Maverick
Side Airbag Curtain Replacement

CERTAIN 2022 MODEL YEAR MAVERICK VEHICLES — DRIVER AND PASSENGER SIDE CURTAIN AIRBAG REPLACEMENT

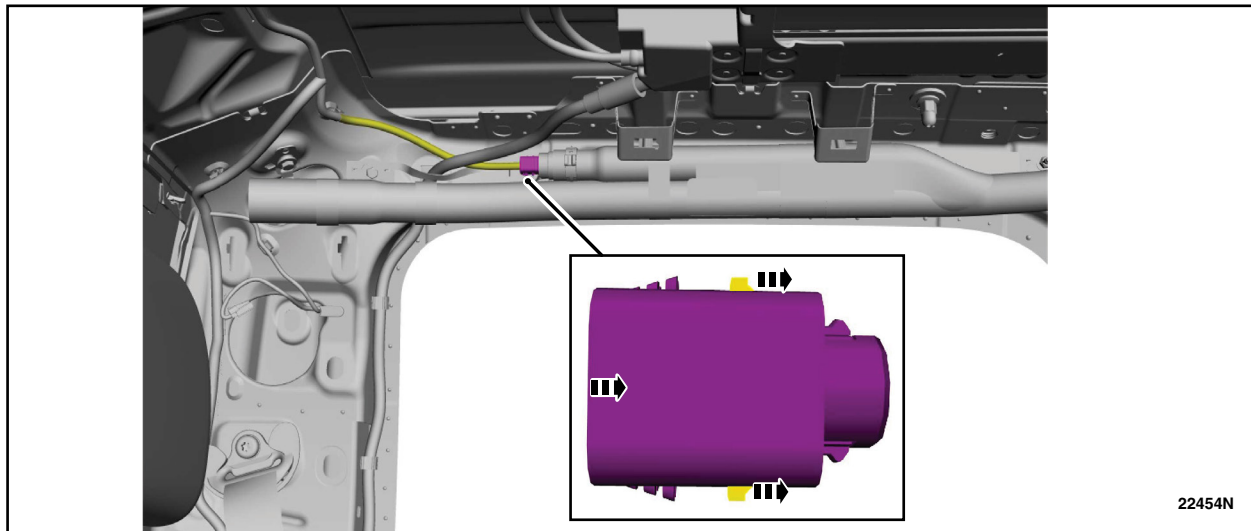
FIGURE 33

35. Connect the side curtain airbag electrical connector and ensure that the spring-loaded locking tabs have engaged. See Figure 33.

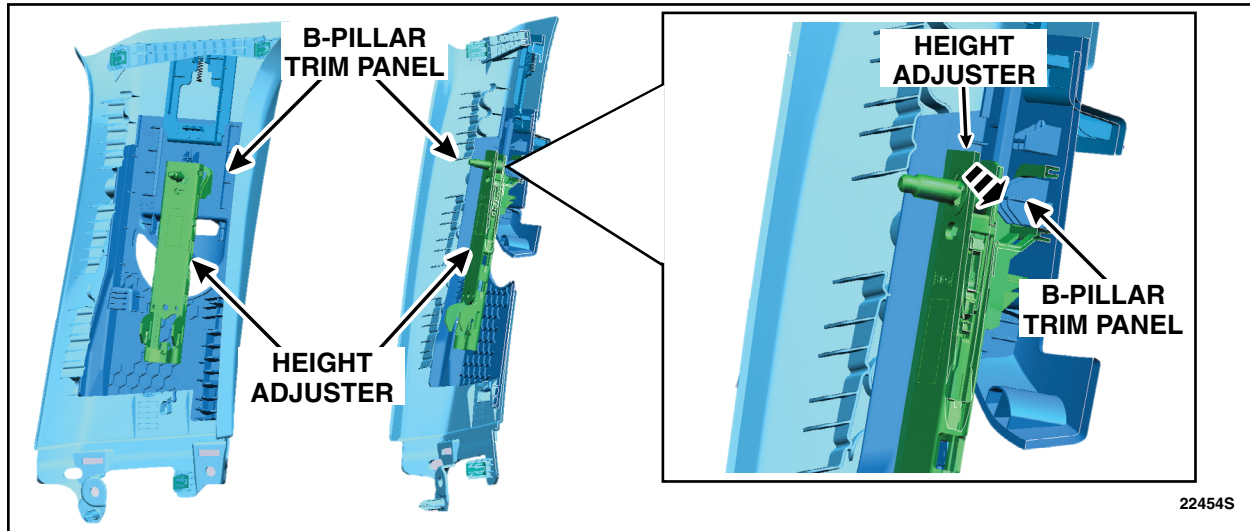
FIGURE 34

NOTE: When installing the B-Pillar upper trim ensure the correct connection between the height adjuster and B-Pillar upper trim. See Figure 34.

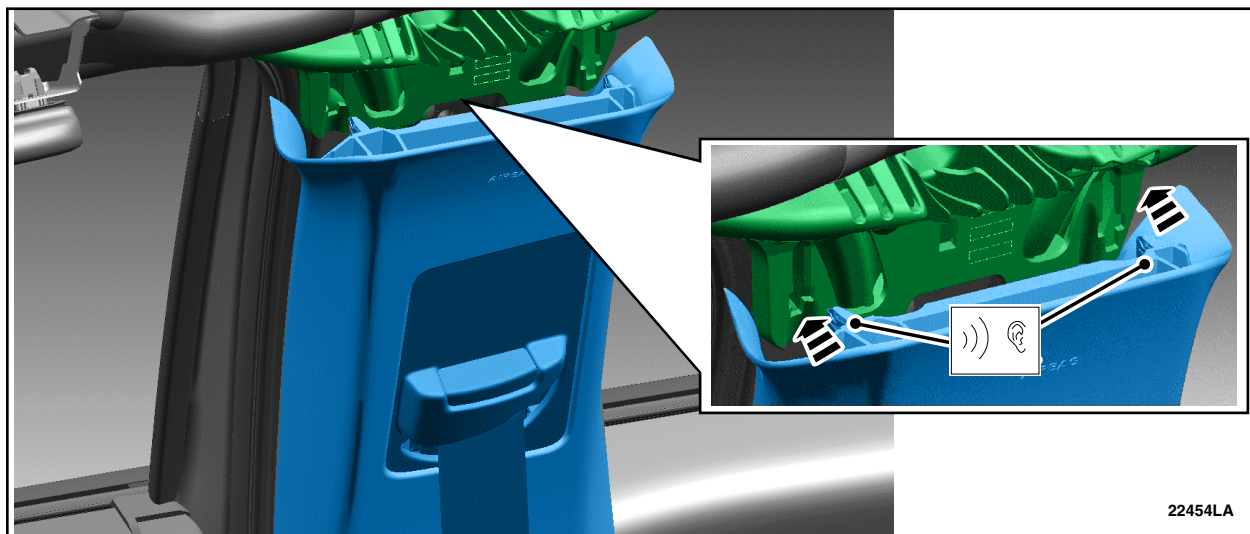
FIGURE 35

NOTE: When reassembled, ensure that the B-pillar clips are correctly inserted in the T shape slots. An audible “click” must be heard when correctly reassembled. See Figure 35.

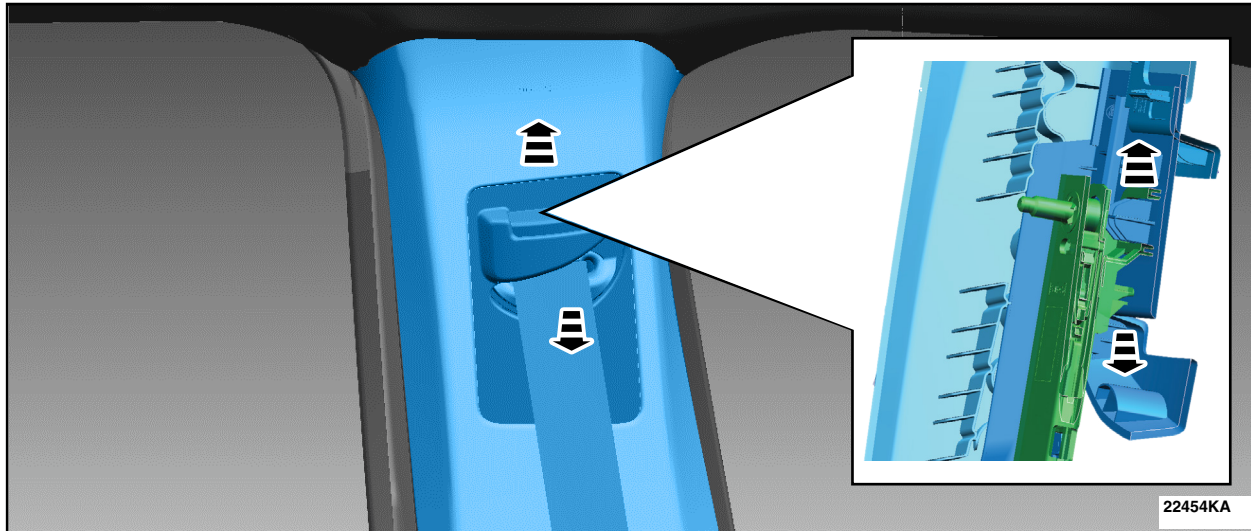
FIGURE 36

38. Slide the B-Pillar Upper Trim, Up and Down three times to ensure they were properly assembled.
See Figure 36.

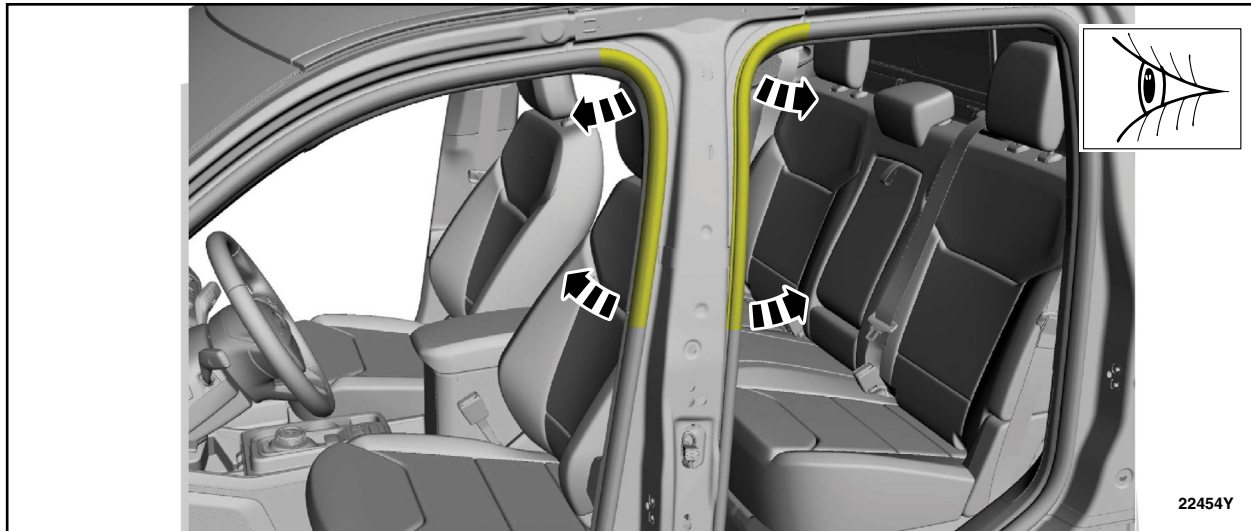
FIGURE 37

39. Inspect and position the front and rear door weather strip lips so that they overlap the top of the B-pillar upper trim panel. See Figure 37.
