David J. Johnson
 Director
 Service Engineering Operations
 Ford Customer Service Division

August 15, 2022

**SUBJECT: NEW VEHICLE DEMONSTRATION / DELIVERY HOLD -
 Safety Recall 22S53**

Certain 2021-2022 Model Year F-150 Vehicles Equipped with Crew Cab, 145" Wheelbase, 4x4, One-Piece Aluminum Driveshaft, and MFAL BHDAA (Less Sound Insulation Packs)* Loose/Sagging Underbody Insulators

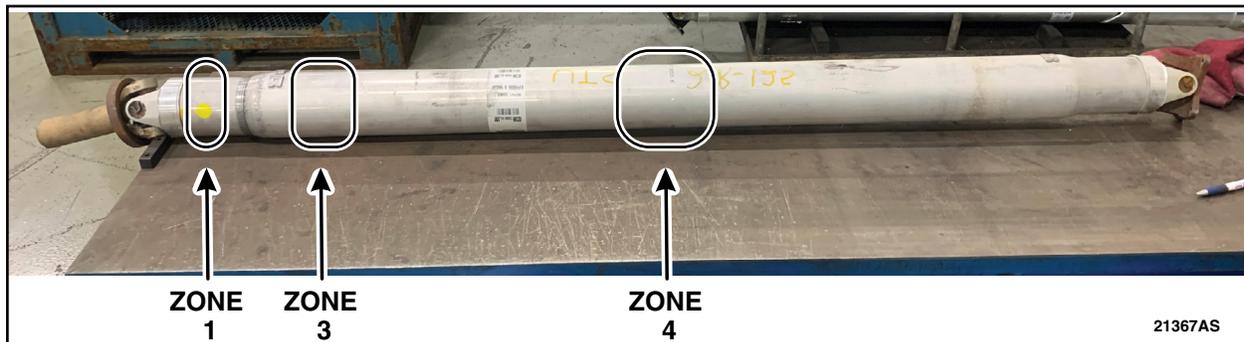
FIGURE 2

- Inspect Zones 1, 3 and 4 of the rear driveshaft for any marks caused by the front and/or rear edges of the passenger side insulator. Are there any marks present in Zones 1, 3 or 4? See Figure 2.

Yes – Proceed to step 6.
No – Proceed to step 8.

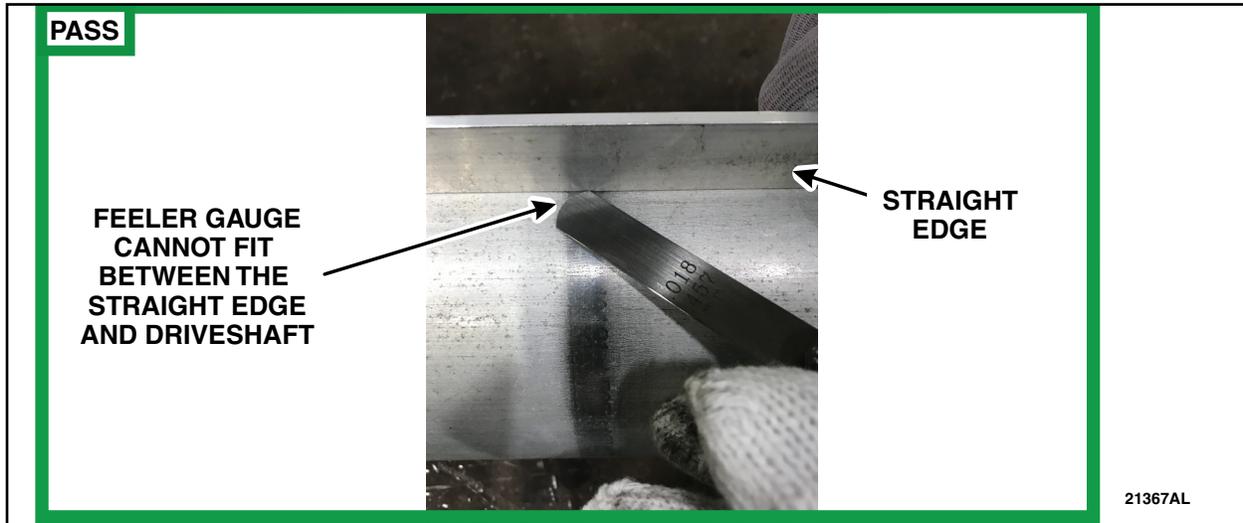
FIGURE 3

- Place a straight edge along the driveshaft over the wear mark and attempt to fit a 0.018in (0.45mm) feeler gauge between the flat edge and the wear mark. Can the feeler gauge fit between the straight edge and anywhere along the wear mark? See Figures 3 and 4.

Yes – Does not pass inspection. Contact the SSSC and provide a picture of the driveshaft with the feeler gauge fitting between the straight edge and wear mark. Once approved, rear driveshaft replacement will be required, but do not install at this time. Proceed to step 10.

No – Passes inspection. Proceed to step 8.

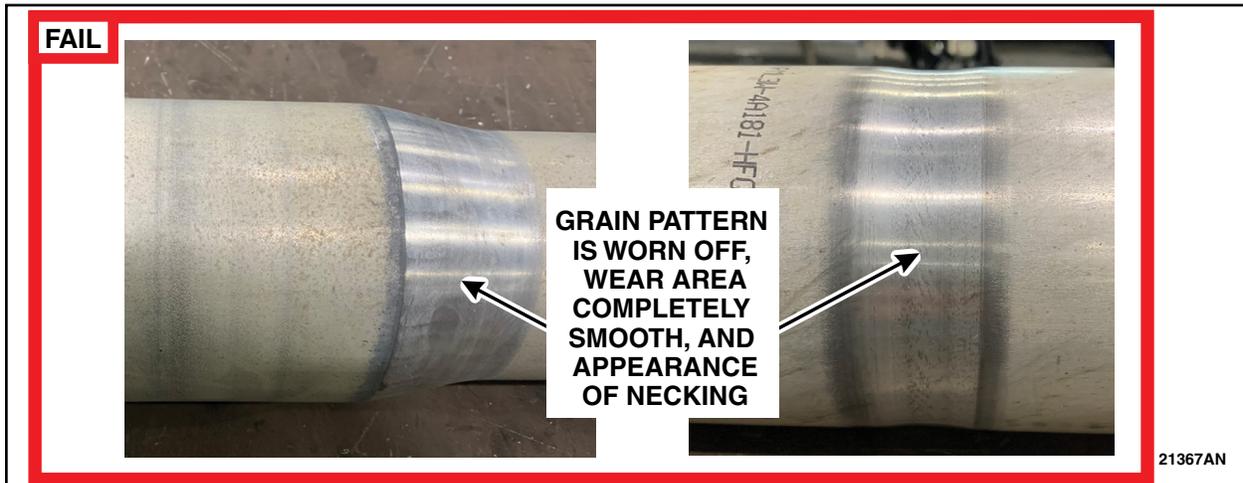
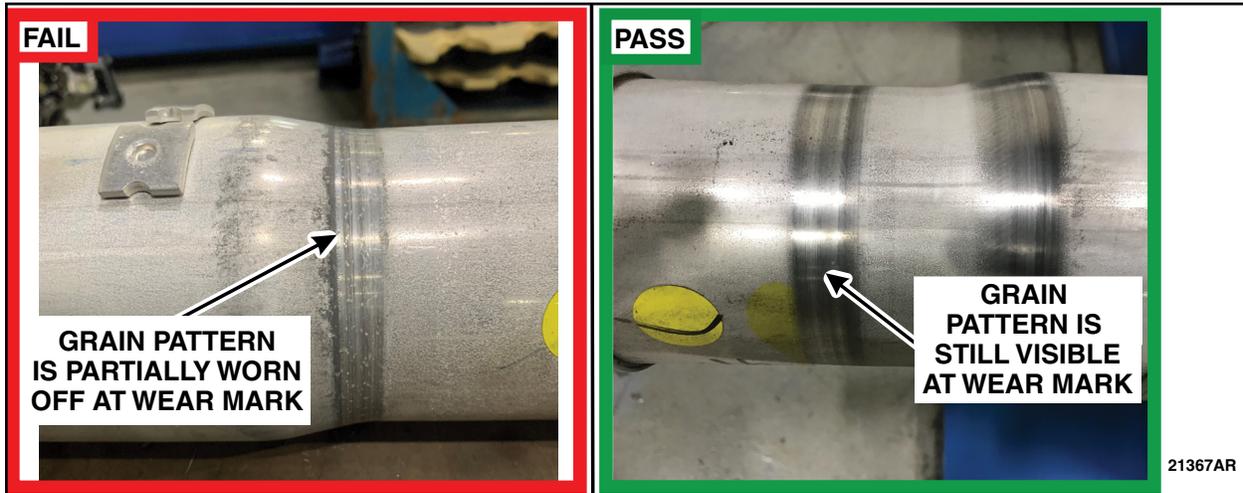
9. Inspect the marks found on Zone 2. Is the aluminum tube surface grain pattern worn off, completely smooth, or have an appearance of necking? See Figures 6 through 9.

Yes – Does not pass inspection. Contact the SSSC and provide a picture of the driveshaft with the grain pattern worn off. Be sure to show a clear image of the grain pattern missing. Once approved, rear driveshaft replacement will be required, but do not install at this time. Proceed to step 10.

No – Passes inspection. Driveshaft may be reused. Proceed to step 10.

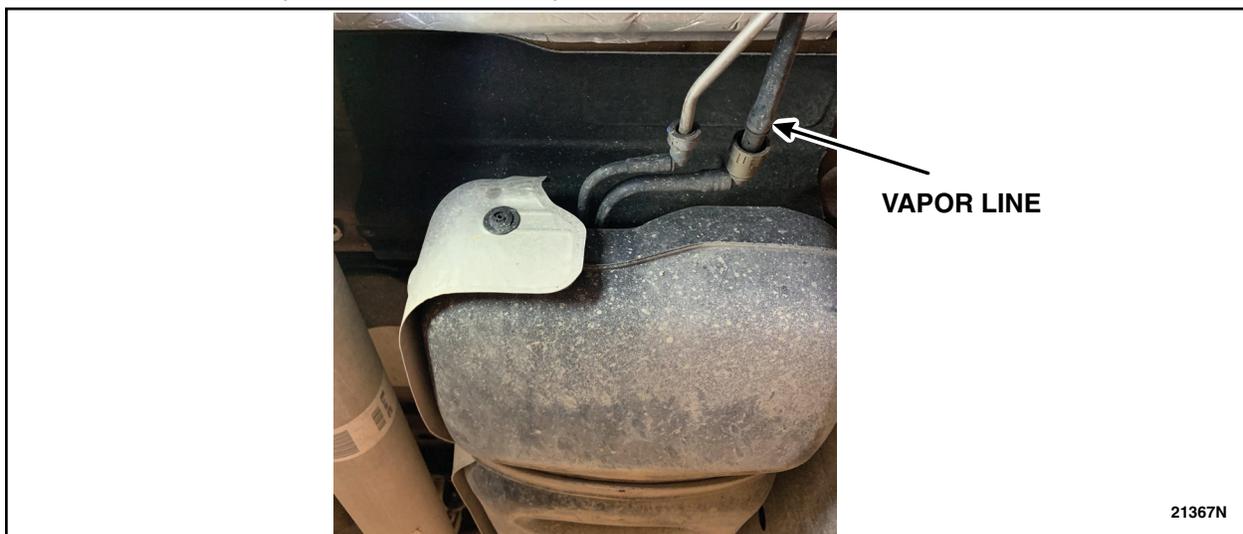
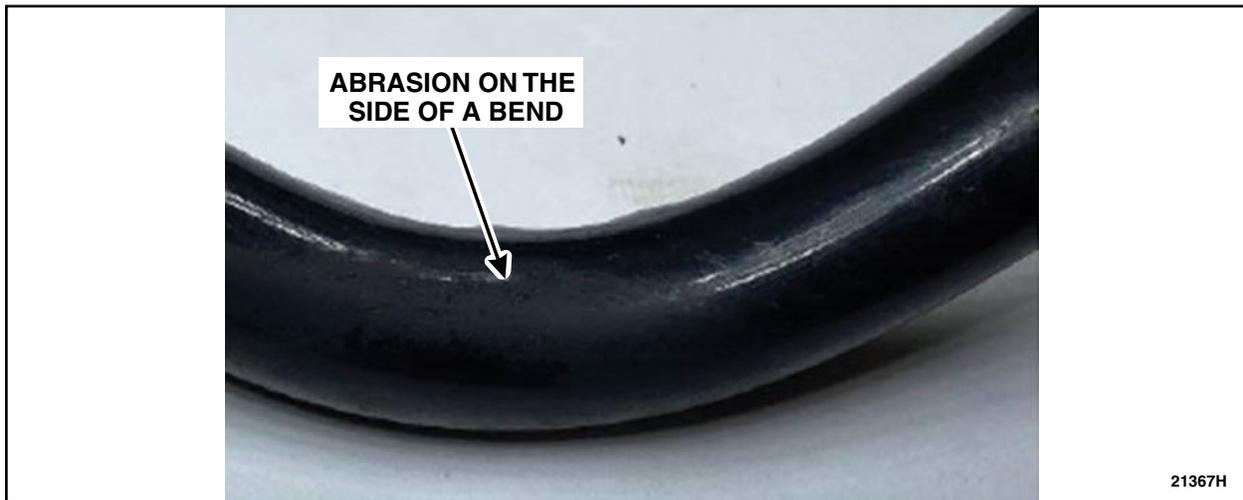
12. Inspect the vapor line for any damage caused by the driver side insulator. Is there any damage to the line? See Figures 11 through 13.

Yes – Does not pass inspection. Replace the damaged line. Please follow WSM procedures in Section 310-01, then proceed to step 13.

No – Passes inspection. Proceed to step 13.

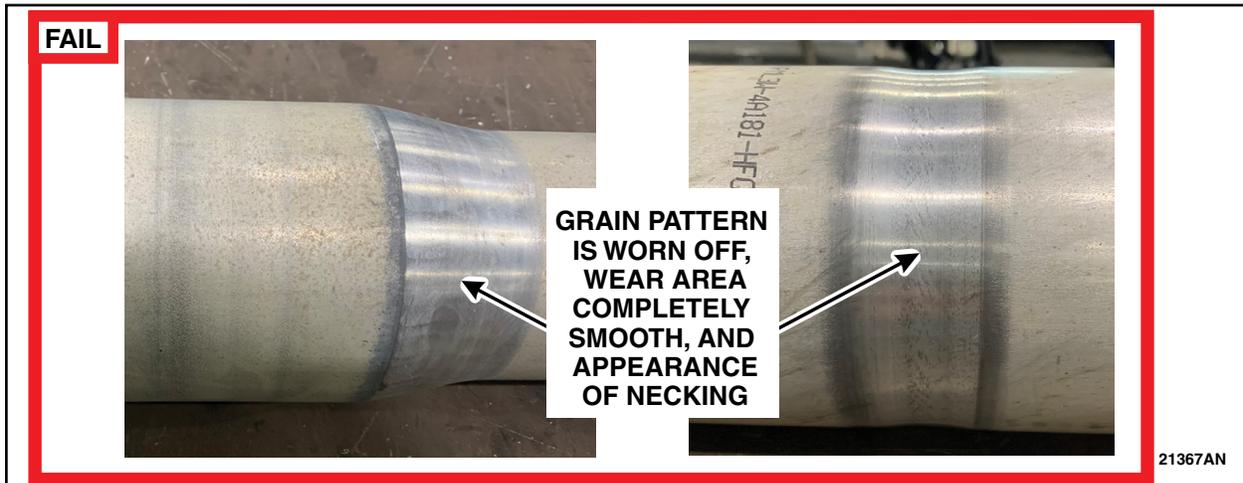
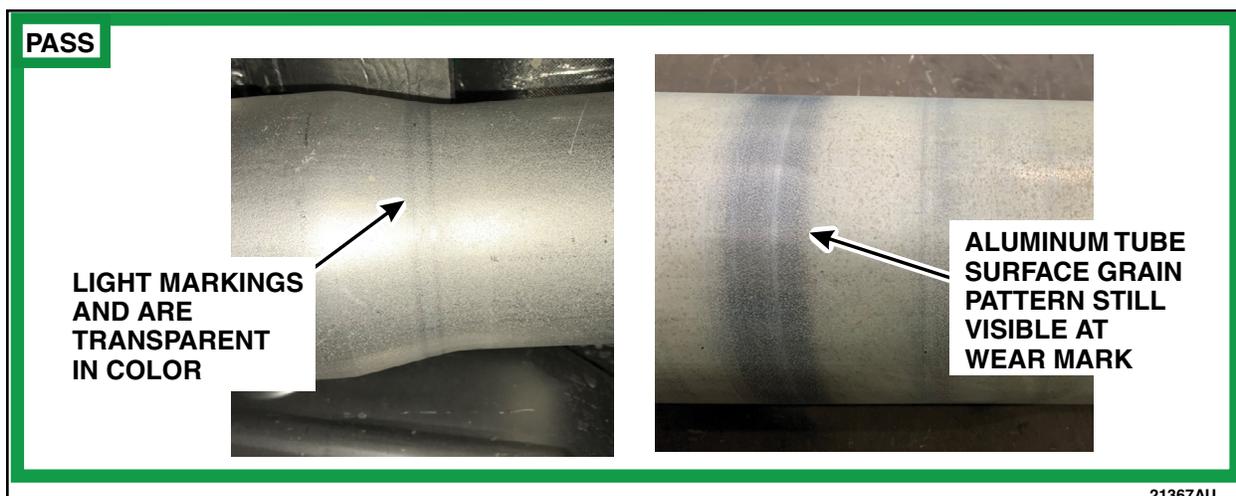
8. Inspect the marks found on Zone 2. Is the aluminum tube surface grain pattern worn off, completely smooth, or have an appearance of necking? See Figures 6 through 9.

Yes – Does not pass inspection. Contact the SSSC and provide a picture of the driveshaft with the grain pattern worn off. Be sure to show a clear image of the grain pattern missing. Once approved, rear driveshaft replacement will be required, but do not install at this time. Proceed to step 9.

No – Passes inspection. Driveshaft may be reused. Proceed to step 9.

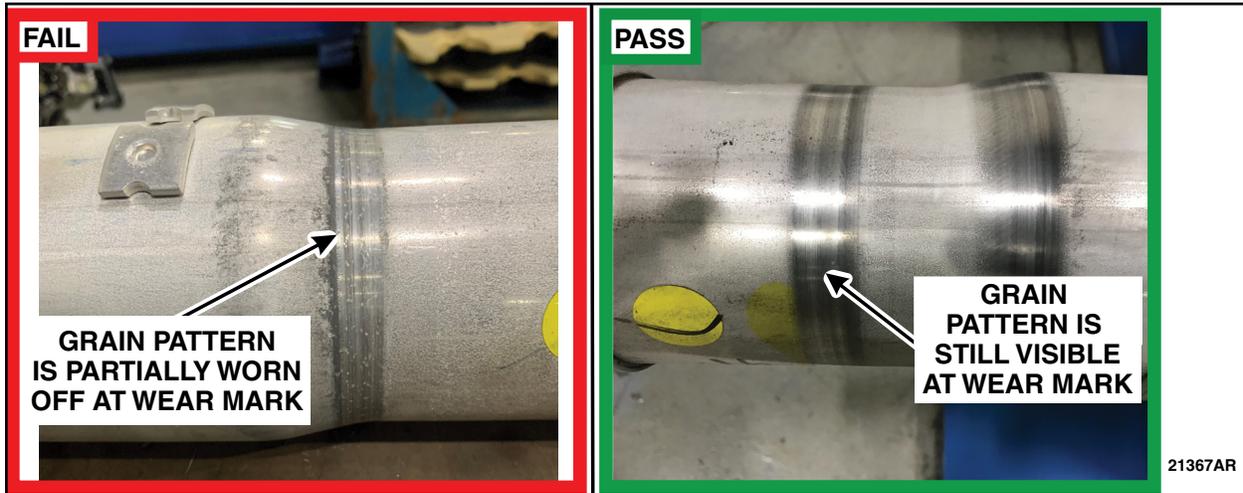
8. Inspect the marks found on Zone 2. Is the aluminum tube surface grain pattern worn off, completely smooth, or have an appearance of necking? See Figures 6 through 9.

No – Passes inspection. Driveshaft may be reused. Proceed to step 9.

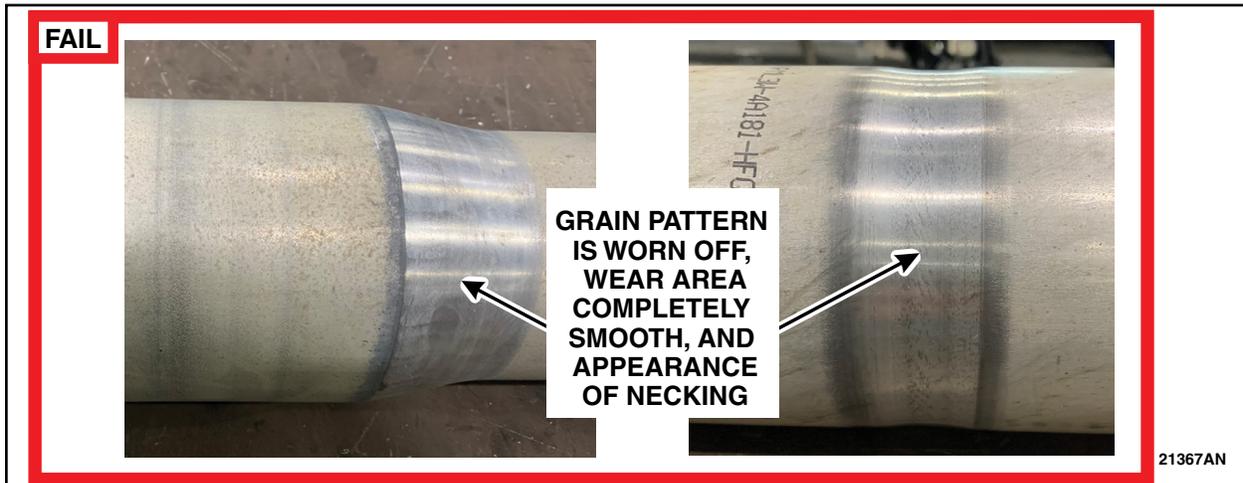
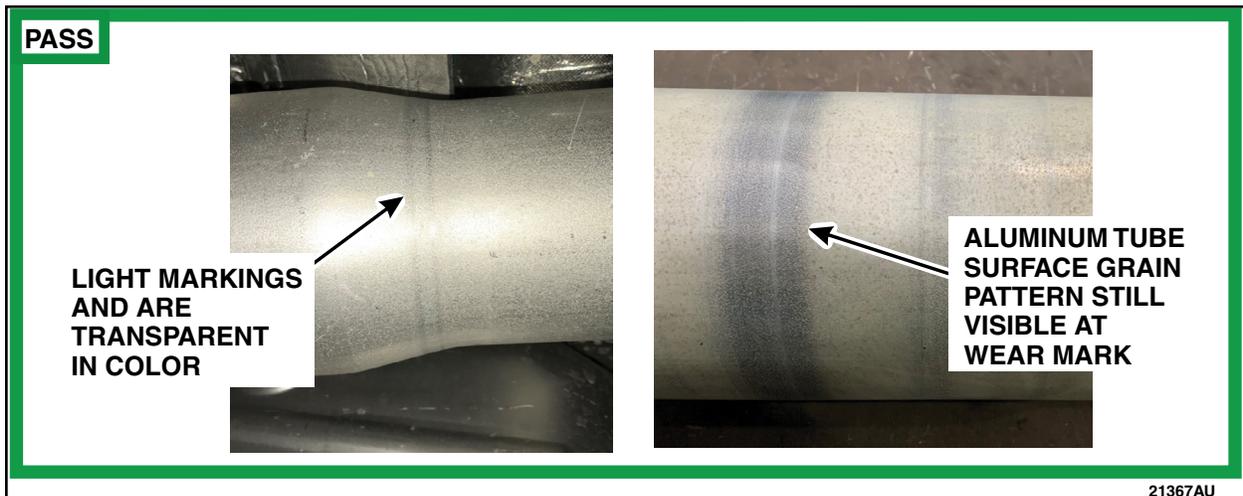
9. Inspect the marks found on Zone 2. Is the aluminum tube surface grain pattern worn off, completely smooth, or have an appearance of necking? See Figures 6 through 9.

No – Passes inspection. Driveshaft may be reused. Proceed to step 10.
