David J. Johnson
 Director
 Service Engineering Operations
 Ford Customer Service Division

**SUBJECT: NEW VEHICLE DEMONSTRATION / DELIVERY HOLD -
 Safety Recall 22S53**

Certain 2021-2022 Model Year F-150 Vehicles Equipped with Crew Cab, 145" Wheelbase, 4x4, One-Piece Aluminum Driveshaft, and MFAL BHDAA (Less Sound Insulation Packs)* Loose/Sagging Underbody Insulators

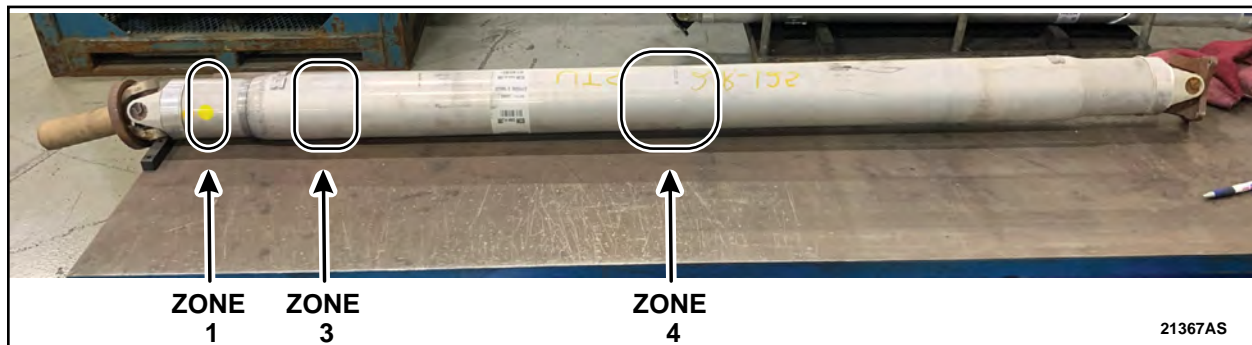
FIGURE 2

- Inspect Zones 1, 3 and 4 of the rear driveshaft for any marks caused by the front and/or rear edges of the passenger side insulator. Are there any marks present in Zones 1, 3 or 4? See Figure 2.

Yes – Proceed to step 6.
No – Proceed to step 8.

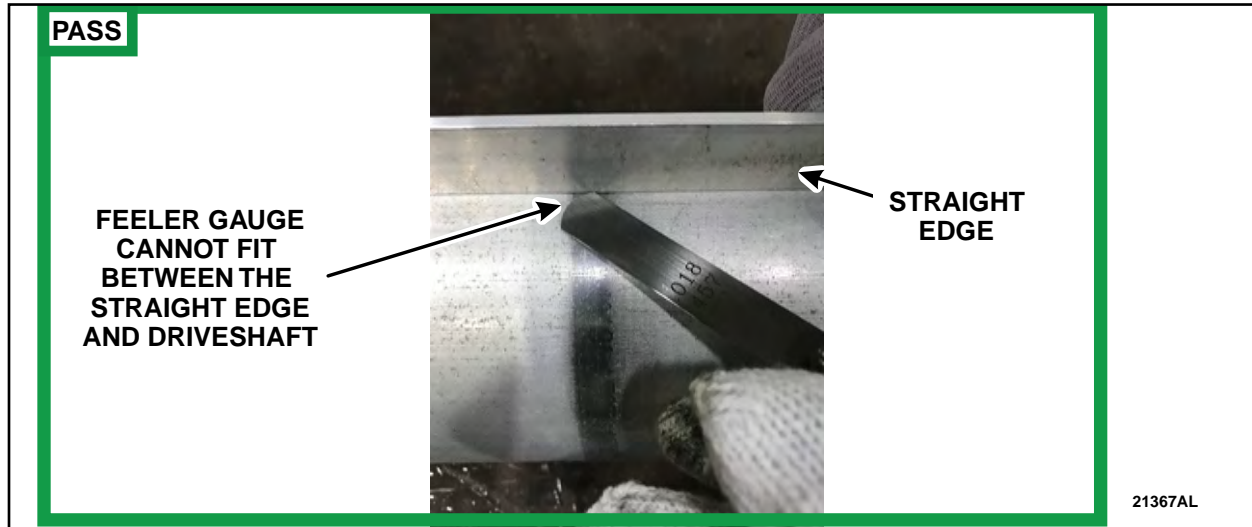
FIGURE 3

7. Place a straight edge along the driveshaft over the wear mark and attempt to fit a 0.018in (0.45mm) feeler gauge between the flat edge and the wear mark. Can the feeler gauge fit between the straight edge and anywhere along the wear mark? See Figures 3 and 4.

Yes – Does not pass inspection. Contact the SSSC and provide a picture of the driveshaft with the feeler gauge fitting between the straight edge and wear mark. Once approved, rear driveshaft replacement will be required, but do not install at this time. Proceed to step 10.

No – Passes inspection. Proceed to step 8.

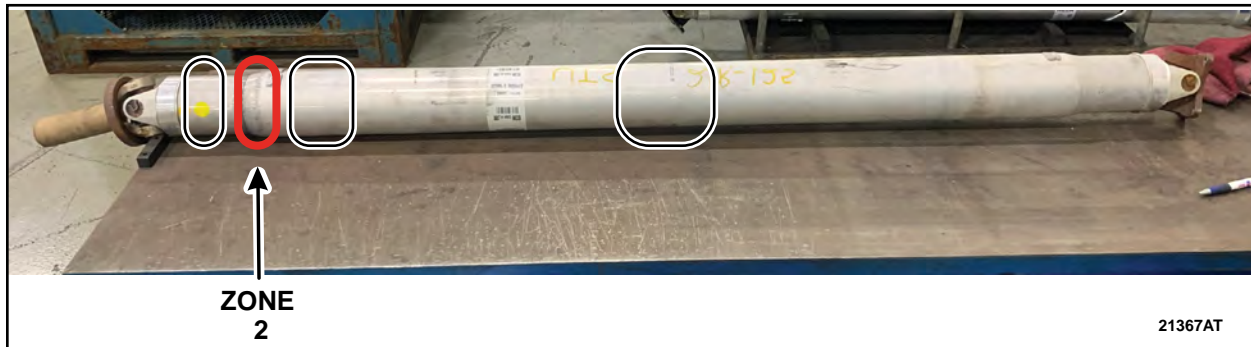
FIGURE 5

8. Inspect Zone 2 (transition from larger tube diameter to smaller diameter section) of the driveshaft tube for any marks caused by the front edge of the passenger side insulator. Are there any marks present? See Figure 5.

Yes – Does not pass inspection. Proceed to step 9.

No – Passes inspection. Driveshaft may be reused. Proceed to step 10.

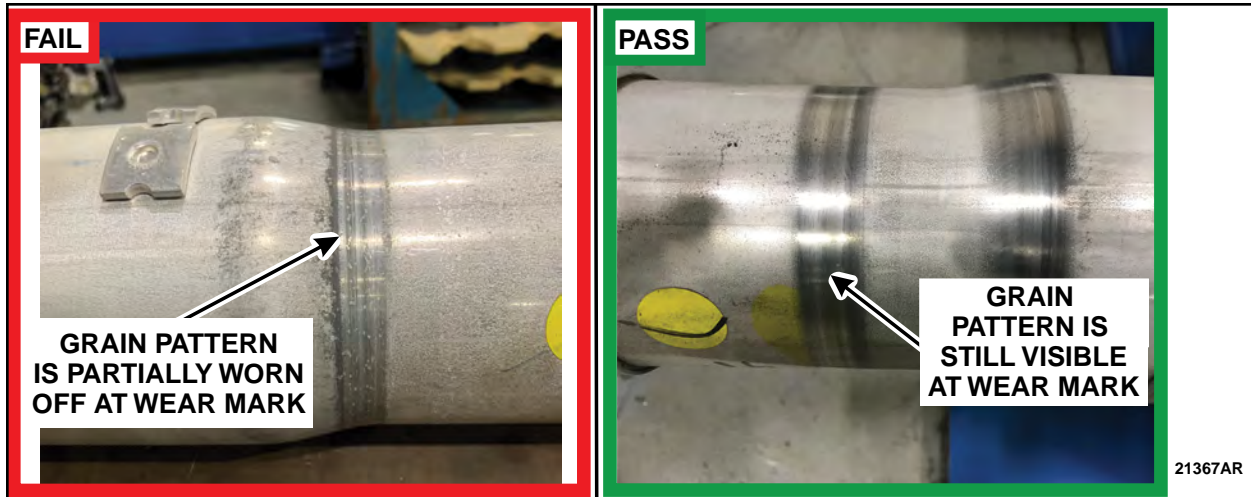
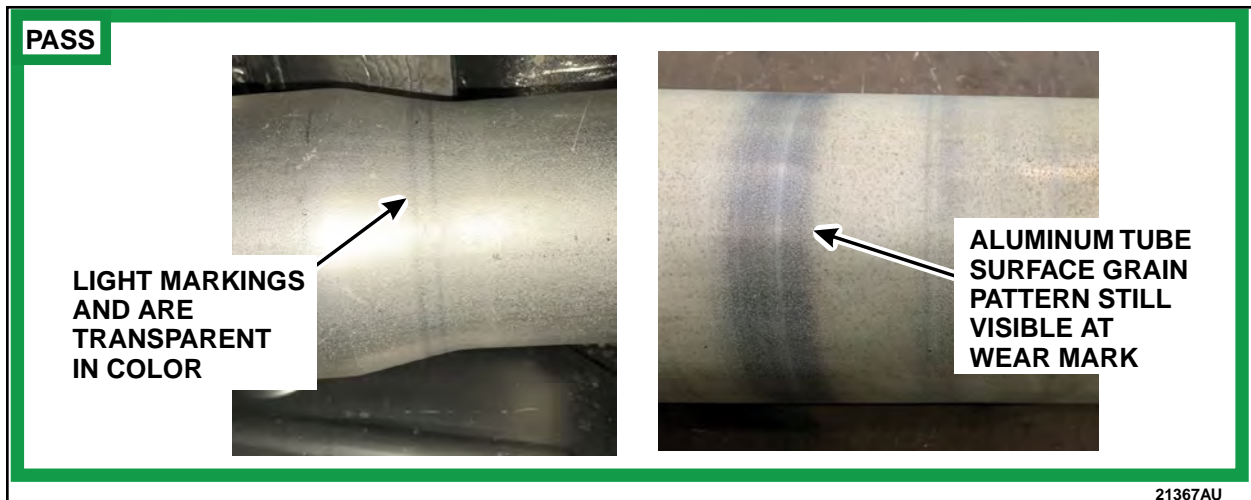
9. Inspect the marks found on Zone 2. Is the aluminum tube surface grain pattern worn off, completely smooth, or have an appearance of necking? See Figures 6 through 9.

Yes – Does not pass inspection. Contact the SSSC and provide a picture of the driveshaft with the grain pattern worn off. Be sure to show a clear image of the grain pattern missing. Once approved, rear driveshaft replacement will be required, but do not install at this time. Proceed to step 10.

No – Passes inspection. Driveshaft may be reused. Proceed to step 10.

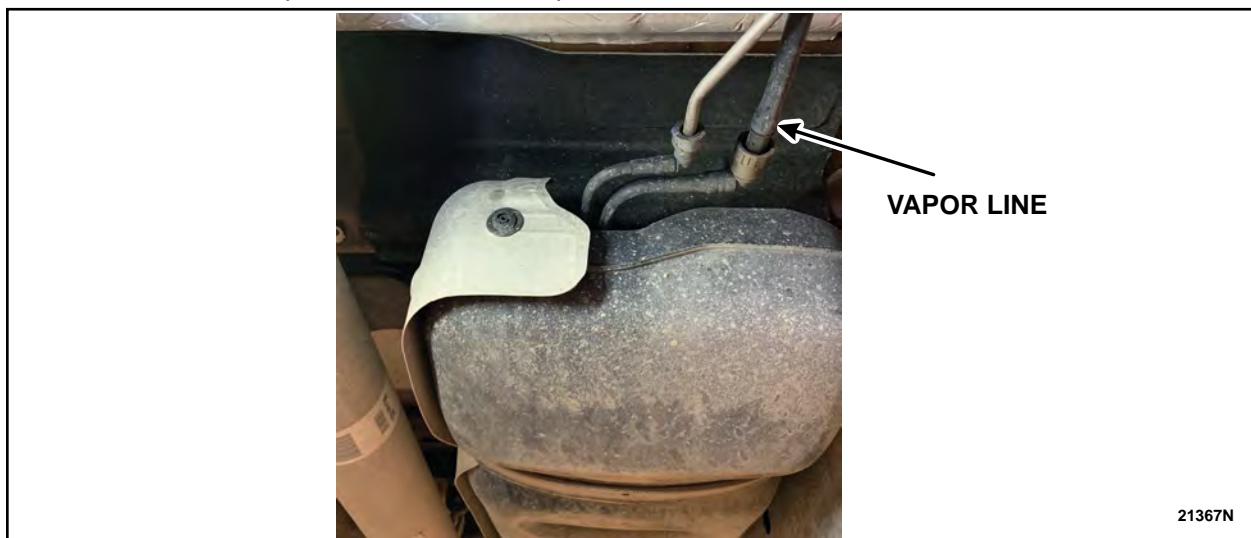
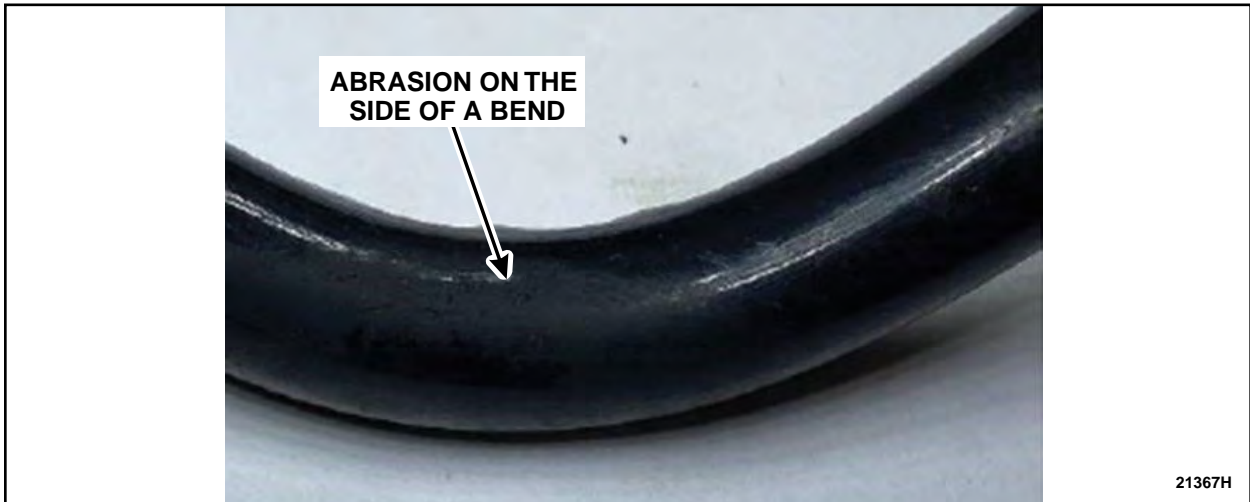
12. Inspect the vapor line for any damage caused by the driver side insulator. Is there any damage to the line? See Figures 11 through 13.

Yes – Does not pass inspection. Replace the damaged line. Please follow WSM procedures in Section 310-01, then proceed to step 13.

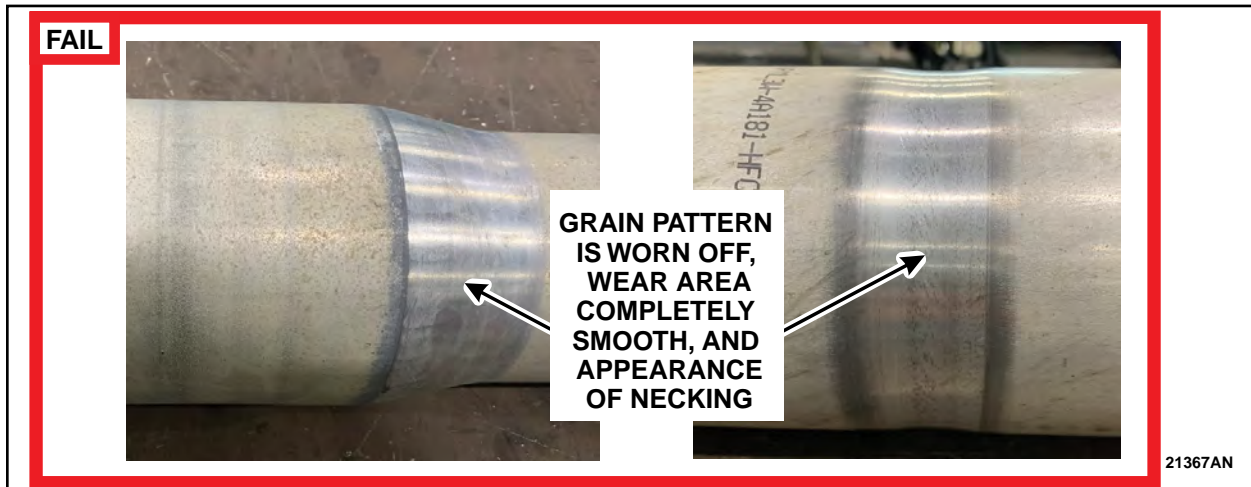
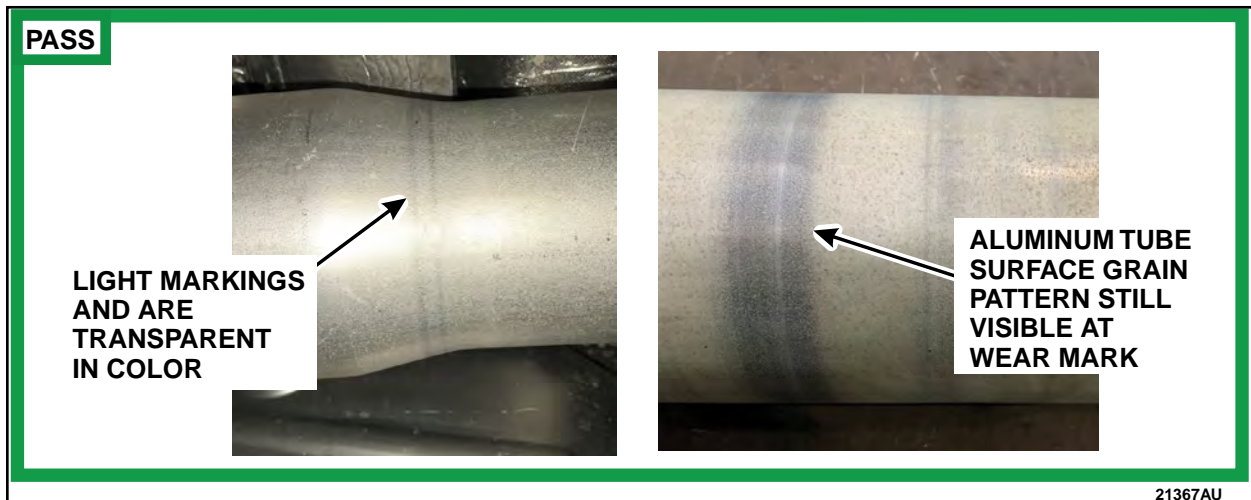
8. Inspect the marks found on Zone 2. Is the aluminum tube surface grain pattern worn off, completely smooth, or have an appearance of necking? See Figures 6 through 9.

Yes – Does not pass inspection. Contact the SSSC and provide a picture of the driveshaft with the grain pattern worn off. Be sure to show a clear image of the grain pattern missing. Once approved, rear driveshaft replacement will be required, but do not install at this time. Proceed to step 9.

No – Passes inspection. Driveshaft may be reused. Proceed to step 9.

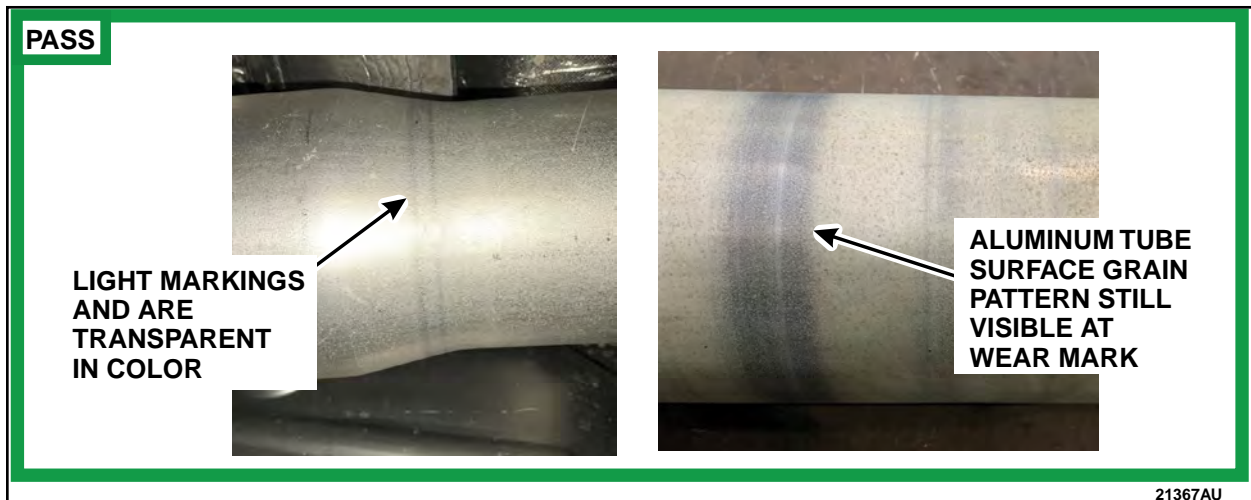
8. Inspect the marks found on Zone 2. Is the aluminum tube surface grain pattern worn off, completely smooth, or have an appearance of necking? See Figures 6 through 9.

No – Passes inspection. Driveshaft may be reused. Proceed to step 9.

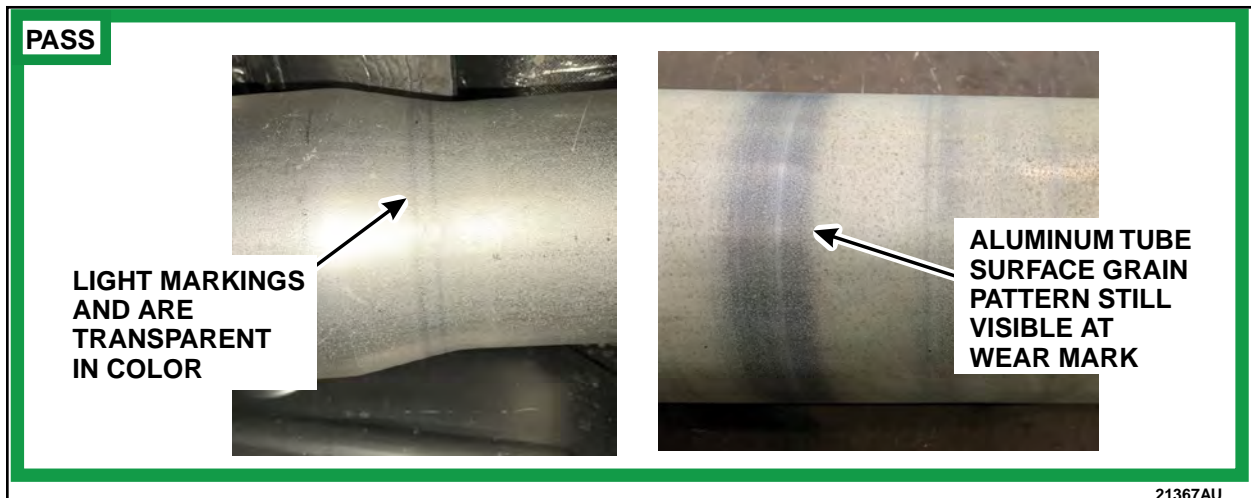
9. Inspect the marks found on Zone 2. Is the aluminum tube surface grain pattern worn off, completely smooth, or have an appearance of necking? See Figures 6 through 9.

No – Passes inspection. Driveshaft may be reused. Proceed to step 10.
