TO: Mercedes-Benz Dealer Principals, General Managers, Sales Managers, Service Managers, Parts Managers	FROM: Gregory Gunther, Department Manager, Vehicle Compliance and Analysis, Engineering Services
RE: Recall Campaign - Launch Notification Check Mounting of Rear Door Trim Bar MY20-22 GLE-Class and GLS-Class (W167 and X167 platform)	DATE: October 14, 2022

Campaign No. 2022090010, October 2022

SUBJECT: **Models GLE-Class and GLS-Class (W167, X167 platform)
Model Year 2020-2022**

Check Mounting of Rear Door Trim Bar

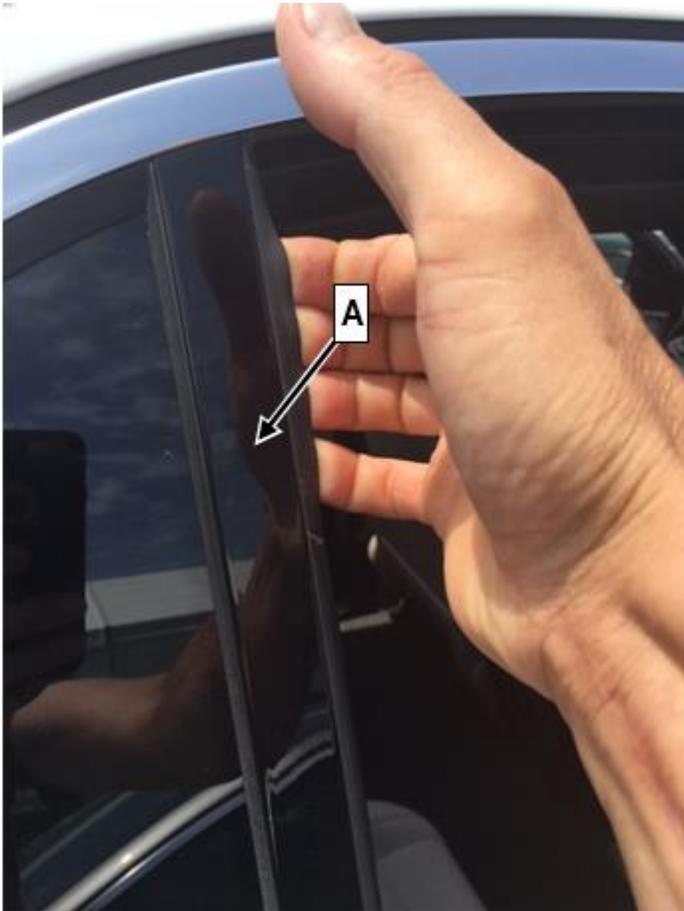
Figure 1

1. Lower side window on the right and left rear doors.
 2. Check whether right and left window dividers (A, Figure 1) are seated tightly.
 - i** To do so, grasp the window divider in the upper area with your hand (Figure 1) and support it with your thumb on the fixed window (see Figure 2). Then pull the window divider outward carefully (**approx. 100 N / 22.5lbs of force**) and check whether it is seated tightly.
 - i** The window divider must **not** work loose.
- Ensure that the window divider is **not** jammed under the trim bar on the window frame (B, Figure 2). This could cause a test error with regard to the holding ability of the trim element on the window divider. A gap of 1 mm from the window divider (A) to the window frame (B) is normal.

- a. Window divider (A) works loose: Carry out **check/test procedure B**.
- b. Window divider (A) does **not** work loose: **End measure**.

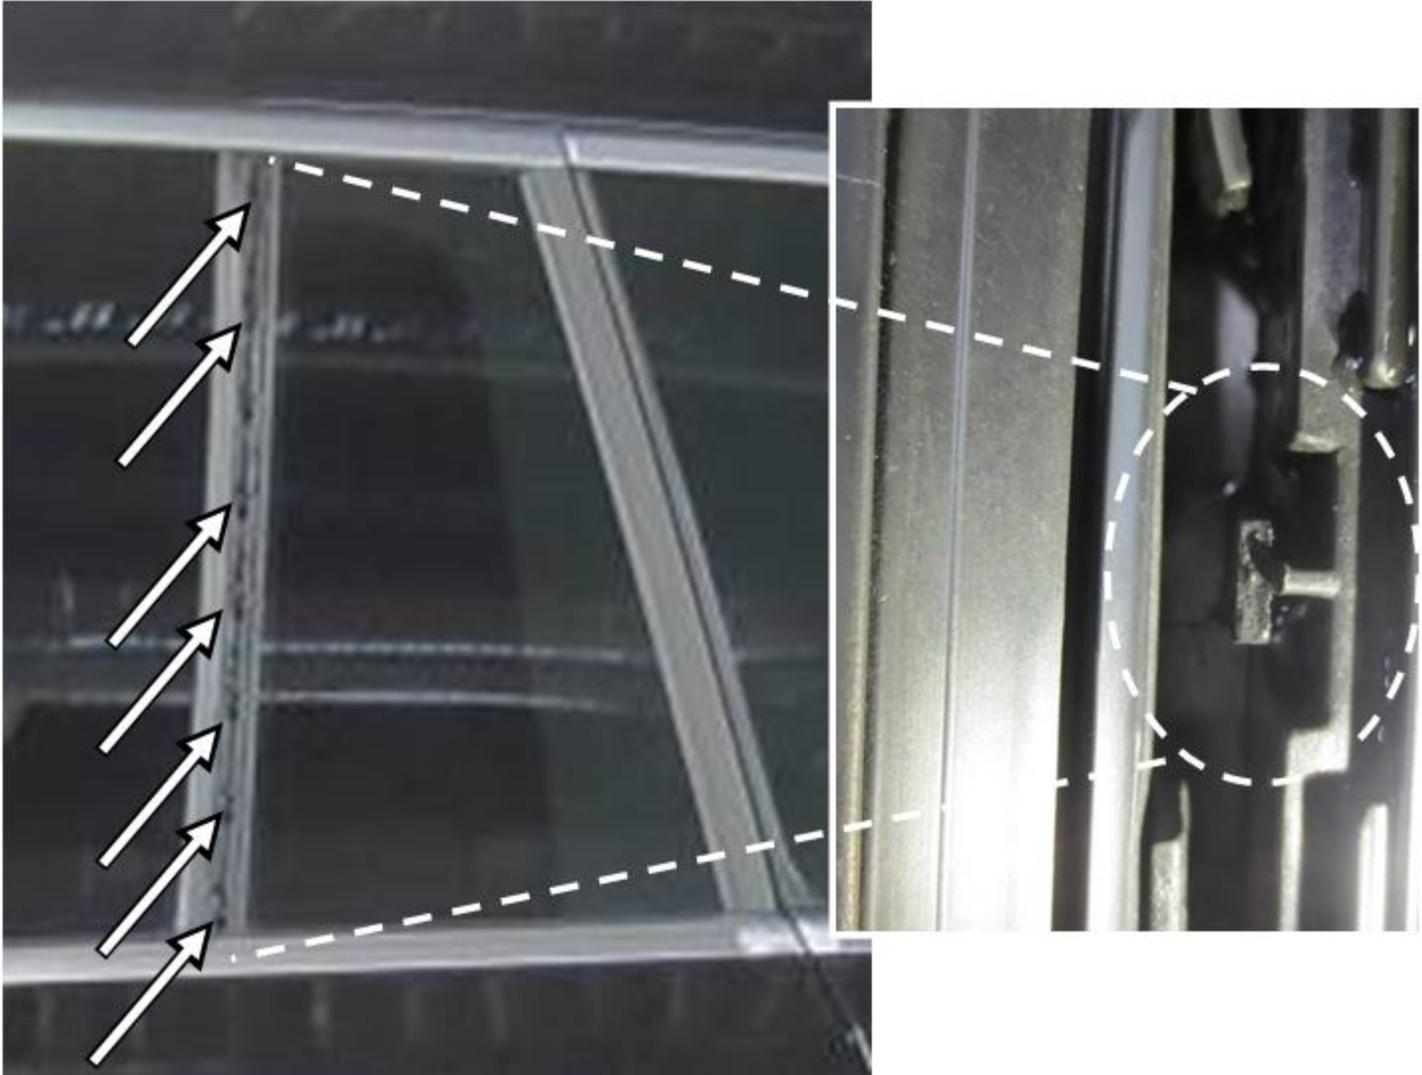
Figure 3

1. Remove window divider completely and check **holder for window divider** on frame of triangular window.

i If no damage is visible, reinstall window divider and check again whether it is tightly seated

a. Holder for window divider broken: Carry out **work procedure**.

b. Holder for window divider **not** broken: **End measure**.

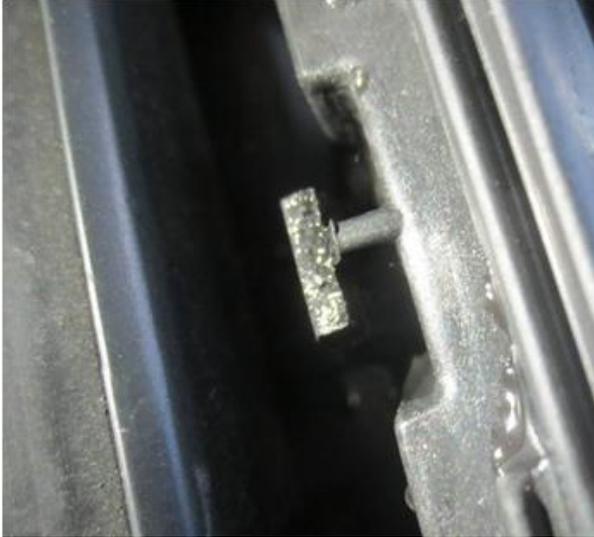
Figure 4

i One or multiple holders for the window divider on the frame of the triangular window are broken (Figure 4).

1. Replace corresponding triangular window of rear door with loose window divider.
