**SUBJECT:** **NEW VEHICLE DEMONSTRATION / DELIVERY HOLD**  
**Compliance Recall 22C22 - Supplement #1**  
 Certain 2022 Model Year Bronco Sport and F-150 Vehicles  
 Front Park Lamp Flicker

**NEW VEHICLE DEMONSTRATION / DELIVERY HOLD**  
**Compliance Recall 22C22 - Supplement #1**  
Certain 2022 Model Year Bronco Sport and F-150 Vehicles  
Front Park Lamp Flicker

## CERTAIN 2022 MODEL YEAR BRONCO SPORT AND F-150 VEHICLES — PARK LAMP FLICKER

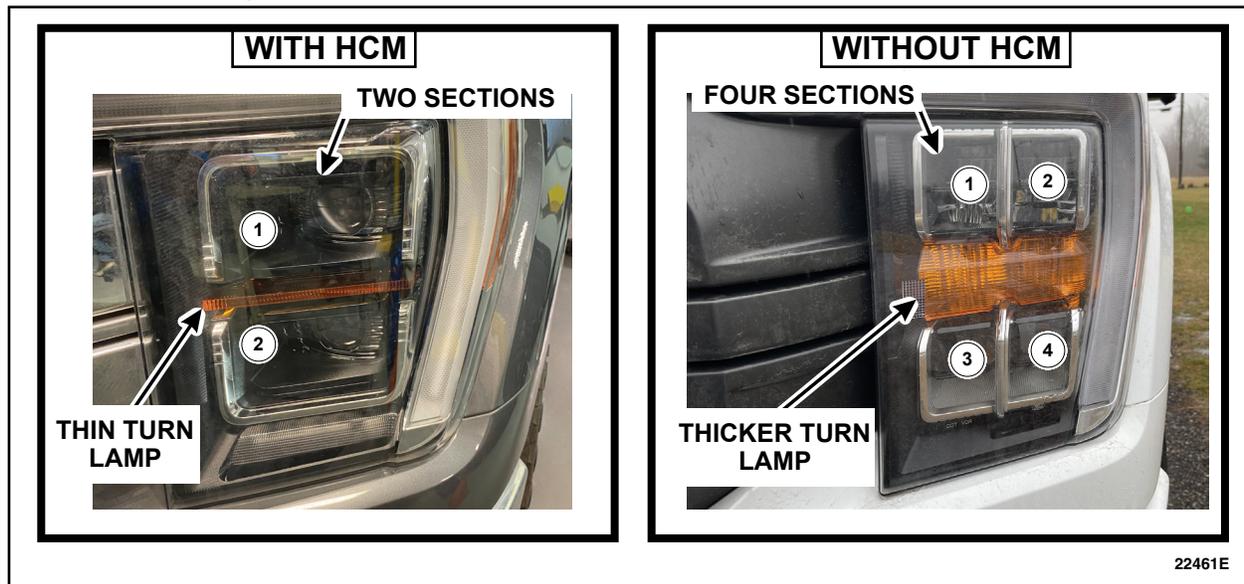
**FIGURE 1**

**With** HCM Identification: Headlamp is split into 2 sections and has a thin turn lamp.  
- Proceed to the *two step* HCM Reprogramming Procedure on Page 8.

**Without** HCM Identification: Headlamp is split into 4 sections and has a thicker turn lamp.  
- Proceed to the *Non-HCM Light Emitting Diode (LED) Control Module Inspection* on Page 2.

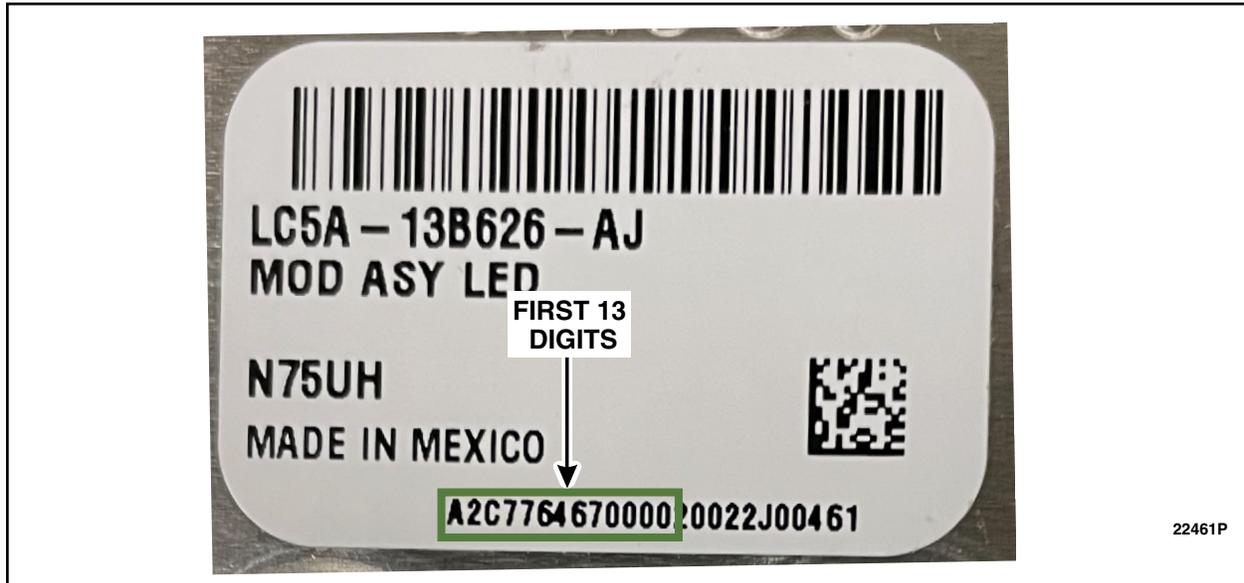
FIGURE 5

9. Does either the LH or RH label EXACTLY match the 13 digits of one of the label numbers on the list above? See Figure 5 for an example that does not match.

6. Take a CLEAR photo of the label with the 13-digit number on the LED module as shown in Figure 5.
7. Repeat steps 4 – 6 on the Right Land (RH) side.
8. Compare both RH and LH 13 digit label numbers to the list below.
