TO: Mercedes-Benz Dealer Principals, General Managers, Sales Managers, Service Managers, Parts Managers	FROM: Gregory Gunther, Department Manager, Vehicle Compliance and Analysis, Engineering Services
RE: <b>Recall Campaign Launch Notification</b> <b>Install 12 Volt Battery Support</b> <b>MY19-22 CLS-Class and E-Class</b> <b>(257 and 213 platform)</b>	DATE: December 21, 2022

Campaign No. 2022100009, December 2022

SUBJECT: **Model CLS-Class and E-Class (257 and 213 platform)**  
**Model Year 2019-2022**

## **Install 12 Volt Battery Support**

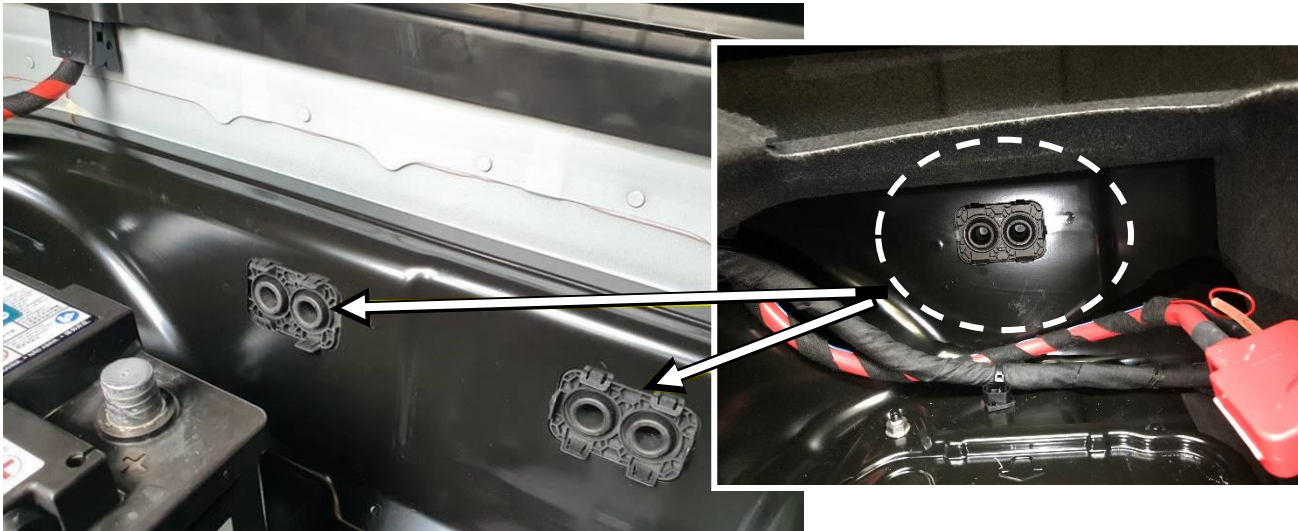
3. Check whether there is an opening with cap (figure 2) behind the battery in the spare wheel well.

- i** If an opening with cap exists, the replacement part must be adapted as described in **work procedure C!**
- i** If **no** opening with cap exists, continue with operation step 4.

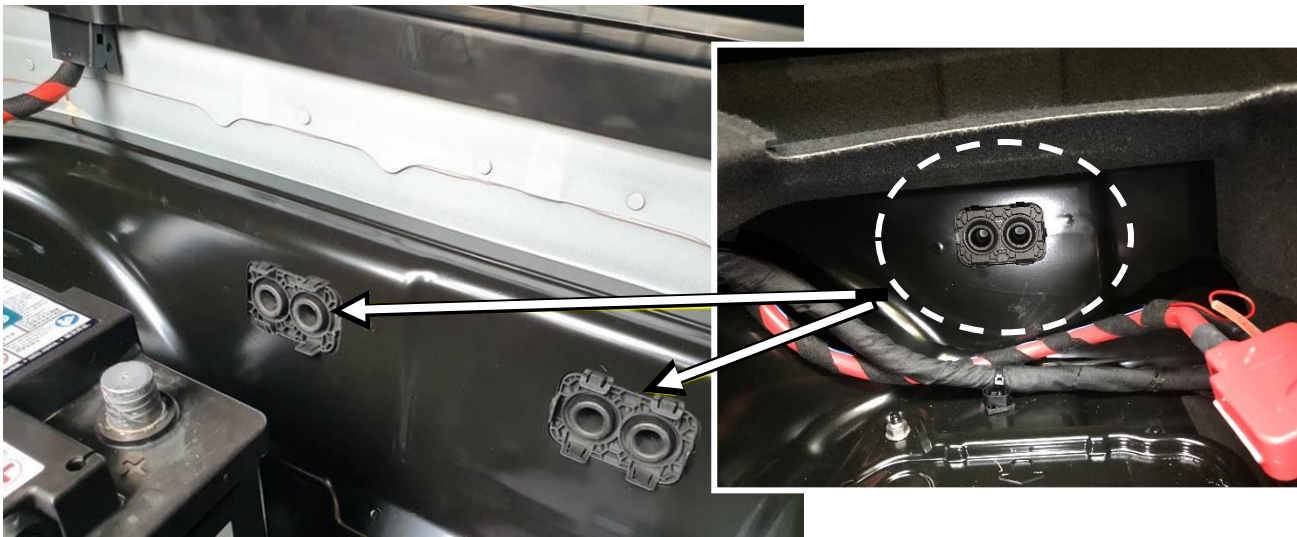
3. Check whether there is an opening with cap behind the battery in the spare wheel well.  
**i** If an opening with cap exists (figure 6), the replacement part must be adapted as described in **work procedure C before the installation!**  
**i** If **no** opening with cap exists, continue with operation step 4.

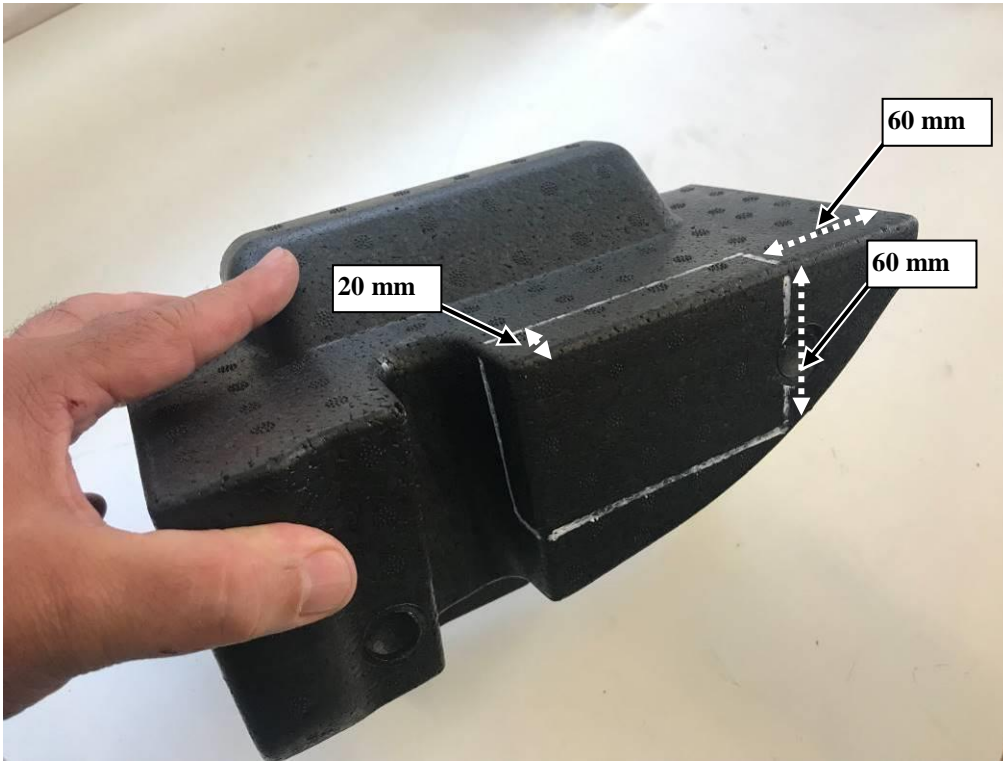
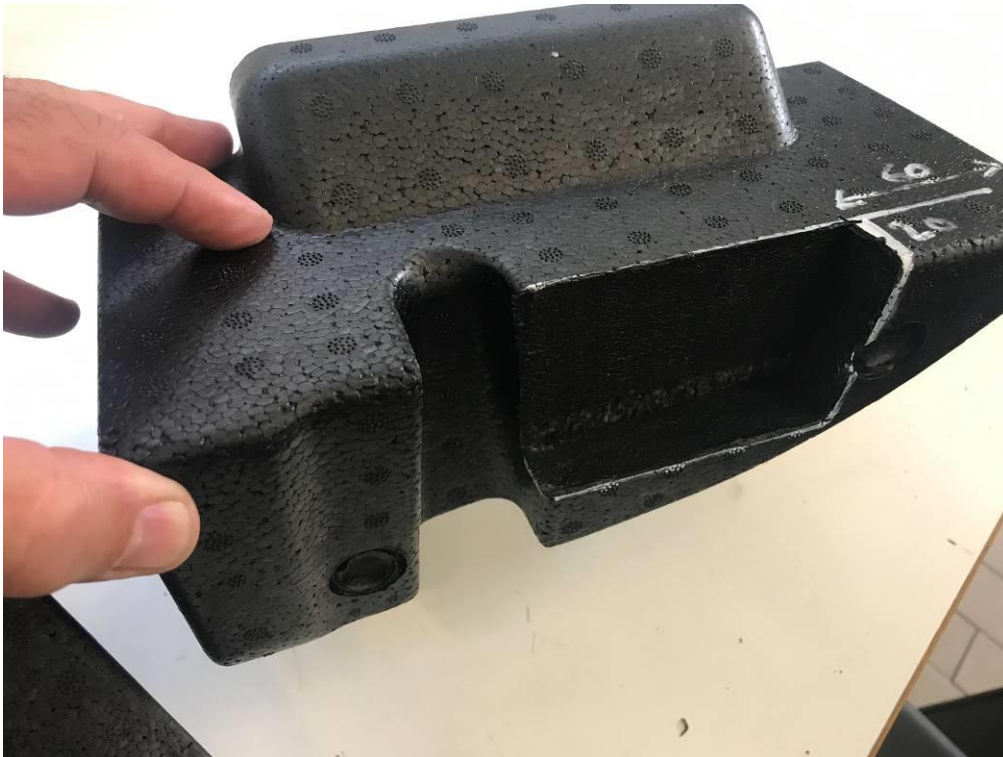
**i** Adaptation of battery support due to spare wheel well with opening and cap.

1. Cut out battery support as shown.
