FL958 A-H

| NHTSA # | 2025 22V-817 |

Subject: Brake Modulator Valves

Models Affected: Specific model years 2017-2023 Freightliner 114SD, Business Class M2, and Cascadia; and Western Star 47X, 49X, and 57X vehicles, manufactured May 3, 2016, through June 18, 2022.

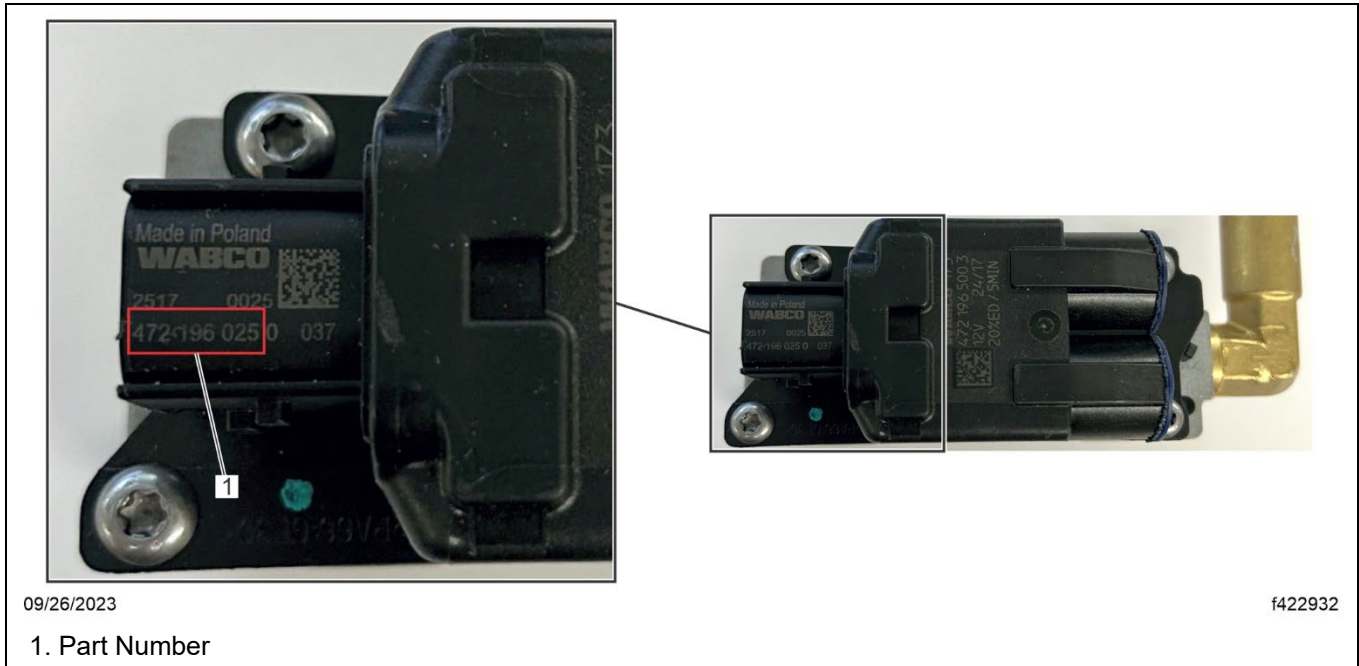
Fig. 1, Modulator Valve

NOTE: Both the left- and right-hand modulator valves must be inspected. If either one of the modulator valves is bad, replace both modulator valves.

- If the part numbers are good, install the connector. Clean a spot on the base label (Form WAR259), and attach a campaign completion sticker for FL958 (Form WAR260), indicating this work has been completed.
- If at least one of the part numbers is bad, go to the replacement procedure for the specified group, and replace both the modulator valves.
