January 2024
FL958A-G
NHTSA #22V-817
Transport Canada #2022-626
SECOND REVISED BULLETIN

Subject: Brake Modulator Valves

Models Affected: Specific model years 2017-2023 Freightliner 114SD, Business Class M2, and Cascadia; and Western Star 47X, 49X, and 57X vehicles, manufactured May 3, 2016, through June 18, 2022.

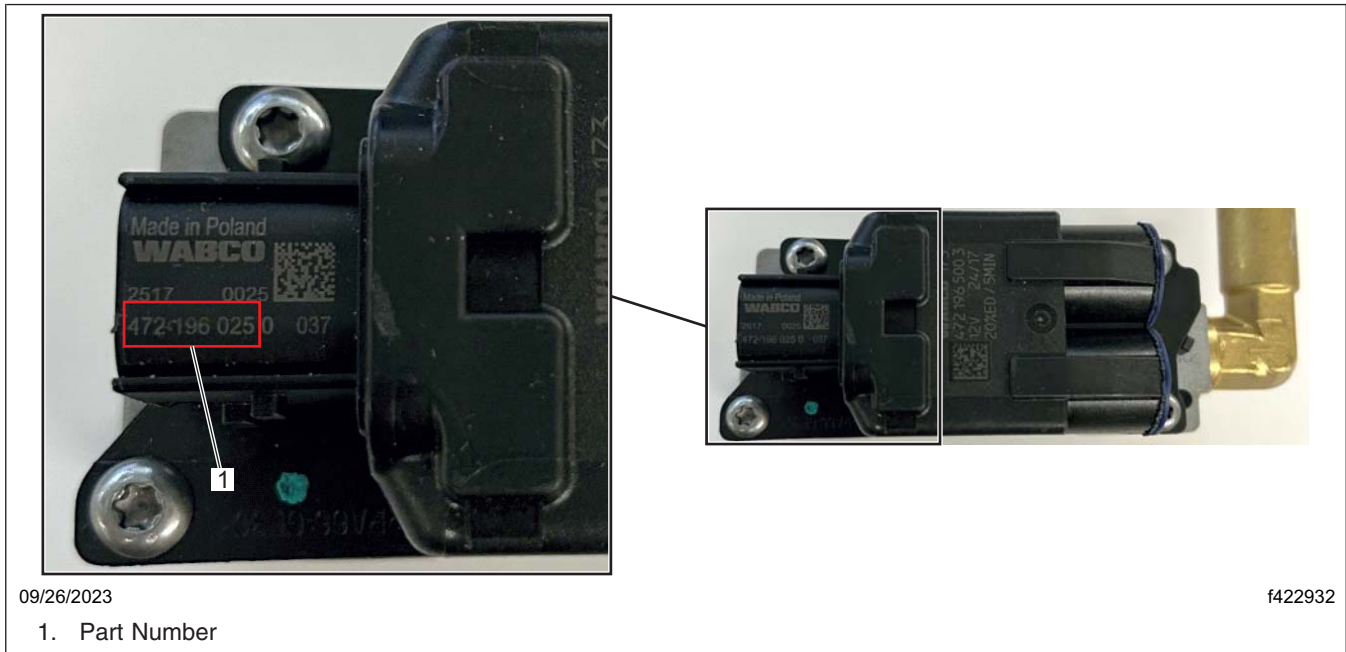
Fig. 1, Modulator Valve

4. Remove the connector from the valve, and inspect the part number underneath the connector. See [Fig. 1](#).

Good part numbers → **472 196 046 0** and **472 196 051 0**

Bad part numbers → **472 196 025 0** and **472 196 037 0**

- If the part numbers are good, install the connector. Clean a spot on the base label (Form WAR259), and attach a campaign completion sticker for FL958 (Form WAR260), indicating this work has been completed.
- If at least one of the part numbers is bad, go to the replacement procedure for the specified group, and replace both the modulator valves.
